# Missouri River Basin Hydrology, Connectivity, and Geomorphology Assessment Report

MINNESOTA DEPARTMENT OF NATURAL RESOURCES:  
DIVISION OF ECOLOGICAL AND WATER RESOURCES

October 10, 2014

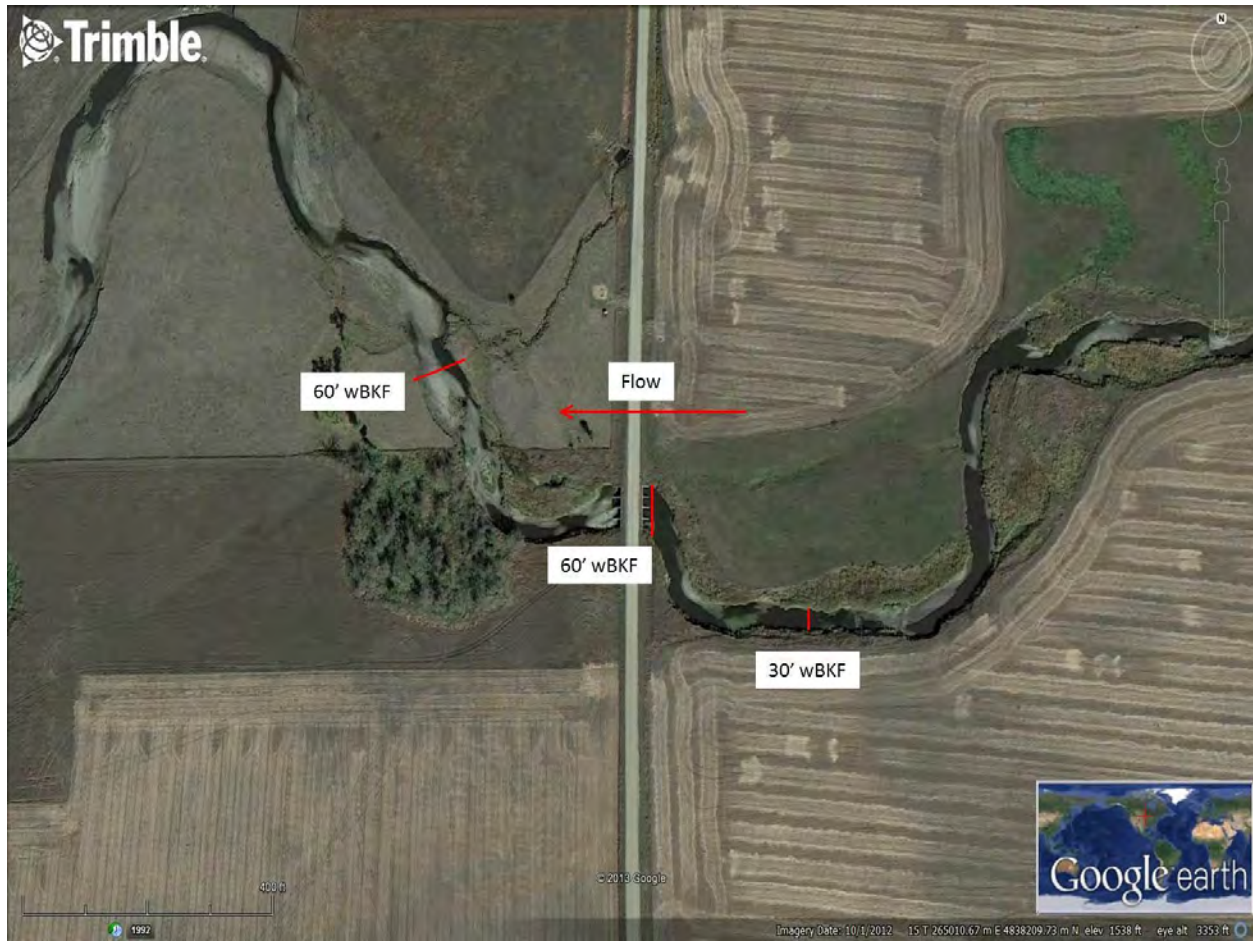
**Figure 21. Aerial imagery of an oversized culvert on Kanaranzi Creek. The stream is flowing from right to left. Upstream of the culvert, the bankfull width is approximately 30 feet. The 4-barrel culvert is approximately 60 feet wide, affecting downstream bankfull widths to be twice as wide as upstream. Improper sizing of culverts can cause an excess amount of sediment downstream resulting in loss of habitat quality for a long distance downstream. Culverts should be properly sized to fit the bankfull channel and have flood relief culverts in the floodplain to handle high flows. Photo courtesy of Google Earth.**

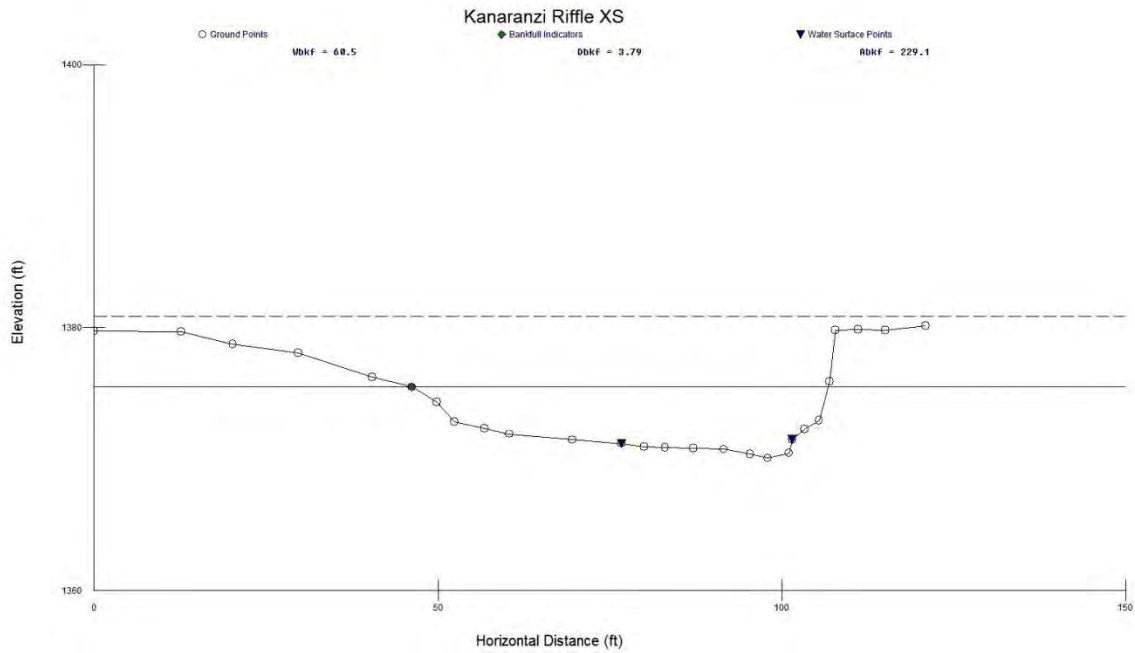
The width-to-depth ratio at the riffle is 15.96 (Figure 24), relatively low for a C channel in an alluvial valley type; however, its tortuous meanders suggest that historically this stream was an E

**Figure 24. Riffle cross section at Kanaranzi Creek geomorphology site. Although there is still good floodplain connectivity, low bank height is only one foot lower than the floodplain elevation.**

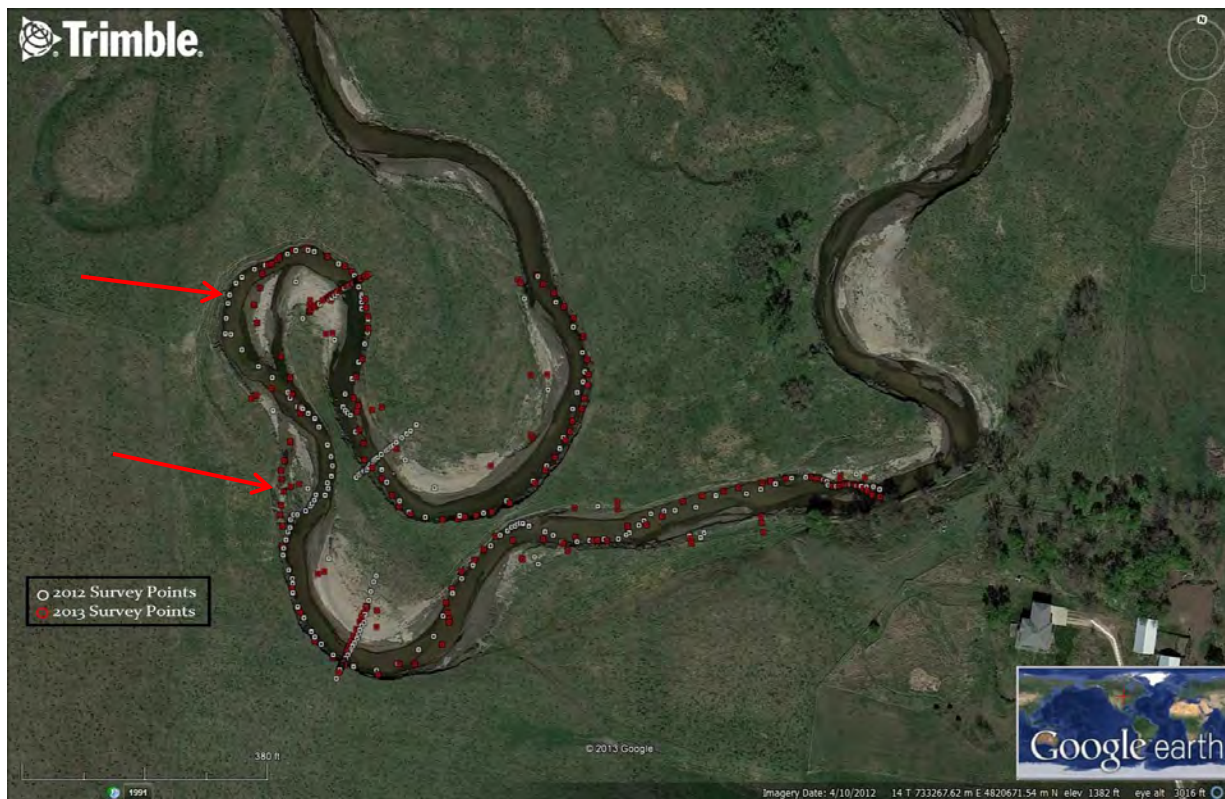
**Figure 27. Aerial photo (from Google Earth) of the Kanaranzi Creek site with 2012 and 2013 survey points. Notice the thalweg migration in the areas pointed out.**

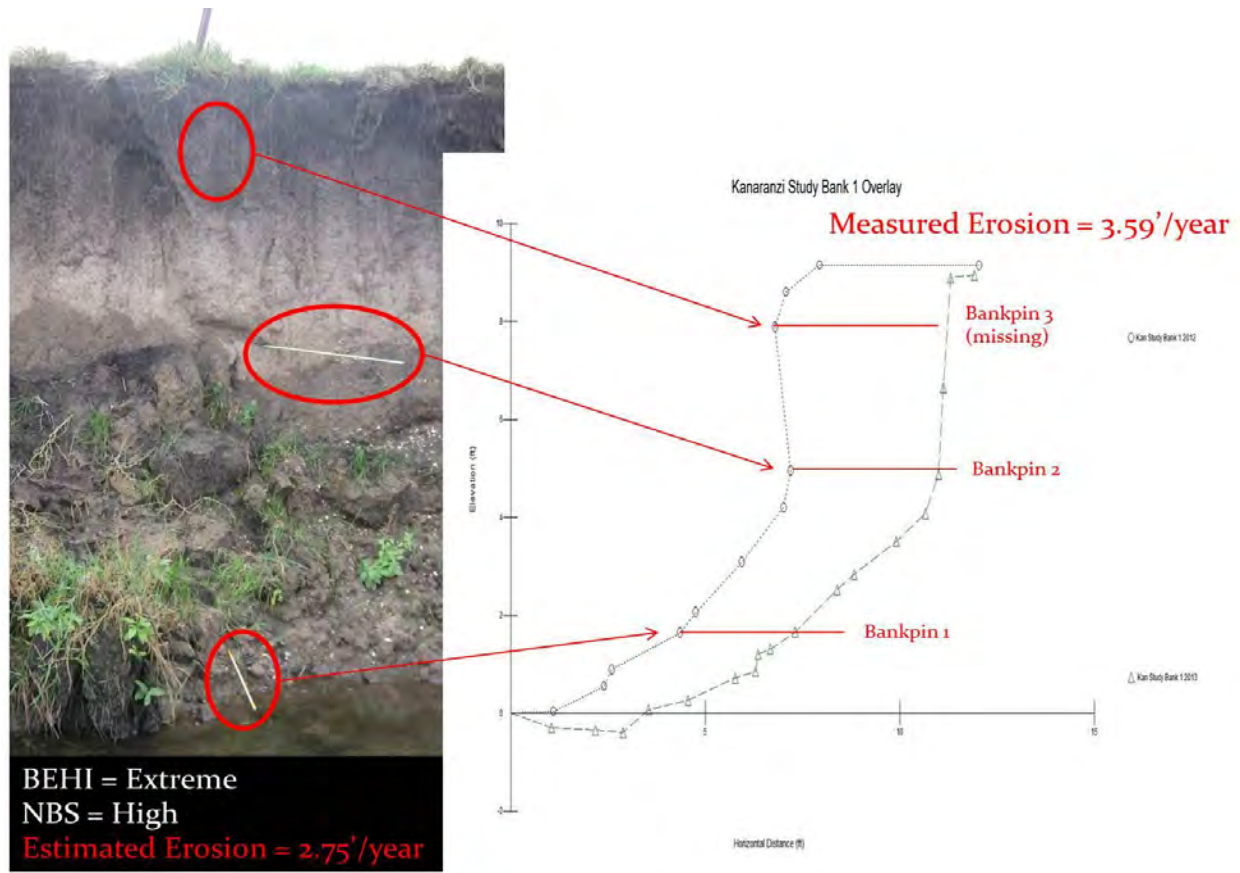
**Figure 28. Visual of study bank used to validate bank erosion model by monumenting a cross section and installing three 4' bank pins into the bank. The model estimated there would be 2.75' of bank erosion and actual bank erosion was 3.59' in one year, with the top bank pin being completely removed from the bank. On the other study bank, the model estimated 1.074' and measured 1.86' of bank erosion; again, an underestimation.**

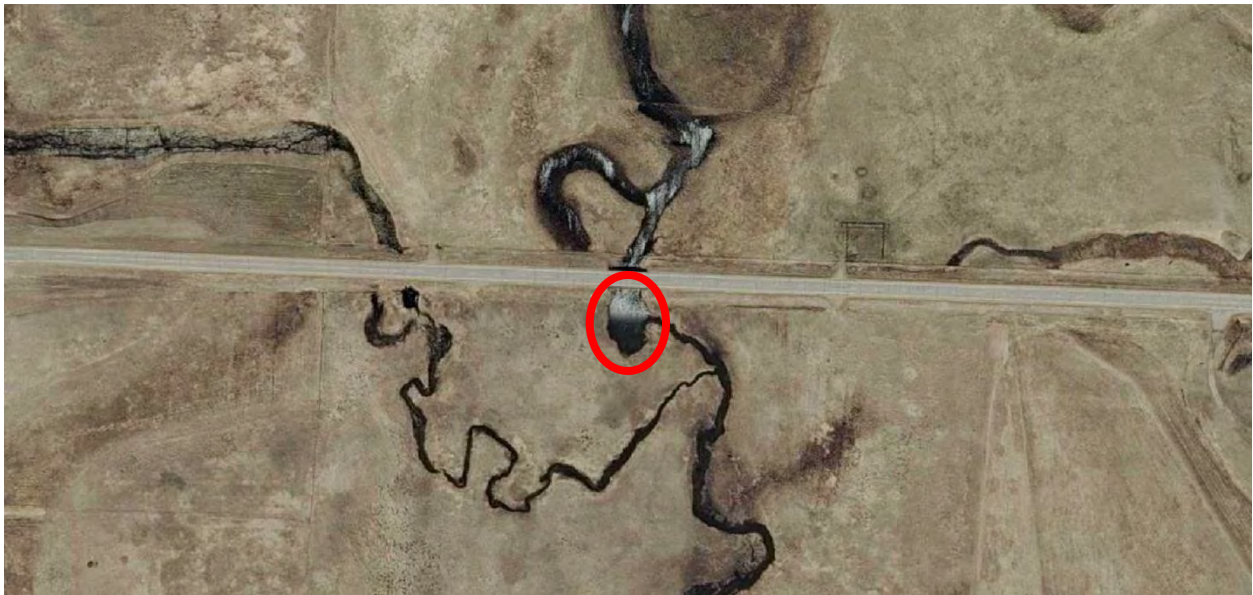
One potential concern with this site is the bridge located upstream of the study reach. Immediately downstream of the bridge there is an uncharacteristic pool for this stream that indicates the bridge is a stressor to channel stability (Figure 33). The bridge could be affecting the channel by improper sizing or by reducing the flood-prone area. Changes in dimension of the channel can disrupt sediment transport, resulting in excess deposition of fine materials.

**Figure 33. Aerial photo of oversized pool downstream of bridge, immediately upstream of the geomorphology survey reach.**

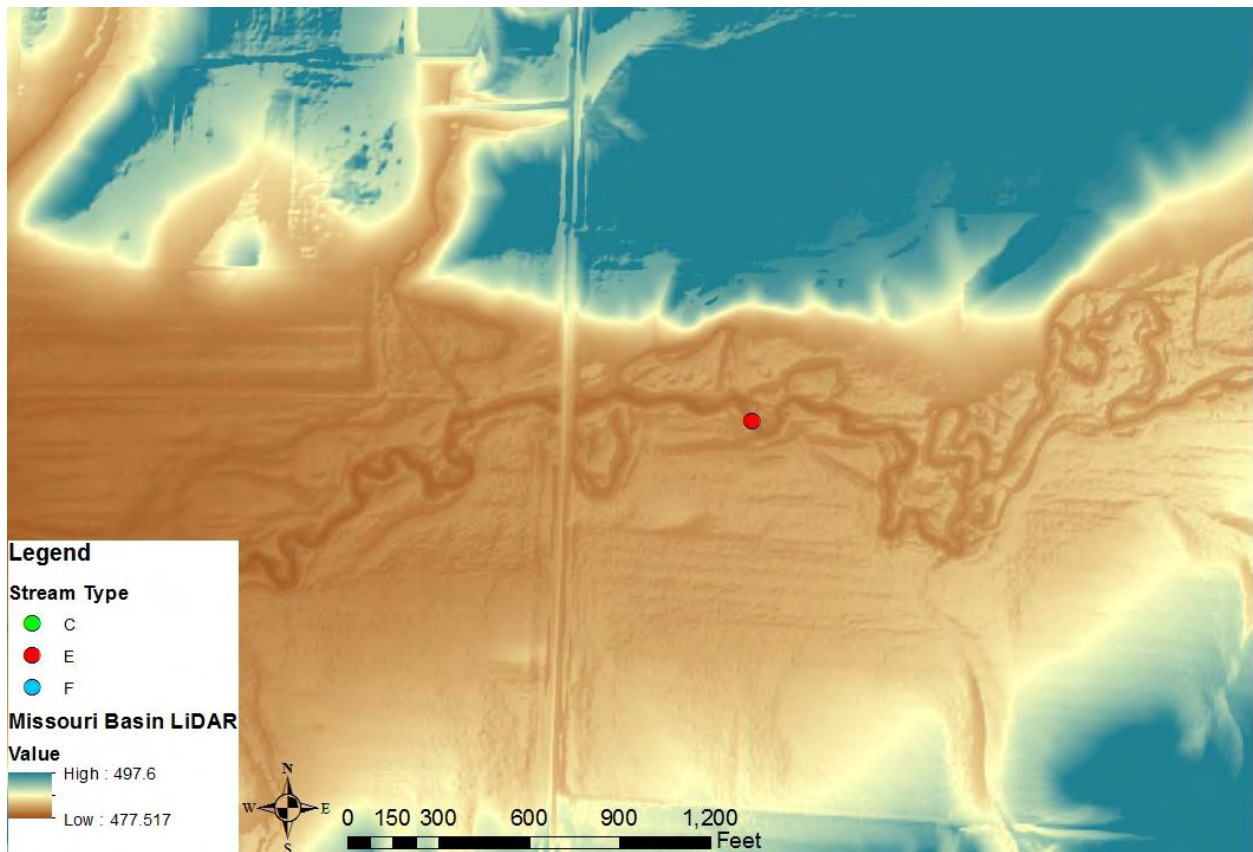
**Figure 41. LiDAR imagery shows old meander scrolls in the study reach that had wider belt widths, more consistent with upstream and downstream than what is currently observed. This is likely due to straightening of the channel to go through the culverts under the road crossing.**

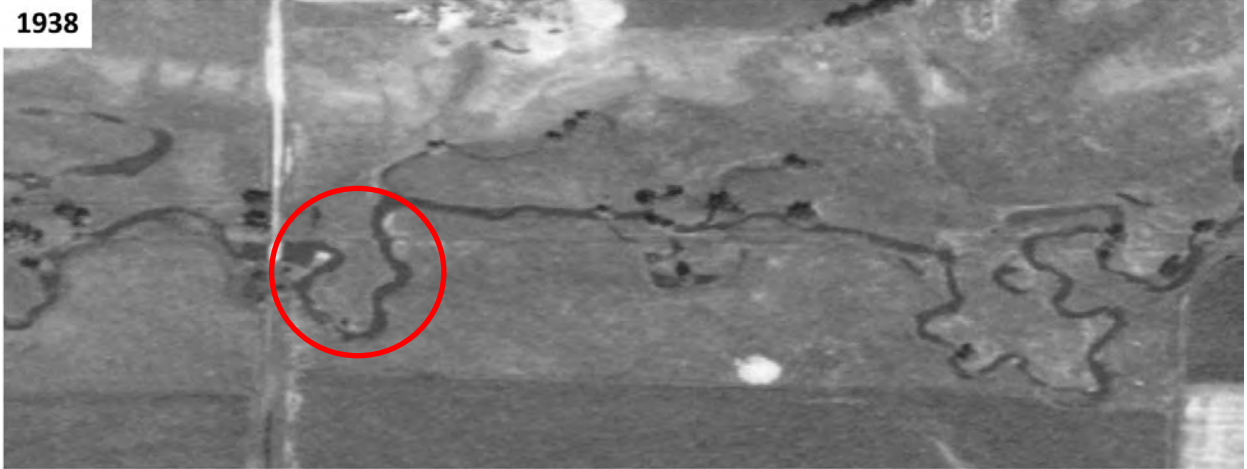
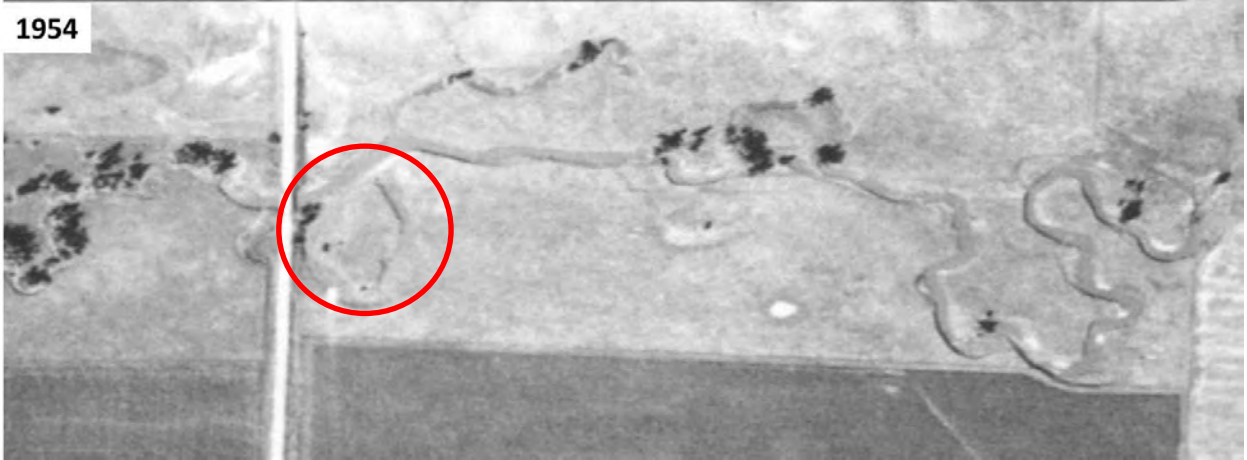
**Figure 42. Comparison of the 1938 and 1954 aerial photos at the Little Rock River geomorphology site. Notice the abandonment of the channel (oxbow) immediately upstream of the road crossing from 1938 to 1954.**

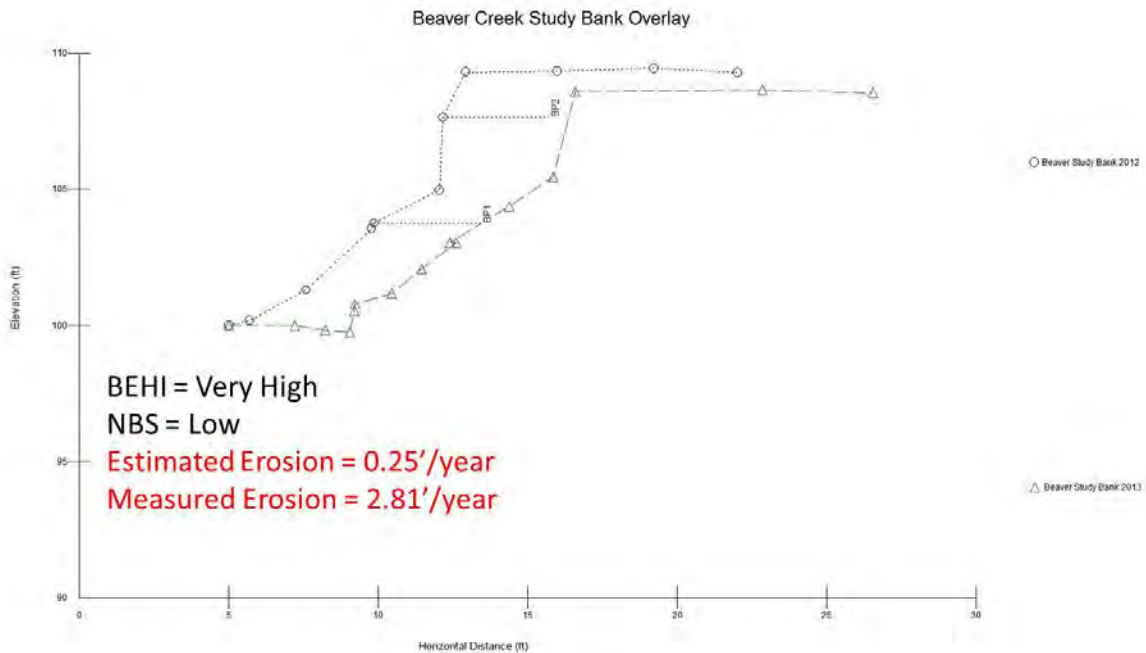
**Figure 54. Study bank cross overlay for the Beaver Creek site with estimated and measured erosion rates. Both bank pins were missing when the cross section was resurveyed in 2013. There are some discrepancies with this cross section because the toe pin was buried from thalweg migration and the monument rebar was not there anymore.**

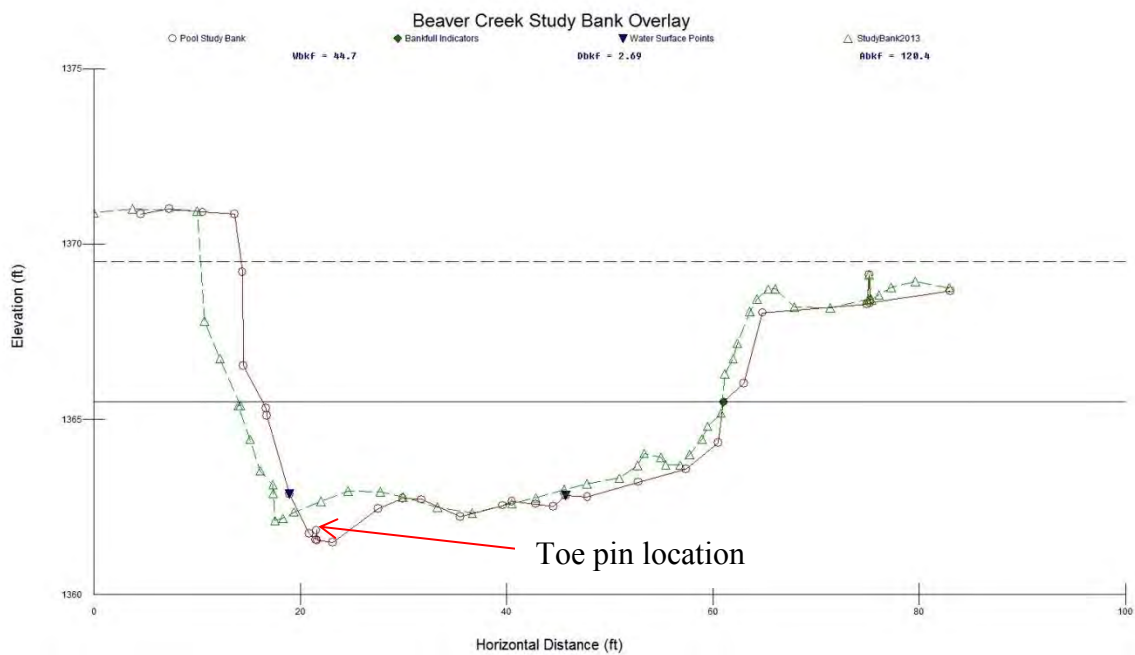
**Figure 55. Study bank cross section overlay at the Beaver Creek site. Notice how the thalweg moved and buried the toe pin for the study bank.**

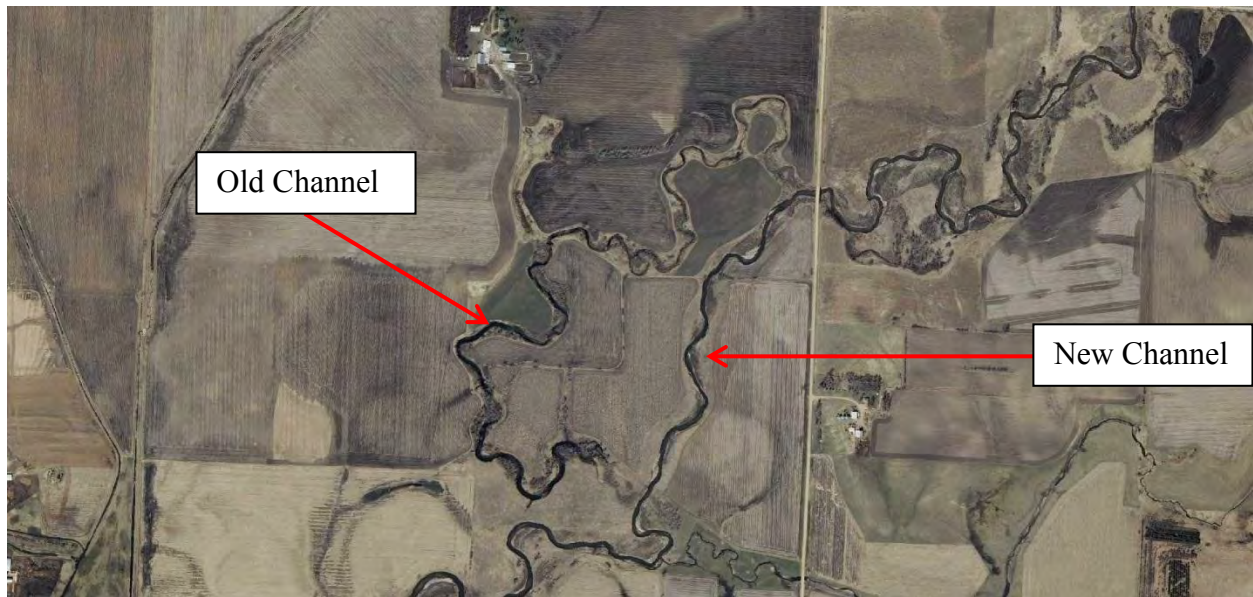
**Figure 56. Historical channel cutoff on Kanaranzi Creek upstream of study site. The old channel measures out to be 10,708 feet, while the current channel measures out at 3,319 feet; a difference in 7,389 feet or 1.4 miles. Areas like this should be restored into their old channel in order to achieve higher water storage potential and maintain channel stability.**

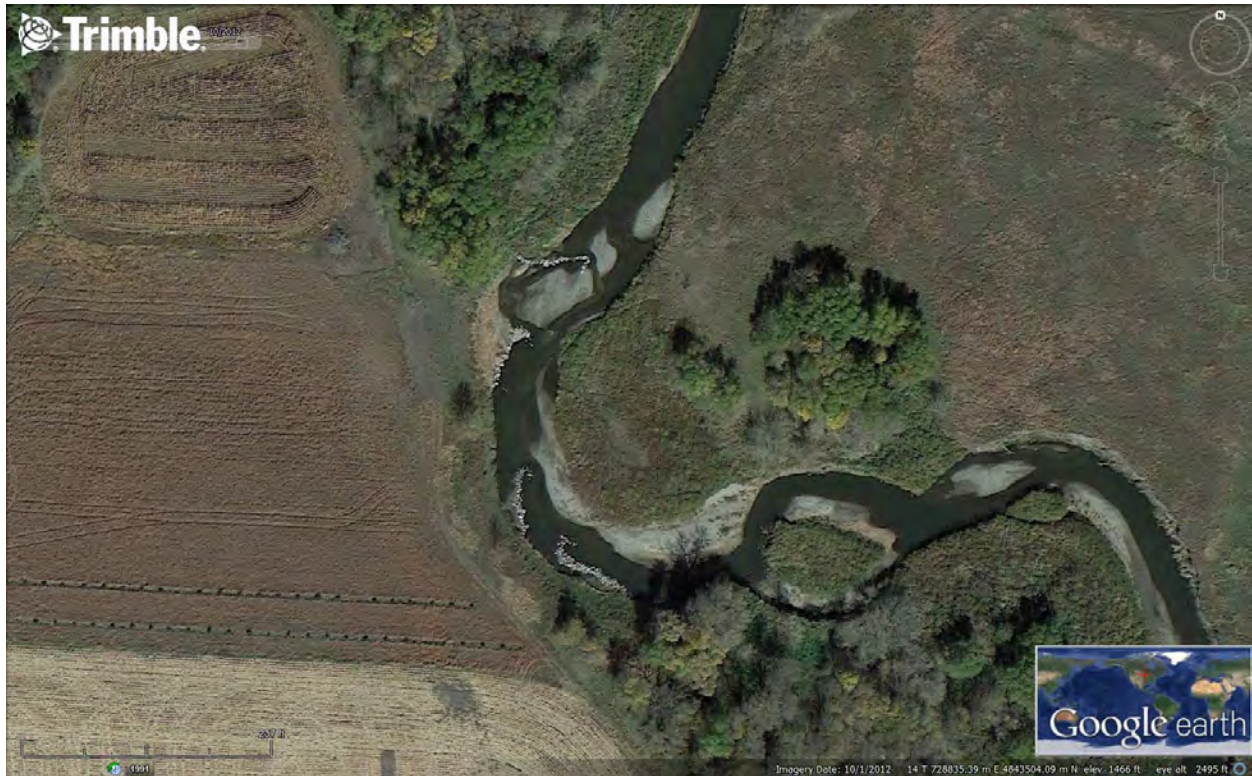
**Figure 57. Aerial photo of a J-hook project on the Rock River that was designed outside of specifications made for J-hooks. This has resulted in issues with bedload deposition downstream of the 1st J-hook. Photo courtesy of Google Earth.**

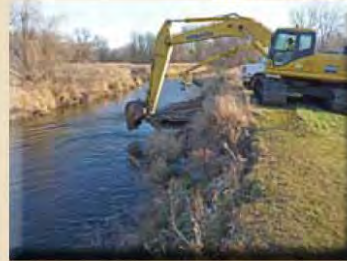
Unstable bank and failing flood control dike protecting a mobile home park. The project started with the placement of woody debris and insertion of root wads.
