Effects of Liquid Manure Storage Systems on Ground Water Quality

April 2001

Minnesota Pollution Control Agency
Ground Water and Toxics Monitoring Unit
Environmental Monitoring and Analysis Section
Environmental Outcomes Division
520 Lafayette Road
St. Paul, Minnesota 55155-4194
(651) 296-6300 or (800) 657-3864

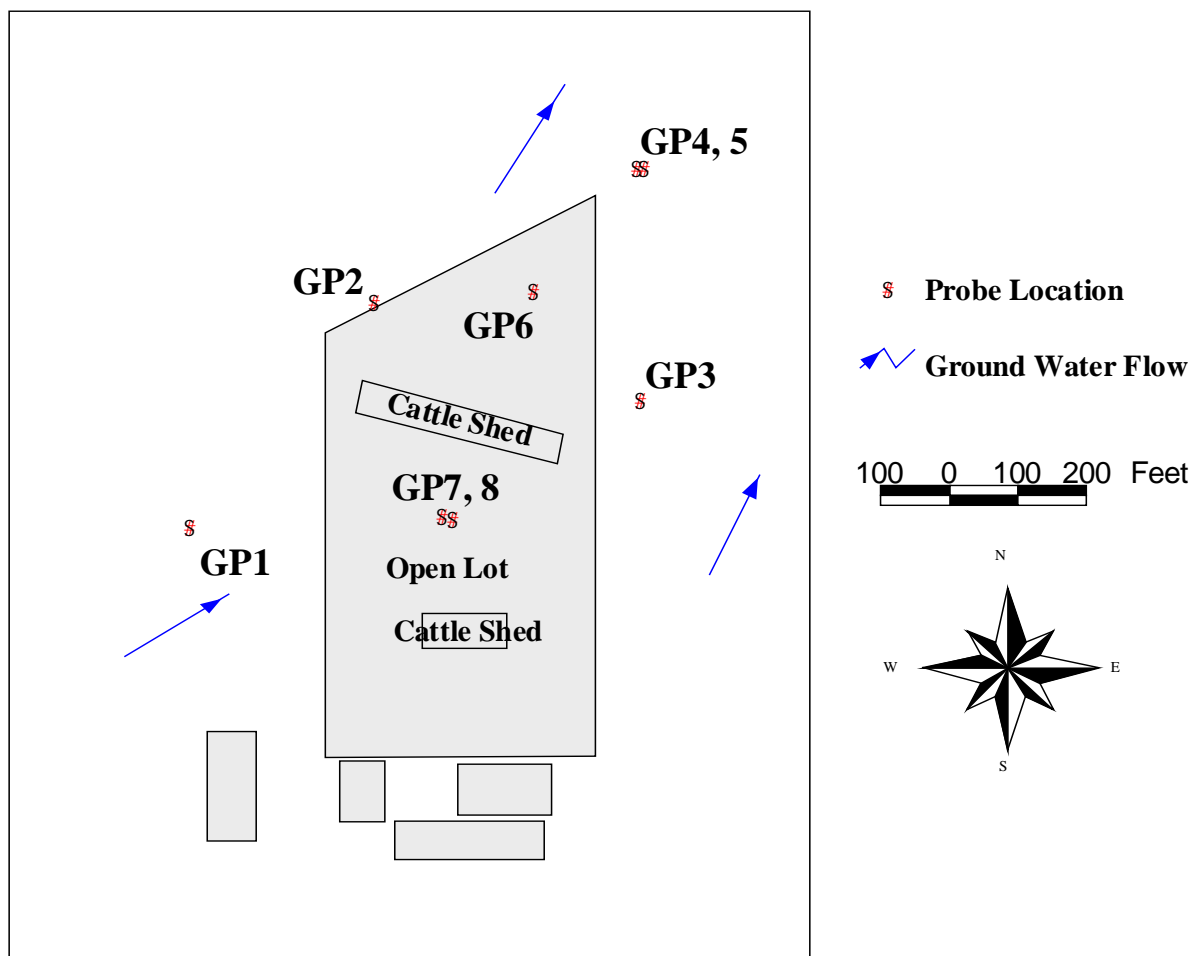
Figure 3 illustrates the location of temporary wells at Site O2. Ground water flow is to the northeast. Table 4 summarizes water quality data for each of the wells.

Figure 3: Location of temporary wells and direction of ground water flow at Site O2.

found at most other sites. Second, Site O2 operates as a temporary feedlot, where animals are removed on a periodic basis and manure and soil are scraped and removed. Because of the intermittent animal activity and the deep water table, soils at the site may not be excessively compacted and water leaching through the soil may be oxidized. Nitrogen therefore leaches as nitrate. Total nitrogen concentrations at Wells 4 and 5, located about 220 feet down-gradient of the feedlot, were about an order of magnitude greater than in Well 1. A nitrate plume therefore extends at least 220 feet from the feedlot.

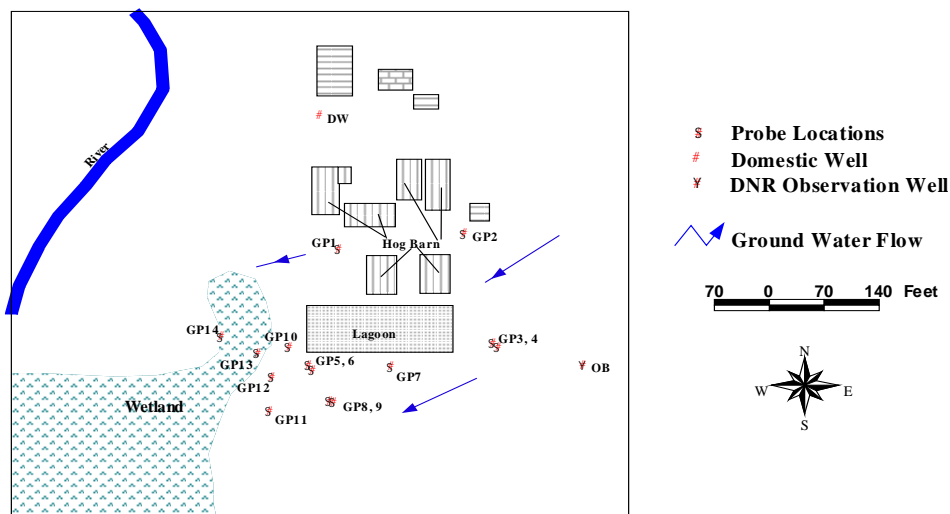
Figure 10 illustrates the location of temporary wells at Site U3. Ground water flow is to the southwest. Table 11 summarizes water quality data for each of the wells.

Figure 10: Location of temporary wells and ground water flow direction at Site U3.

Concentrations of *E. coli* bacteria do not correlate with the location of the unlined basin. Bacteria were found in Wells 3 and 4, which are up-gradient of the basin, and in Wells 10, 13, and 14, which are the furthest down-gradient wells. No bacteria were found in wells closest to the basin. Bacteria in up-gradient wells may be associated with spreading of manure, although we do not have information on the cropping history of fields adjacent to the manure storage

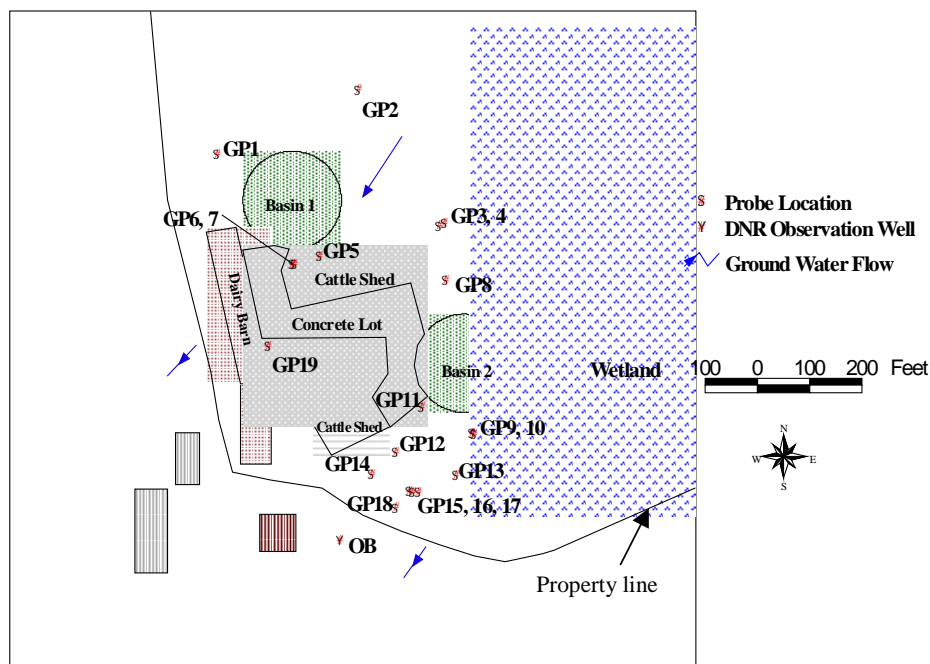
Figure 13: Location of temporary wells and ground water flow direction at Site E1.

Well 7, located immediately down-gradient of Basin 1, showed impacts from manure storage. Concentrations of ammonia, chloride, dissolved organic carbon, phosphorus, and Kjeldahl nitrogen were 66, 94, 39, 0.55, and 77 mg/L, respectively. This compares with concentrations of 0.05, 8.1, 1.0, 0.04, and 0.3, respectively, in Well 2, which was up-gradient of the feedlot. The Eh in Well 7 was very low (73 mV), while iron concentrations were high (22.4 mg/L), reflecting nitrate-reducing conditions. Well 6, which formed a nest with Well 7, was drilled five feet deeper than Well 7. No water quality impacts were evident in Well 6. A plume extends to Well 19, since concentrations of ammonia in this well were 8.78 mg/L. Well 19 was located about 275 feet from the center of Basin 1.

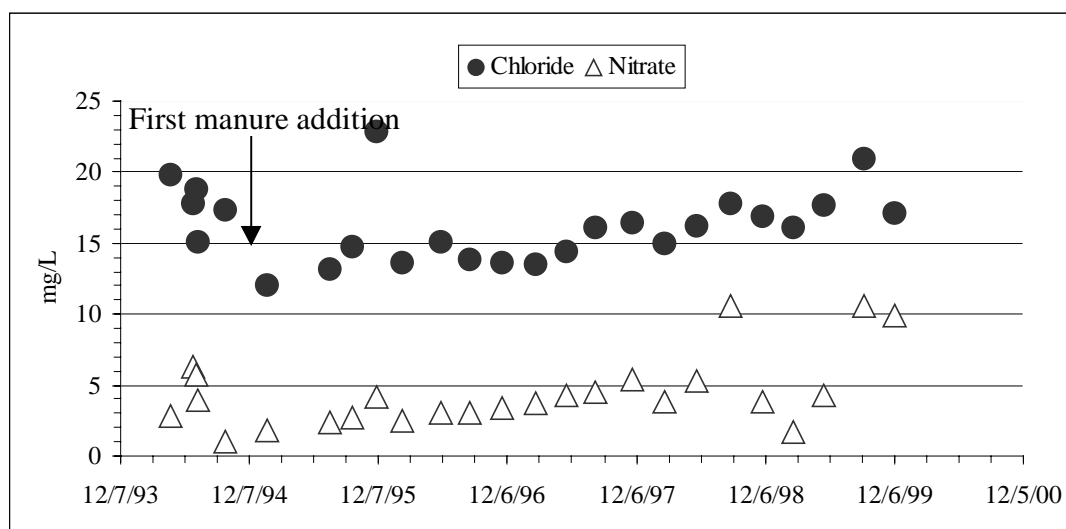
Figure 19: Concentrations of chloride and nitrate as a function of sampling date in Well 3 at Site EM2.

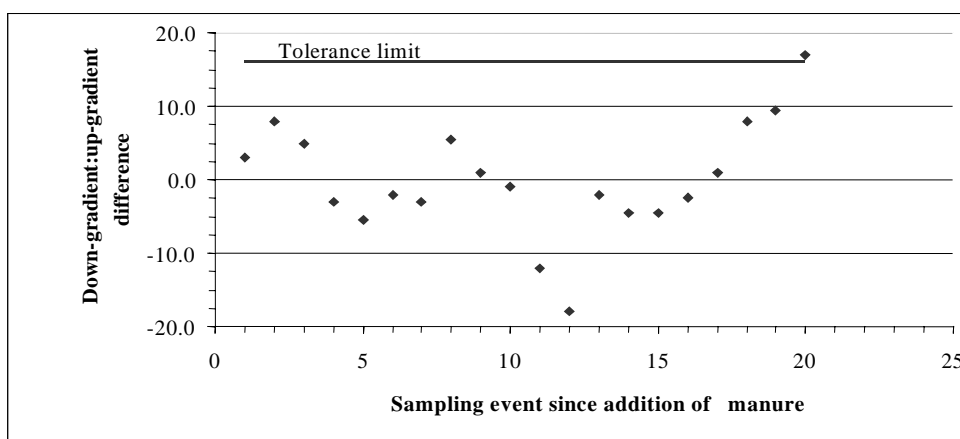
Figure 21: Difference between down-gradient (Wells 3 and 5) and up-gradient (Well 1) ranked concentrations of chloride at site EM3 since addition of manure. The 90 percent tolerance limit is included in the plot.

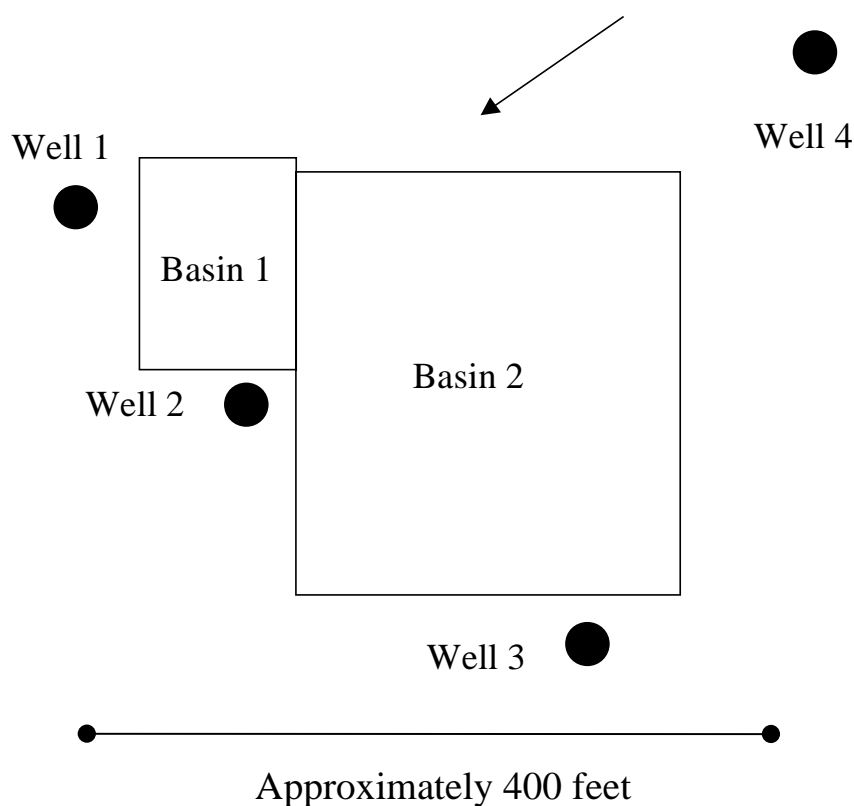
Figure 24: Location of monitoring wells, manure basins, and ground water flow direction (arrow) at site EM5.

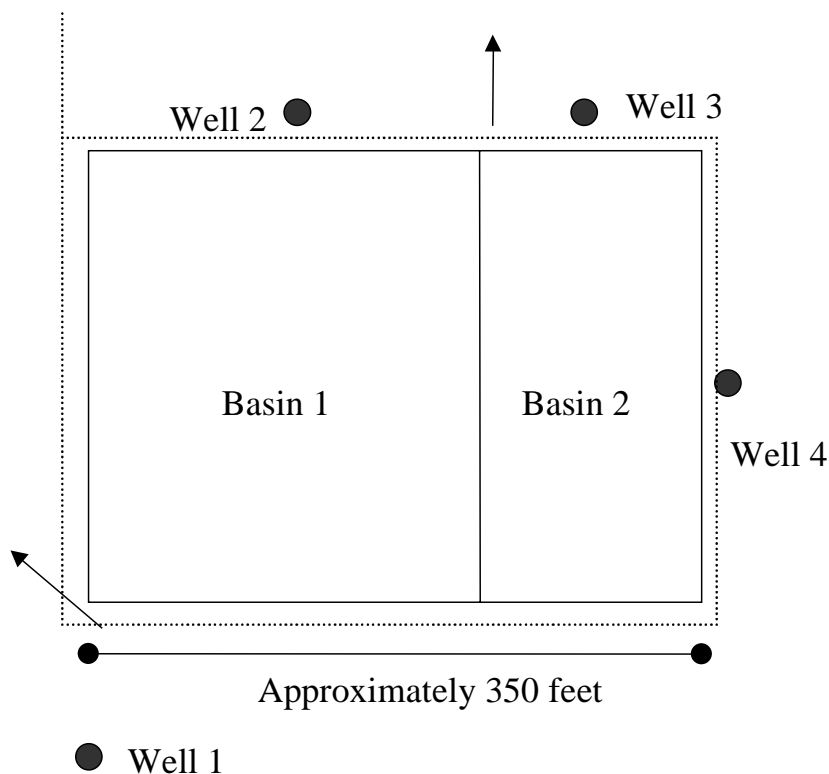
Figure 29: Location of manure storage basins, monitoring wells, and ground water flow direction (arrow) at site EM8. The dashed line illustrates the location of the tile lines.

Well 1 is up-gradient of the basins, while Well 2 is down-gradient. Using nonparametric methods, we calculated 90 percent confidence tolerance limits. We observed no significant differences between Wells 1 and 2 in concentrations of sulfate, chloride, nitrate, specific conductance, total Kjeldahl nitrogen, and ammonia. We observed significant negative correlations between sampling event and specific conductance and concentrations of sulfate and nitrate in Wells 1 and 2 (Table 25).

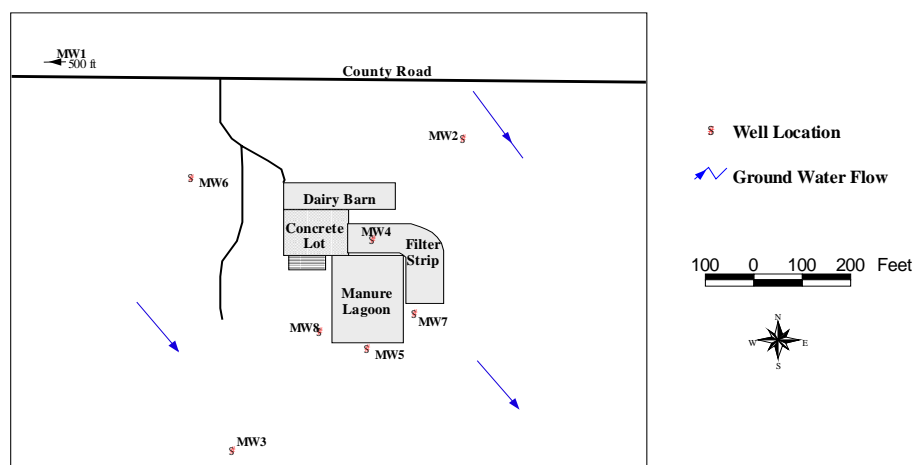
Figure 48: Location of monitoring wells and ground water flow at the site with a geosynthetic liner. Note that wells shown in Figure 48 represent permanent wells drilled after our initial investigation with temporary wells. The well locations in Figure 4 therefore differ from those shown in Figure 48.

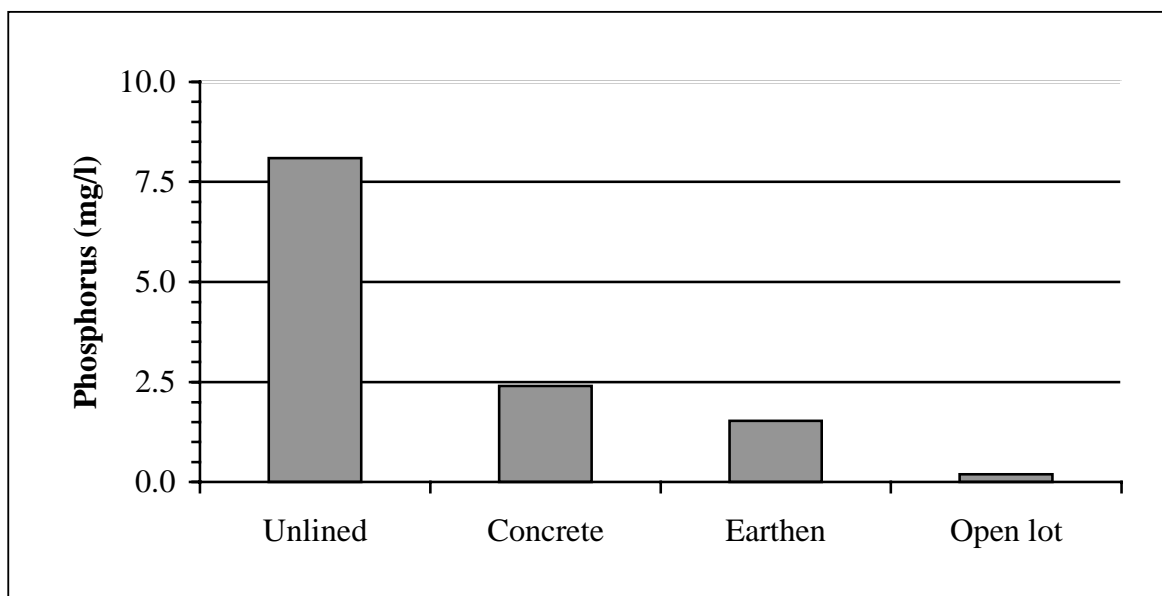
Figure 50: Median phosphorus concentrations for different manure storage systems.

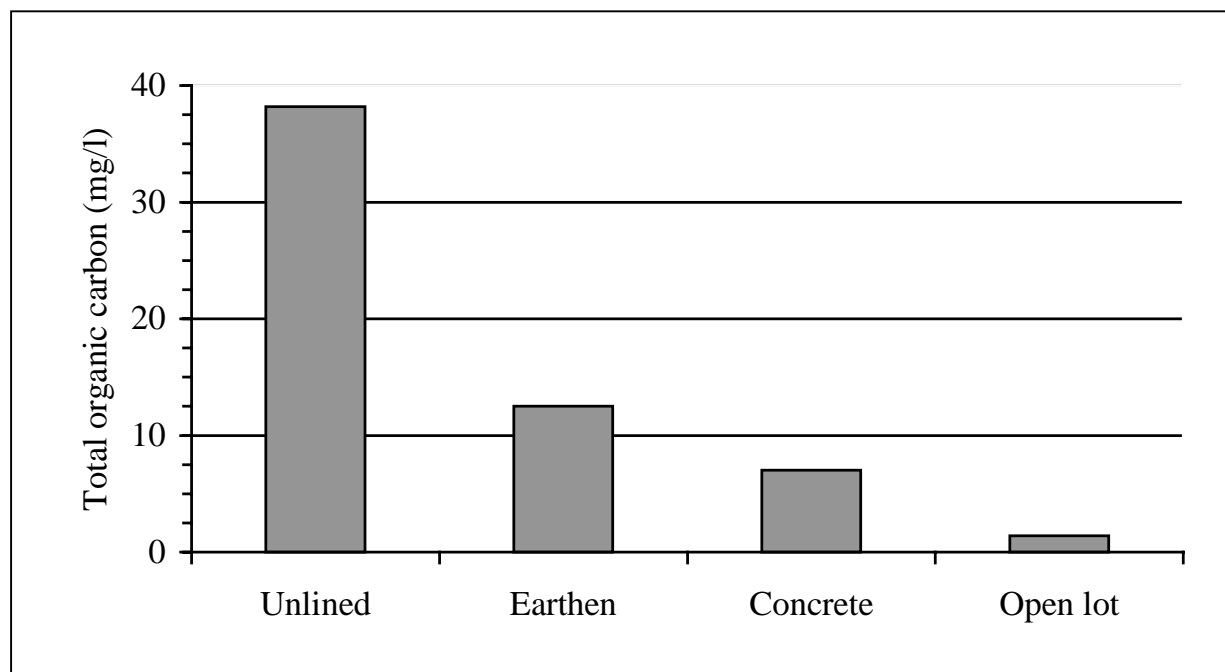
Figure 51: Average concentrations of total organic carbon under four different manure management systems.
