August 2021

# Tamarack River, Horseshoe, Island and Minnewawa Lakes Nine Key Element Plan

Federal Clean Water Act Section 319 Small Watersheds Focus Grant Workplan

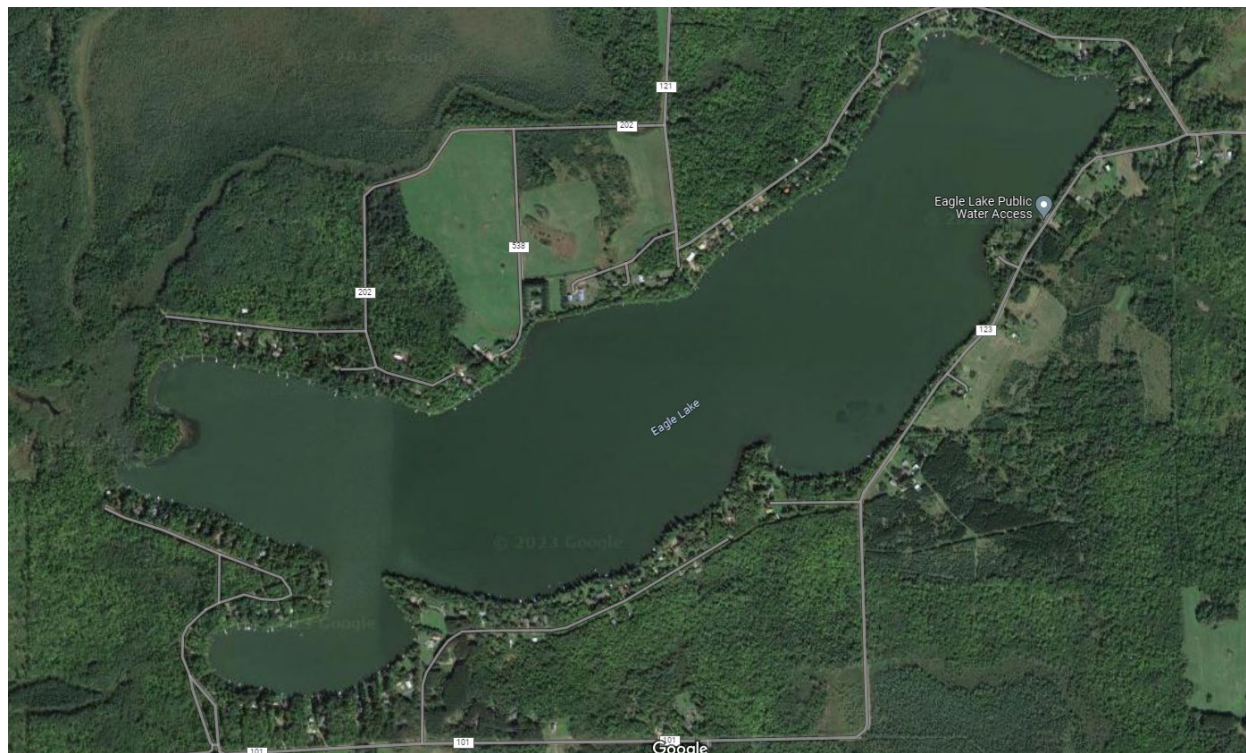
**Figure 4. Eagle Lake lakeshore development map (Google Maps, 2023)**

The shoreline of the lake is well developed with very small lots that were originally seasonal but are currently converting to year-round homes. There are several agricultural farms and pastures within the watershed that are contributing agricultural runoff to the lake. The majority of the runoff is coming from the urban landscape adjacent to the lakes. The main sources include runoff from lawns and impervious surfaces as well as failing septic systems.

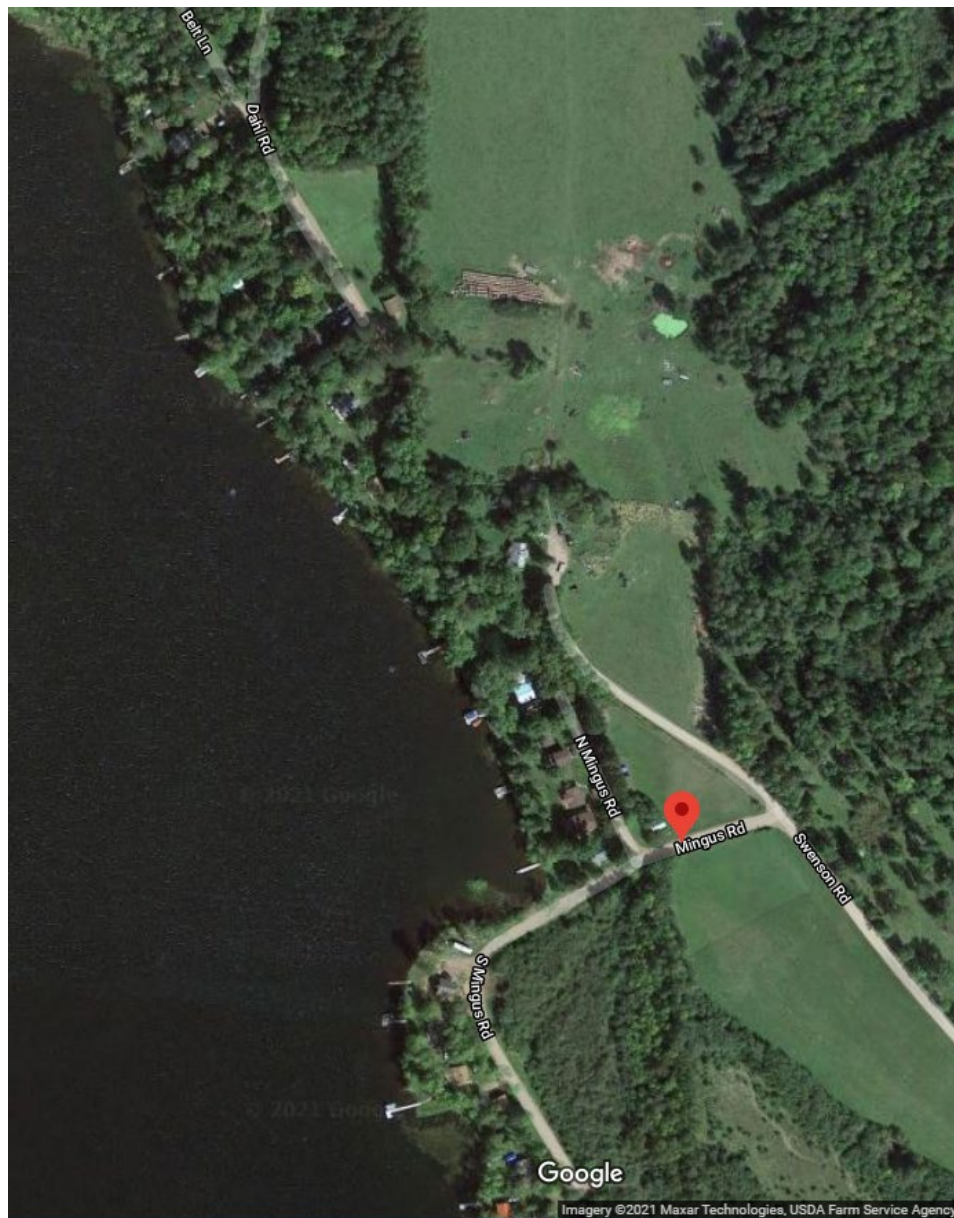
**Figure 10. Map of area Belt Lane and Mingus Road**

Concentrated, small lots on the east side of the lake along Belt Lane and Mingus Road (Figure 10) are highly impervious, densely developed with small lot sizes. This creates a high loading area due to density. Stormwater BMPs will be targeted to address these lots (Figure 5).
