Poplar River Watershed

Total Maximum Daily Load Report: Turbidity Impairment

Minnesota Pollution Control Agency
October – 2013

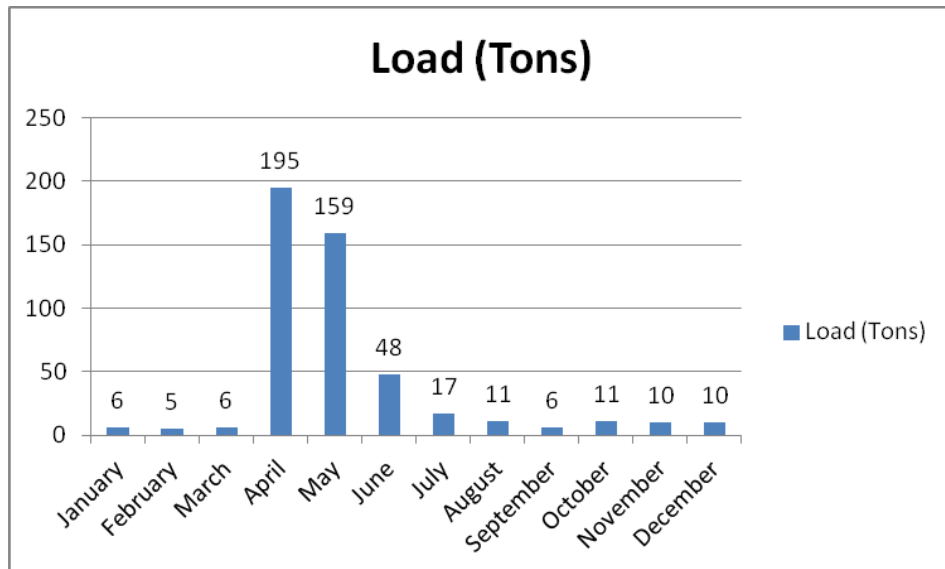
Figure 3.2 Estimated annual loads and average at the downstream station (S000-261).
