# Duluth Urban Area Streams Total Maximum Daily Load

Restoring and protecting urban streams in Duluth and surrounding areas.

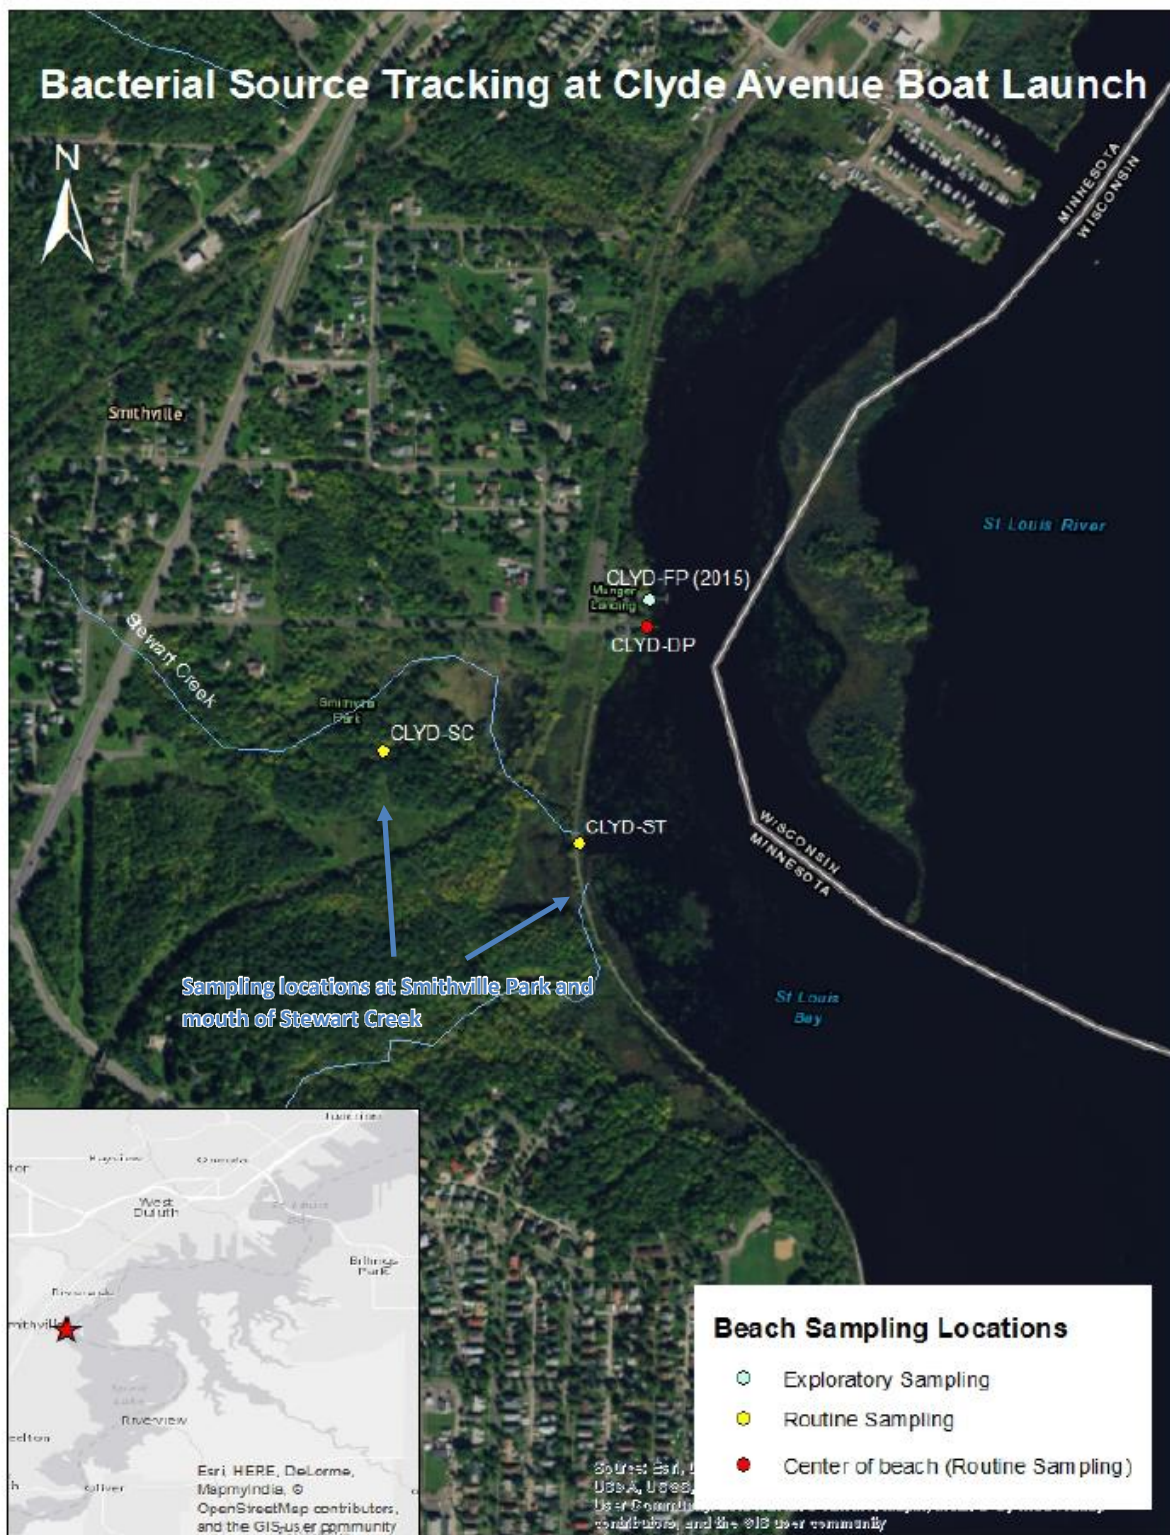
Figure 36. Sampling locations along Stewart Creek for the Clyde Avenue Beach bacterial source assessment (Prihoda et al. 2017).

Ruminant DNA markers were detected in one upstream sample site near Smithville Park. No gull DNA markers were detected in any of the samples that were selected for DNA analysis for the Stewart Creek locations.

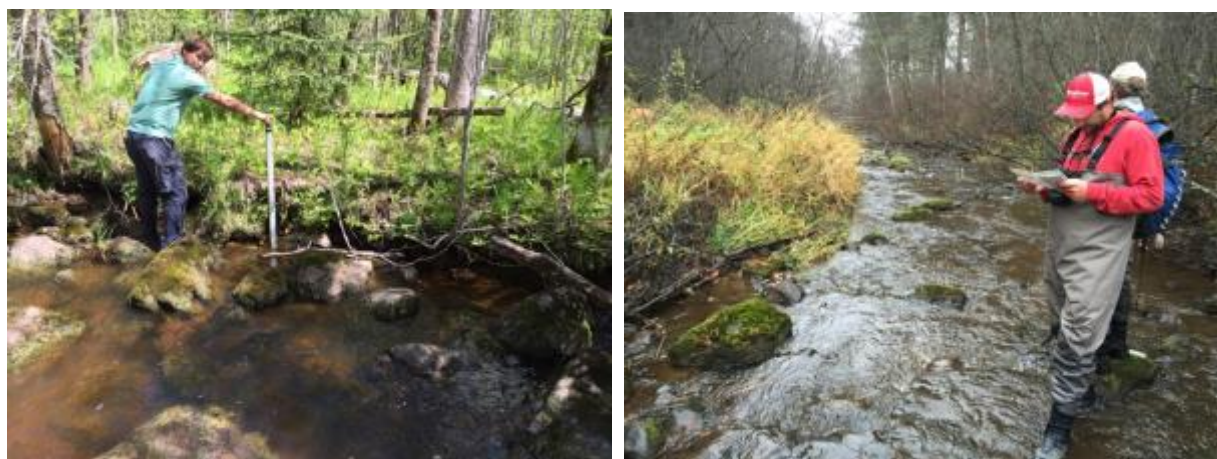
Figure 8. Category 1 Erosion Rates Observed in Reaches AM-14 and EB-3 (less than 0.1 ft/yr).

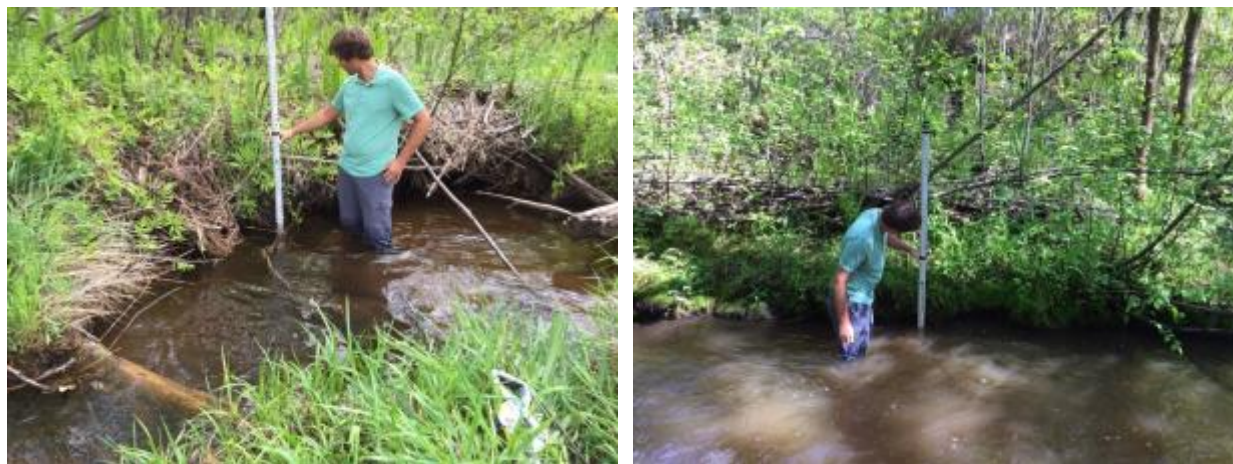
Figure 9. Category 2 Erosion Rates Observed in Reaches EB-5 and AM-10 (0.1 to 0.4 ft/yr).

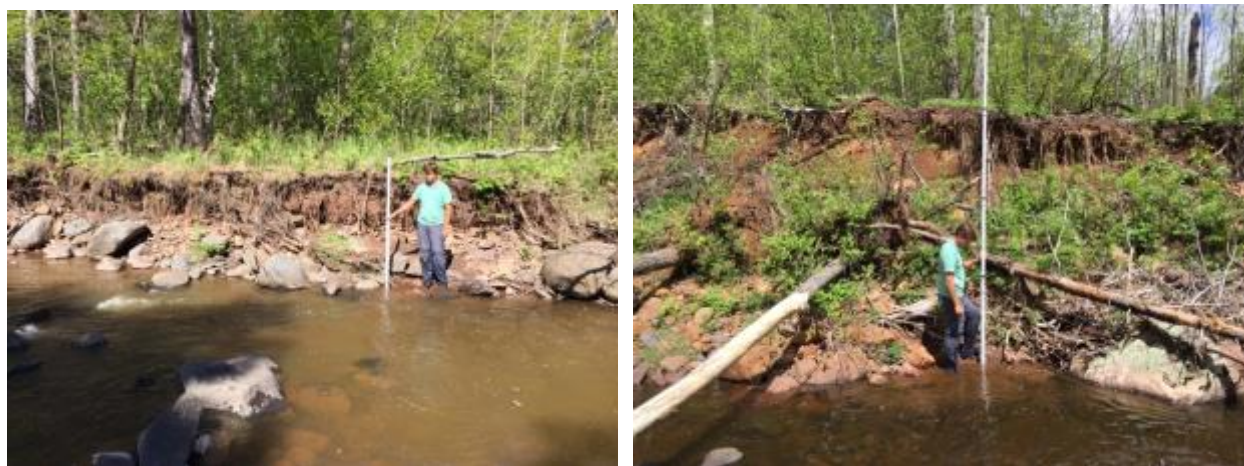
Figure 10. Category 3 Erosion Rates Observed in Reaches AM-2 and EB-2 (0.3 to 0.5 ft/yr).

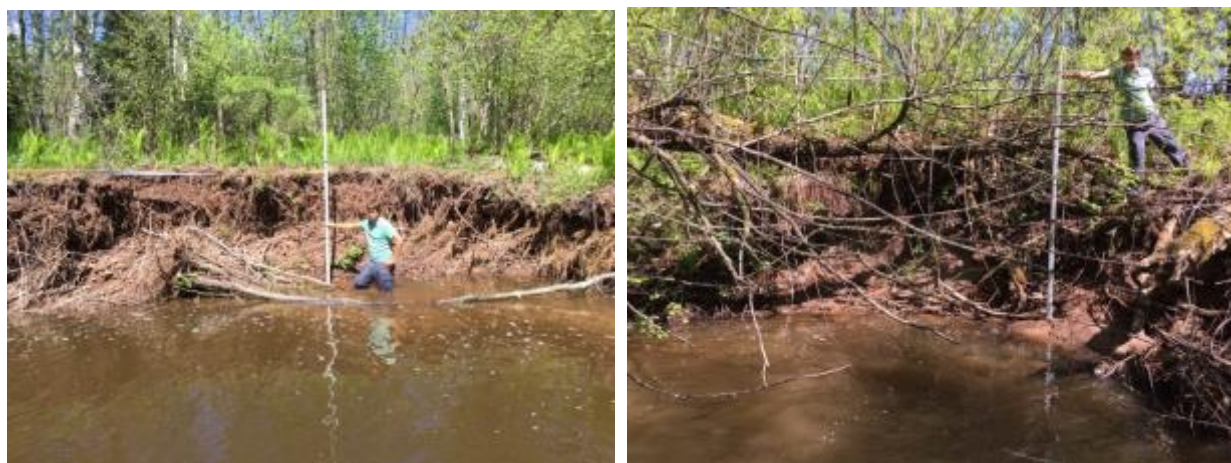
Figure 11. Category 4 Erosion Rates Observed in Reaches AM-9 and AM-10 (0.5 to 2.0 ft/yr).

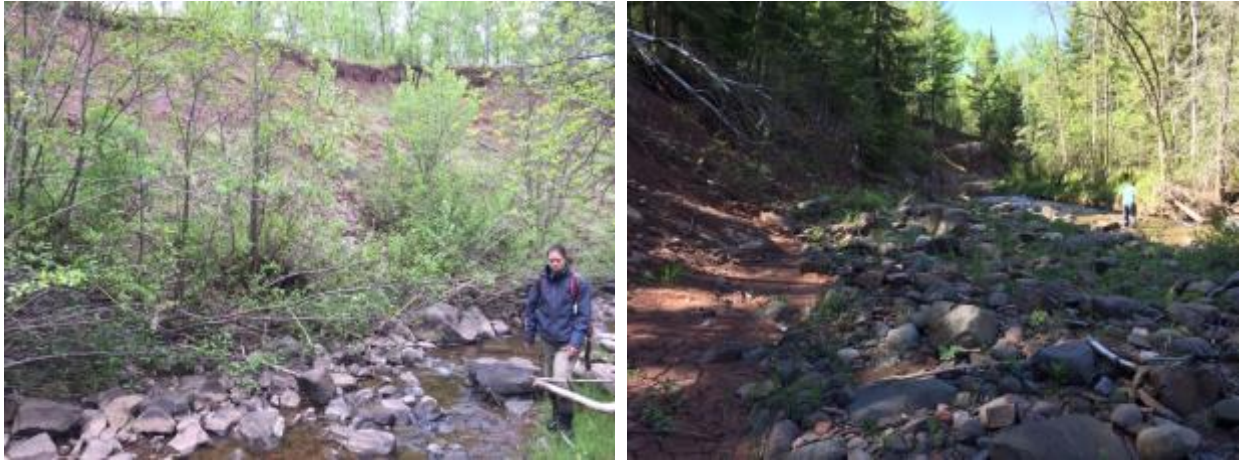
Figure 12. Category 5 Erosion Rates Observed in Reaches AM-3 and AM-2 (less than 0.1 ft/yr streambank erosion and variable hillslope erosion rates).

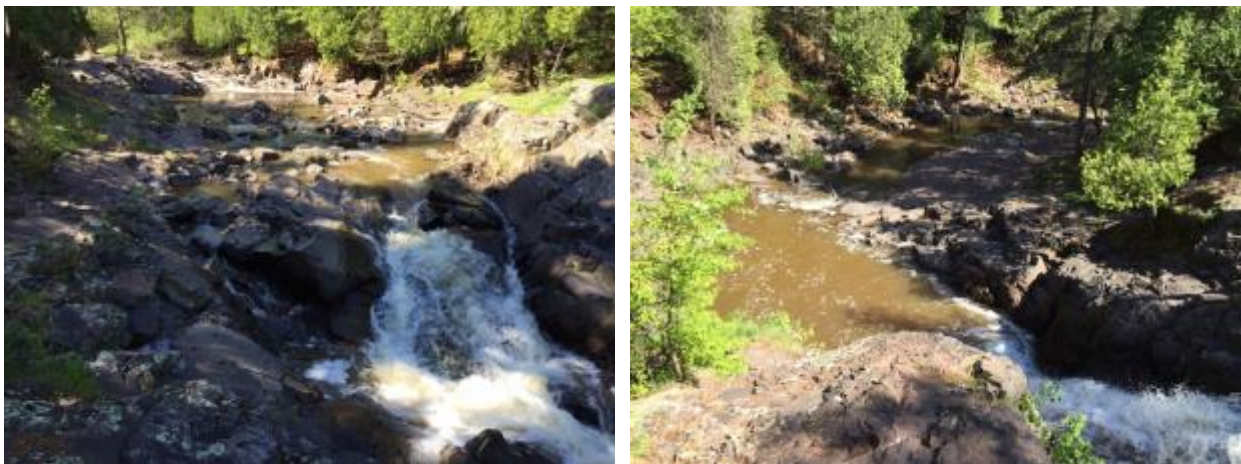
Figure 13. Category 6 Erosion Rates Observed in Reaches AM-1 and AM-8 (less than 0.1 ft/yr streambank erosion and no hillslope erosion).
