# Pomme de Terre River Watershed Biotic Stressor Identification

A study of local stressors limiting the biotic communities in the Pomme de Terre River Watershed.

Minnesota Pollution Control Agency

June 2012

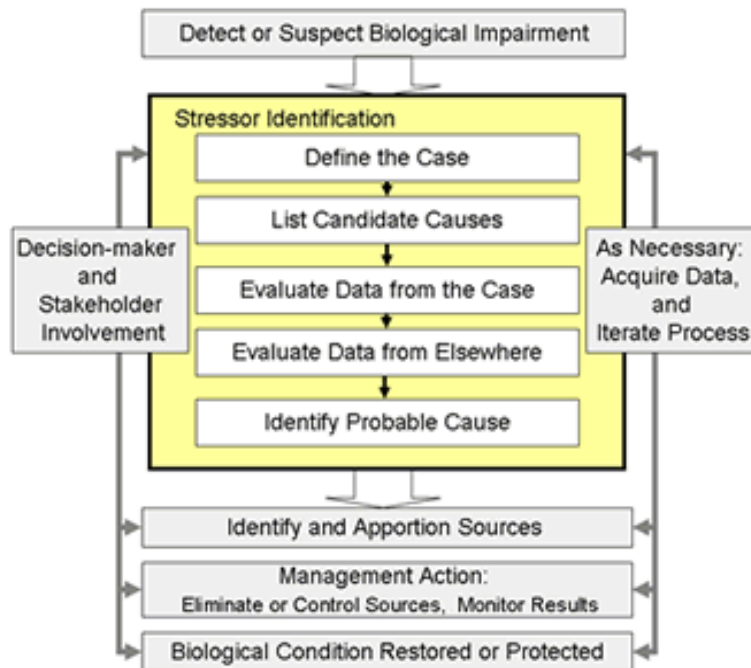
Figure 1. Conceptual model of stressor identification (SID) process

This report describes the step-by-step analytical approach, based on the U.S. EPA's Stressor Identification process (SID), for identifying probable causes of impairment in a particular system (Figure 1). In the Pomme de Terre River watershed, stressors that were examined for possible cause of biotic impairment were low dissolved oxygen, high nitrate-nitrite, excess phosphorus, high turbidity, lack of habitat, lack of connectivity, and altered flow regime. Other stressors were considered but did not have sufficient evidence for further analysis.

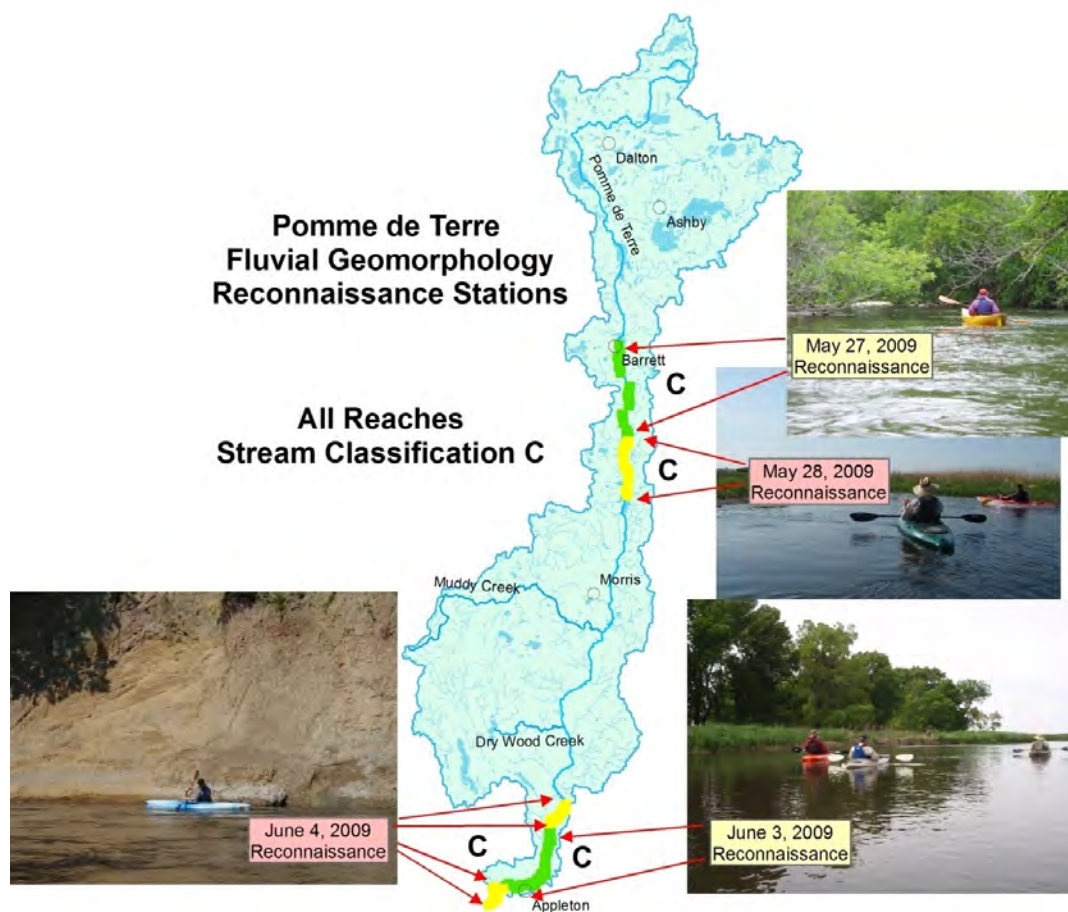
Figure 6. Geomorphology reconnaissance stations

Five reaches of the Pomme de Terre River were assessed by Pomme de Terre Watershed, MPCA, DNR, and MCC staff from kayaks on four dates during the summer and early fall of 2009. Locations and dates for these reconnaissance assessments are shown in Table 6. These assessments roughly covered the area between Barrett Lake and the chain of lakes and from above Highway 12 to the mouth of the river at Marsh Lake. The goals of the recon surveys included collecting data on stream condition, including stream classification, bank erosion potential, stream habitat condition, riparian condition, indices of stream stability, identification of representative areas for collection of additional data, and identification of potential problem and restoration areas.

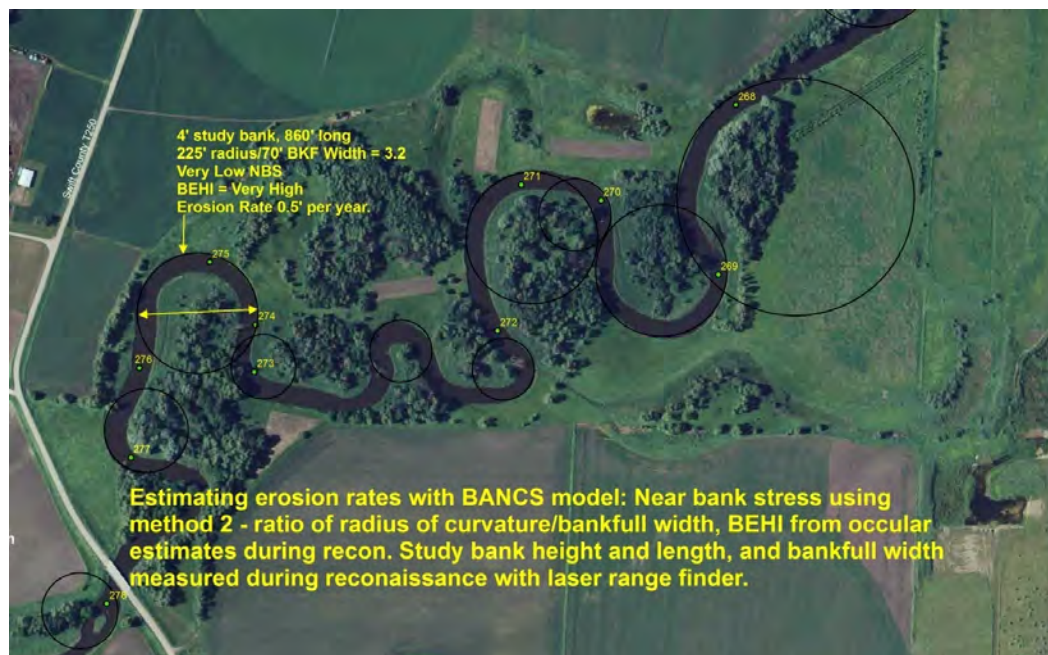
Figure 7. Example of methodology used to estimate erosion rates with BANCS model

The procedure for estimating bank erosion rates and total erosion during the reconnaissance portion of our investigation was a modified version of the “Bank Assessment for Non-point source Consequences of Sediment” (BANCS) model (Rosgen, 1996, 2001b, 2006b). This empirical model uses the Bank Erosion Hazard Index (BEHI) and Near Bank Stress (NBS) erosion estimation tools. Visual estimates of the BEHI were made as we traveled downstream for stream banks where erosional processes were observed. Waypoints and photographs were collected along with bank height and length measurements using laser range finders and waypoint information. NBS was estimated through analysis of aerial photos using method 2, found in the River Stability Field Guide. This method uses the ratio of the radius of curvature of the meanders to the bankfull width of the channel, and is a measure of the tightness of the bends in the river and the degree of boundary shear stress acting on those banks (Figure 7). The annual streambank erosion rate can then be estimated using the BEHI and NBS ratings, and known erosion rates using those relationships. We used known erosion rates from North Carolina, Colorado, and Yellowstone National Park data to estimate a range of possible erosion rates for our study. As we validate more of these erosion rates with bank studies we will develop local erosion rate relationships with BEHI and NBS estimates, which will greatly strengthen our estimates.

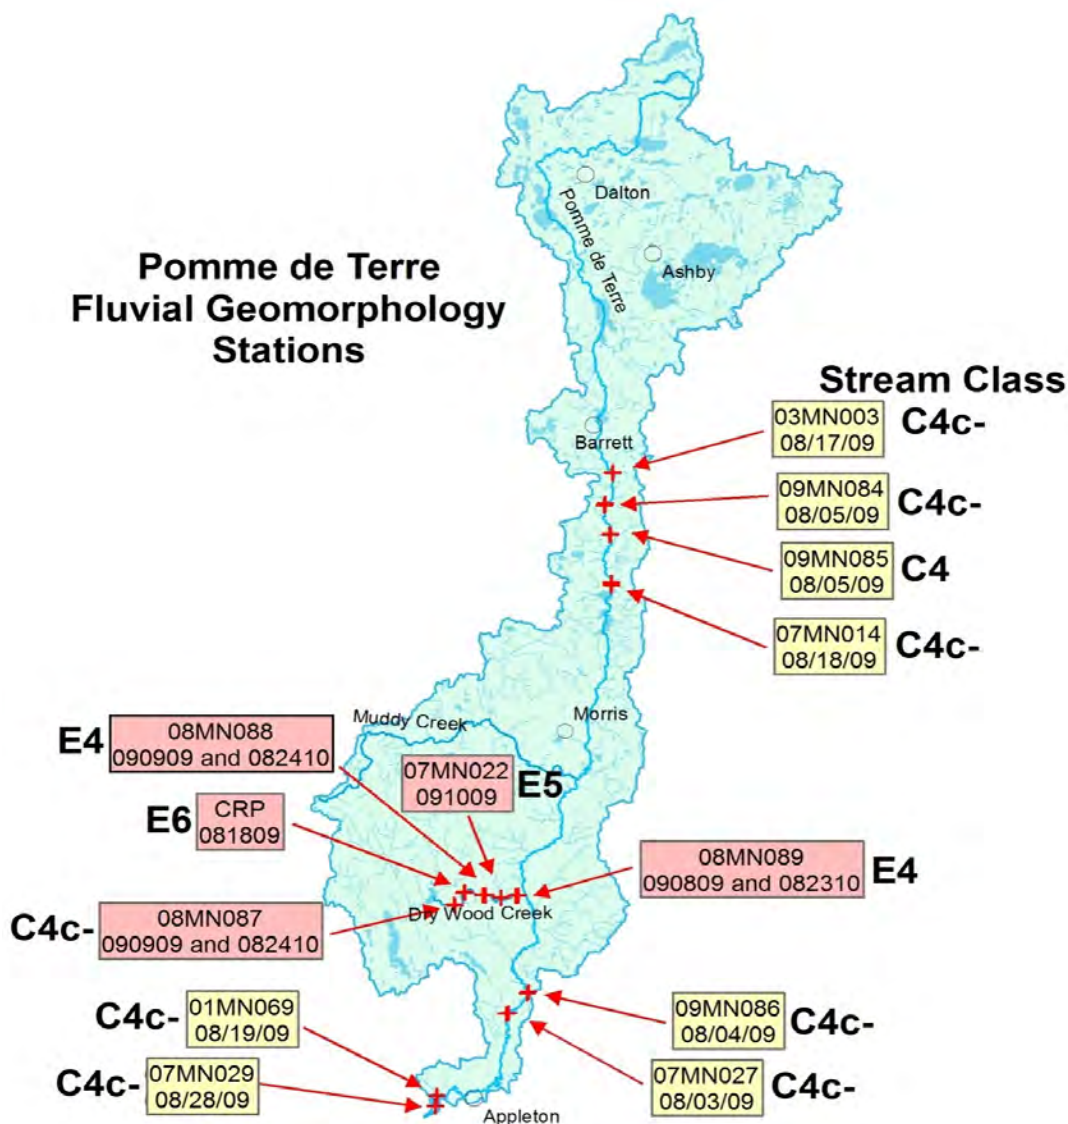
Figure 8. Fluvial geomorphology stations and classifications

Stream reaches were subjected to more intensive geomorphic assessments at 13 locations on the Pomme de Terre and tributaries (Figure 8). These assessments followed the procedures outlined in the “River Stability Field Guide” (Rosgen 2008) levels I-IV. Level I assessment procedures were completed during field reconnaissance including broad level stream classification and valley classification. Level II tasks included cross sections, longitudinal profiles, pebble counts, hydraulic relations, level II stream classification, morphological descriptions, and dimensionless ratios. Level III procedures included the prediction of annual streambank erosion rates using the BANCS empirical model (uses the Bank Erosion Hazard Index and Near Bank Stress). Level IV procedures included the validation of streambank erosion rates by setting up study banks with bank and bed pins and measuring actual annual erosion rates to start to develop local bank erosion relationships.

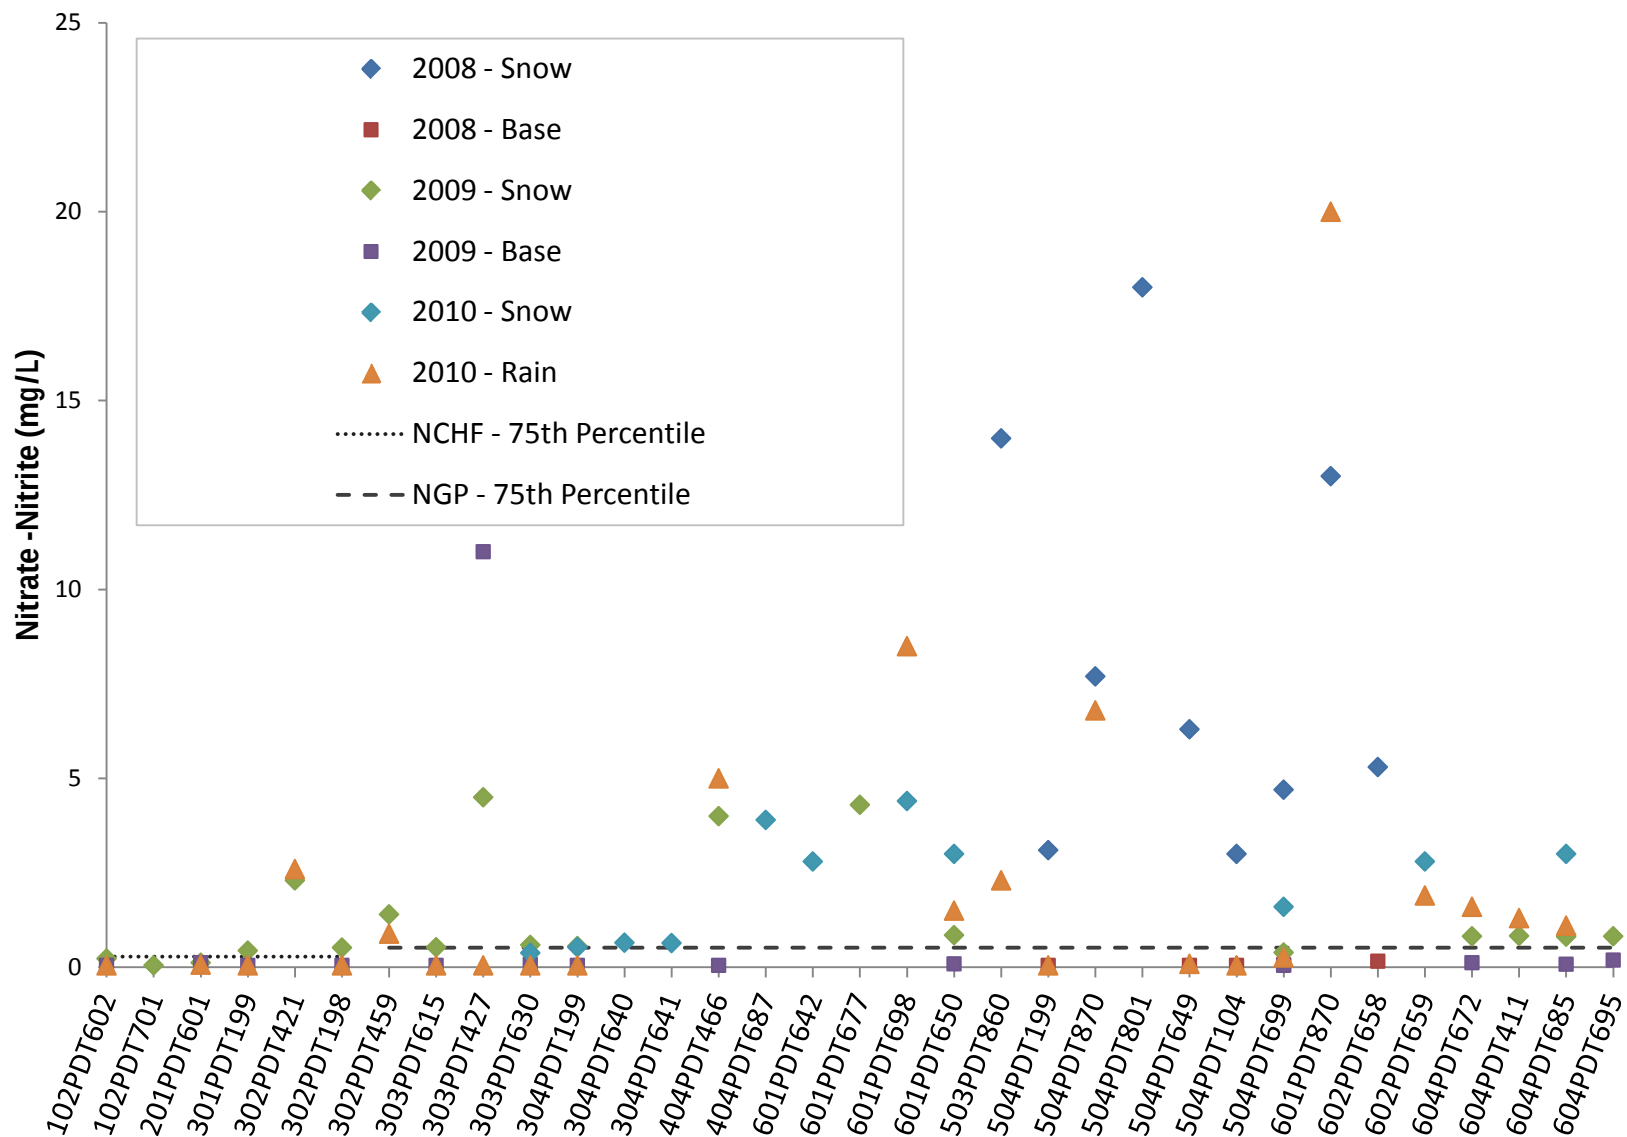
Figure 10. Nitrate-N measurements collected from 2008 to 2010 throughout the Pomme de Terre River watershed

The causes and potential sources for nitrate-nitrite in the Pomme de Terre River watershed are modeled in Figure 11. Helsel (1995) reported nitrate concentrations were the highest below agricultural or urban areas. Figure 10 indicates that nitrate concentrations are elevated during snow melt events and rain events. Some of the highest measurements of nitrate were observed in the drainage system to Dry Wood Creek.

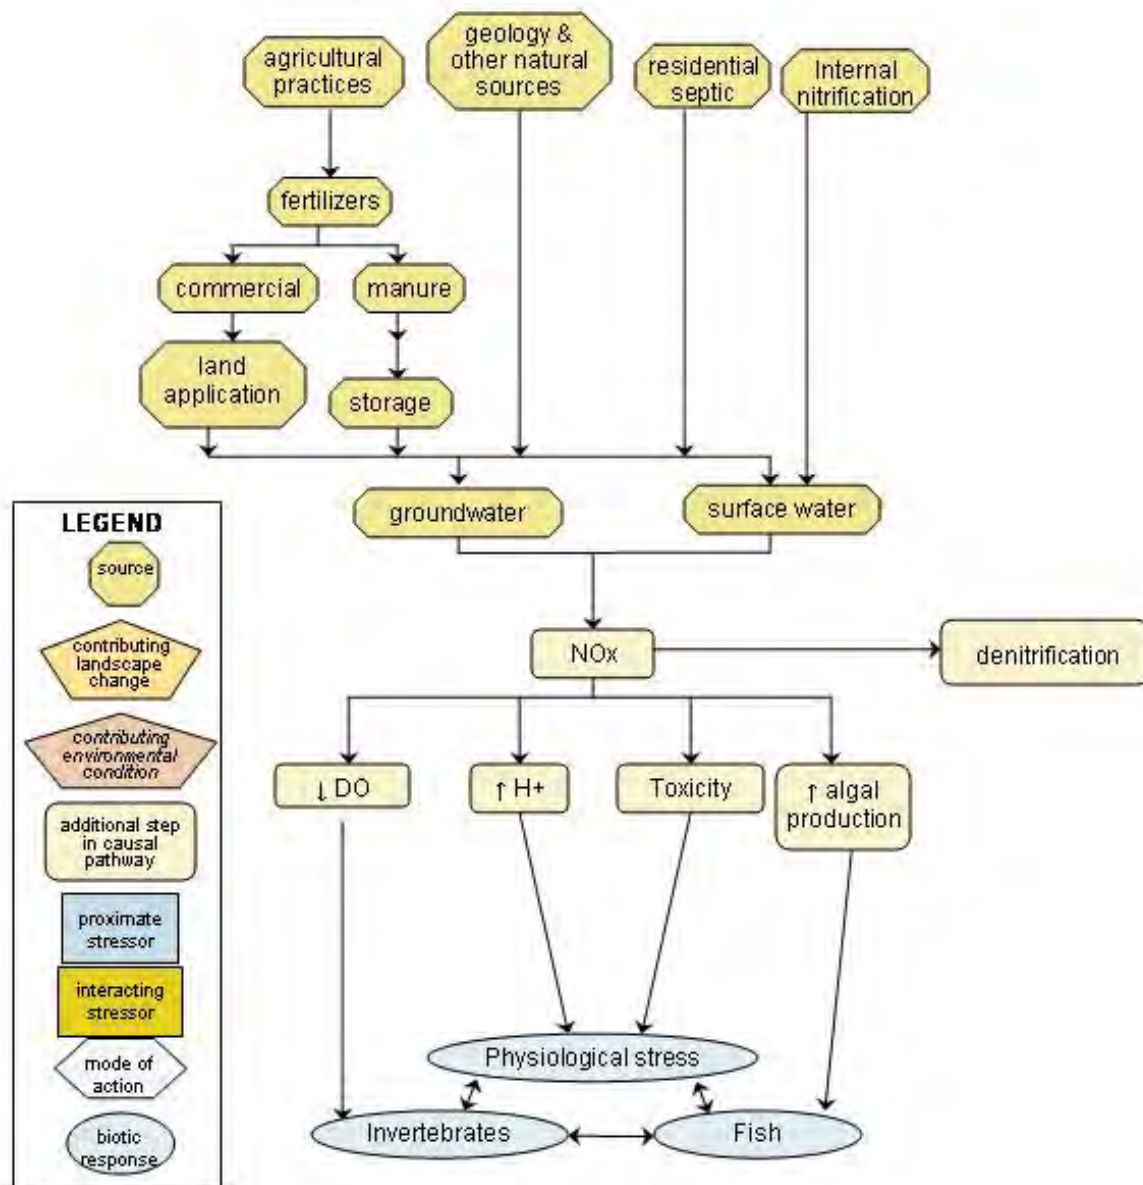
Figure 11. Conceptual model for nitrate stressor on the biotic community

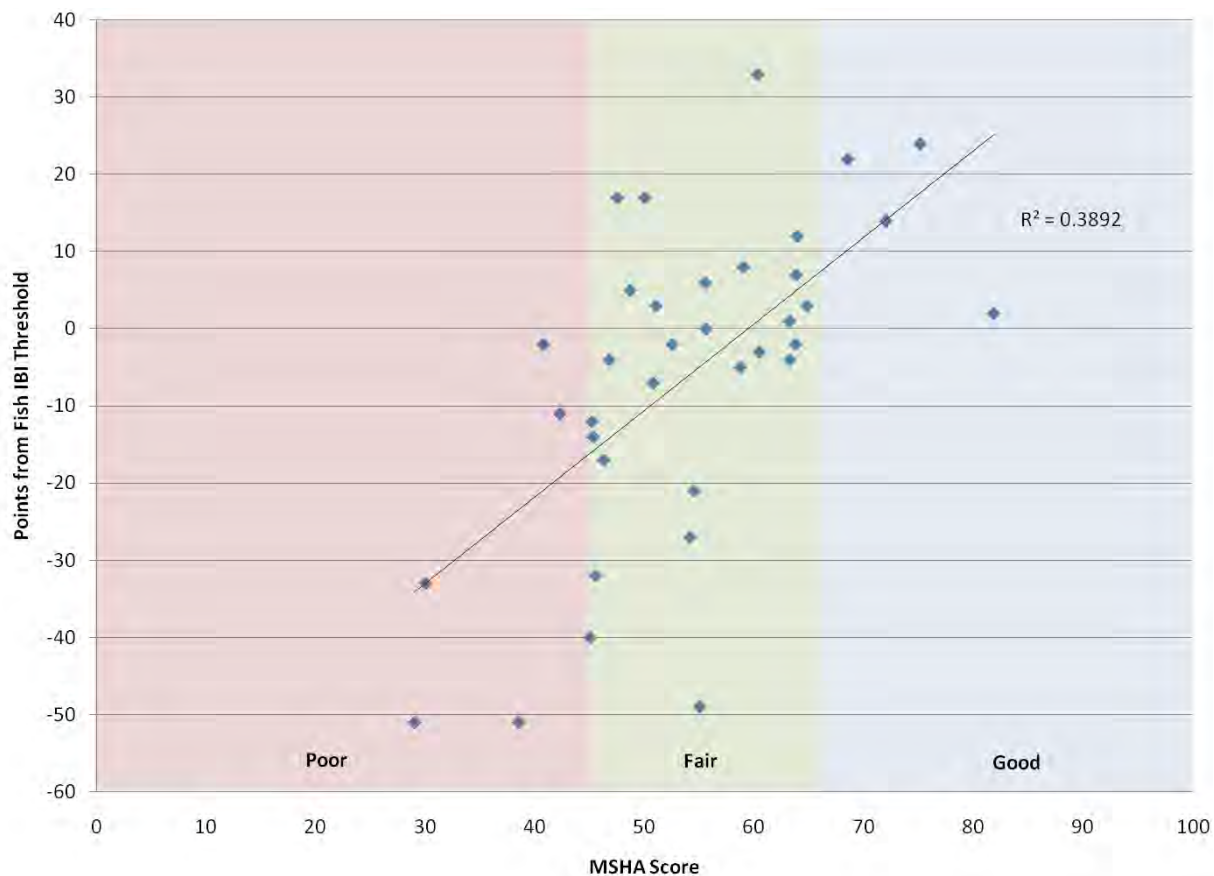
Figure 13. MSHA scores and points above or below fish IBI threshold for all natural channel sites in the Pomme de Terre River watershed

The IBI scores in the Pomme de Terre River watershed have a positive relationship with the total MSHA score (Figure 13). The IBI is comprised of numerous metrics that measure biotic response to various stresses including, but not limited to, habitat.

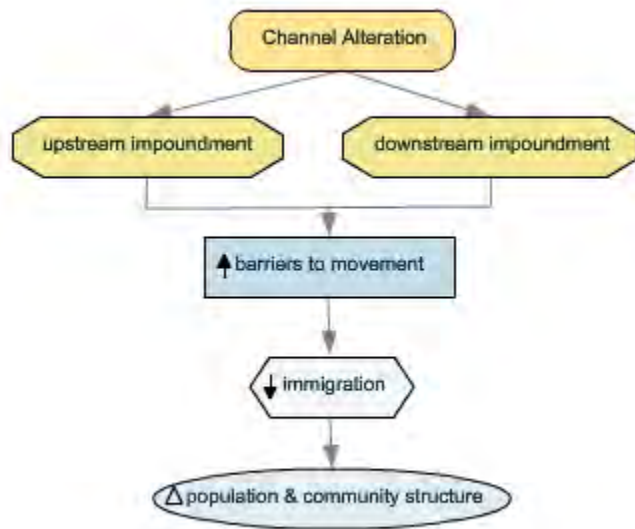
Figure 18. Conceptual model for connectivity

The causes and potential sources for connectivity in the Pomme de Terre River watershed are modeled in Figure 18. Impoundments placed on rivers and streams can create barriers to fish passage and can alter the aquatic community.

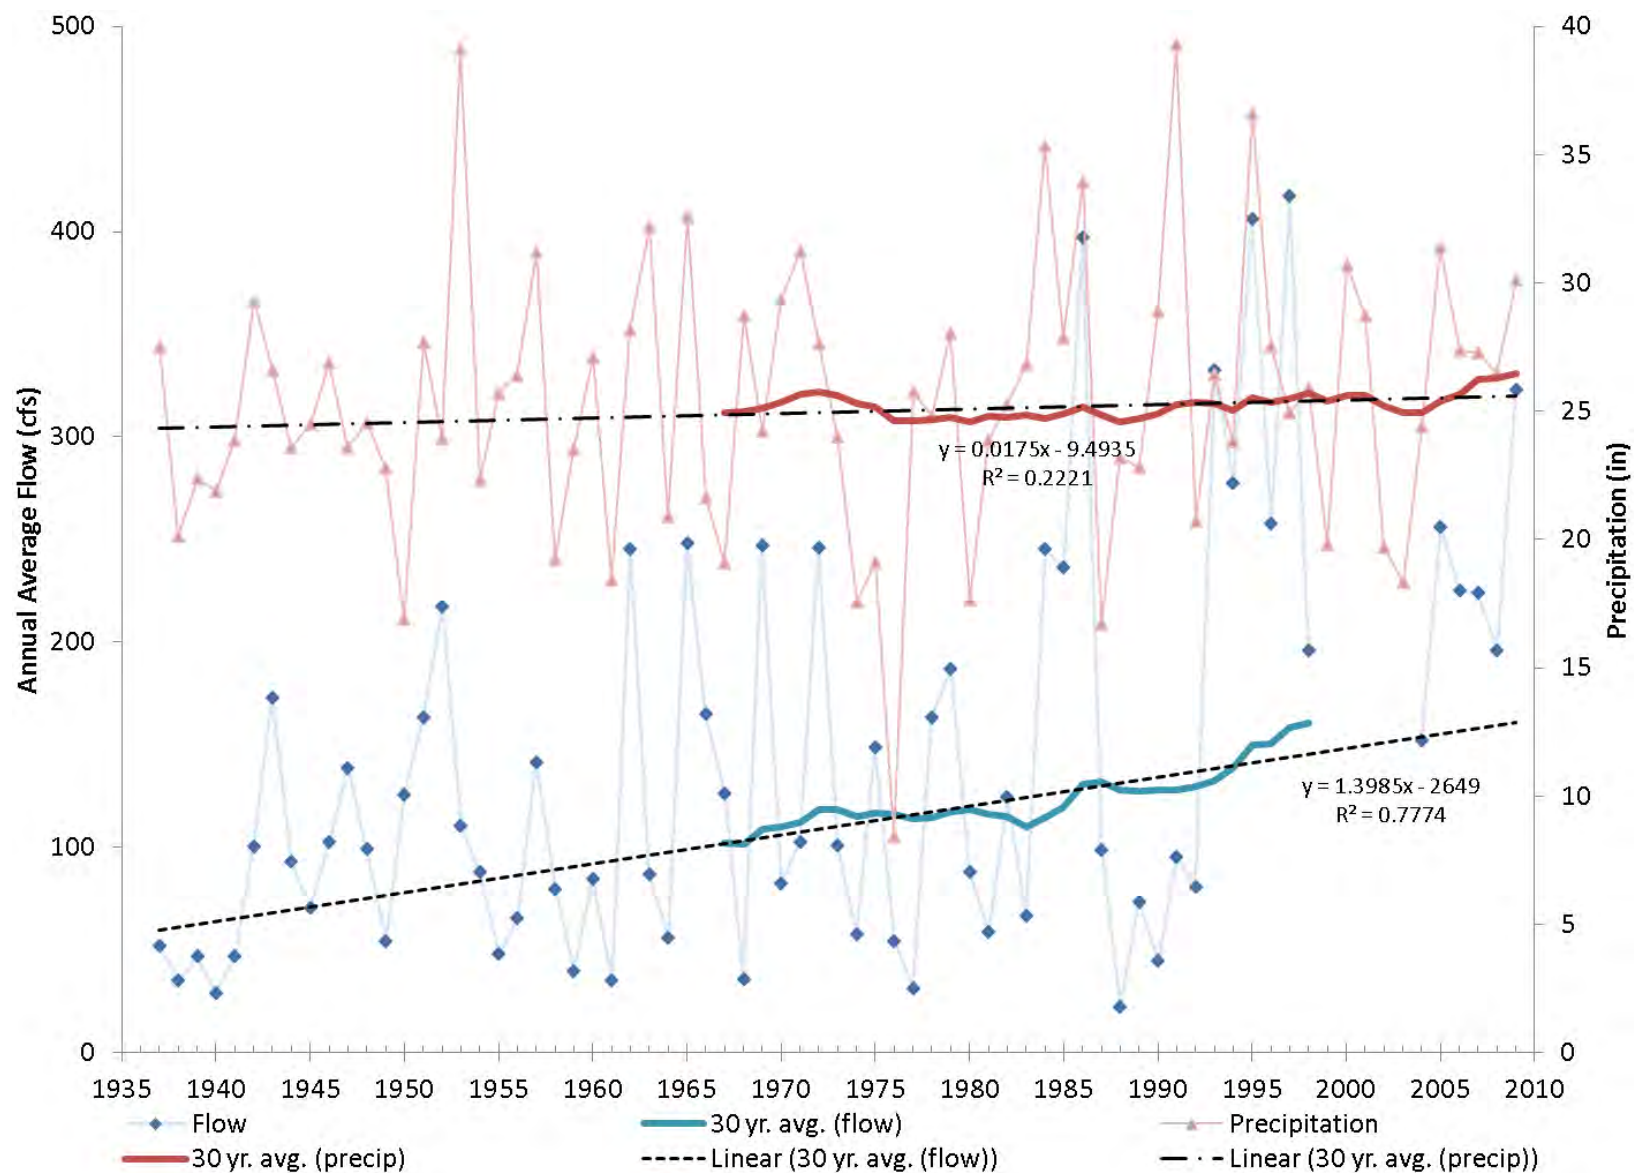
Figure 19. Pomme de Terre River average annual flow and total annual precipitation at Appleton, MN, 1937 – 2009

At the USGS stream gage location in Appleton, the Pomme de Terre River average annual flows have increased to a degree that cannot entirely be attributed to an increase of precipitation (Figure 19). Jason Ulrich, University of Minnesota, is currently evaluating factors contributing to changes in runoff ratio in 21 tributaries to Lake Pepin, including the Pomme de Terre River. In Ulrich's estimates, precipitation accounts for less than 10 percent of the total change in flow in the Pomme de Terre River watershed (personal communication, November 2, 2011). As reflected similarly in Figure 19, Ulrich has found that the annual water yield has increased significantly between the periods of 1940 to 1974 and 1975 to 2009 (50 – 60 percent increase), yet the annual precipitation has not increased significantly between the two time periods. In addition, the frequency of 2 inches per 24 hours storms and 1 inch per 1 hour storms did not increase at the 8 and 4 stations, respectively, in the vicinity of the watershed.

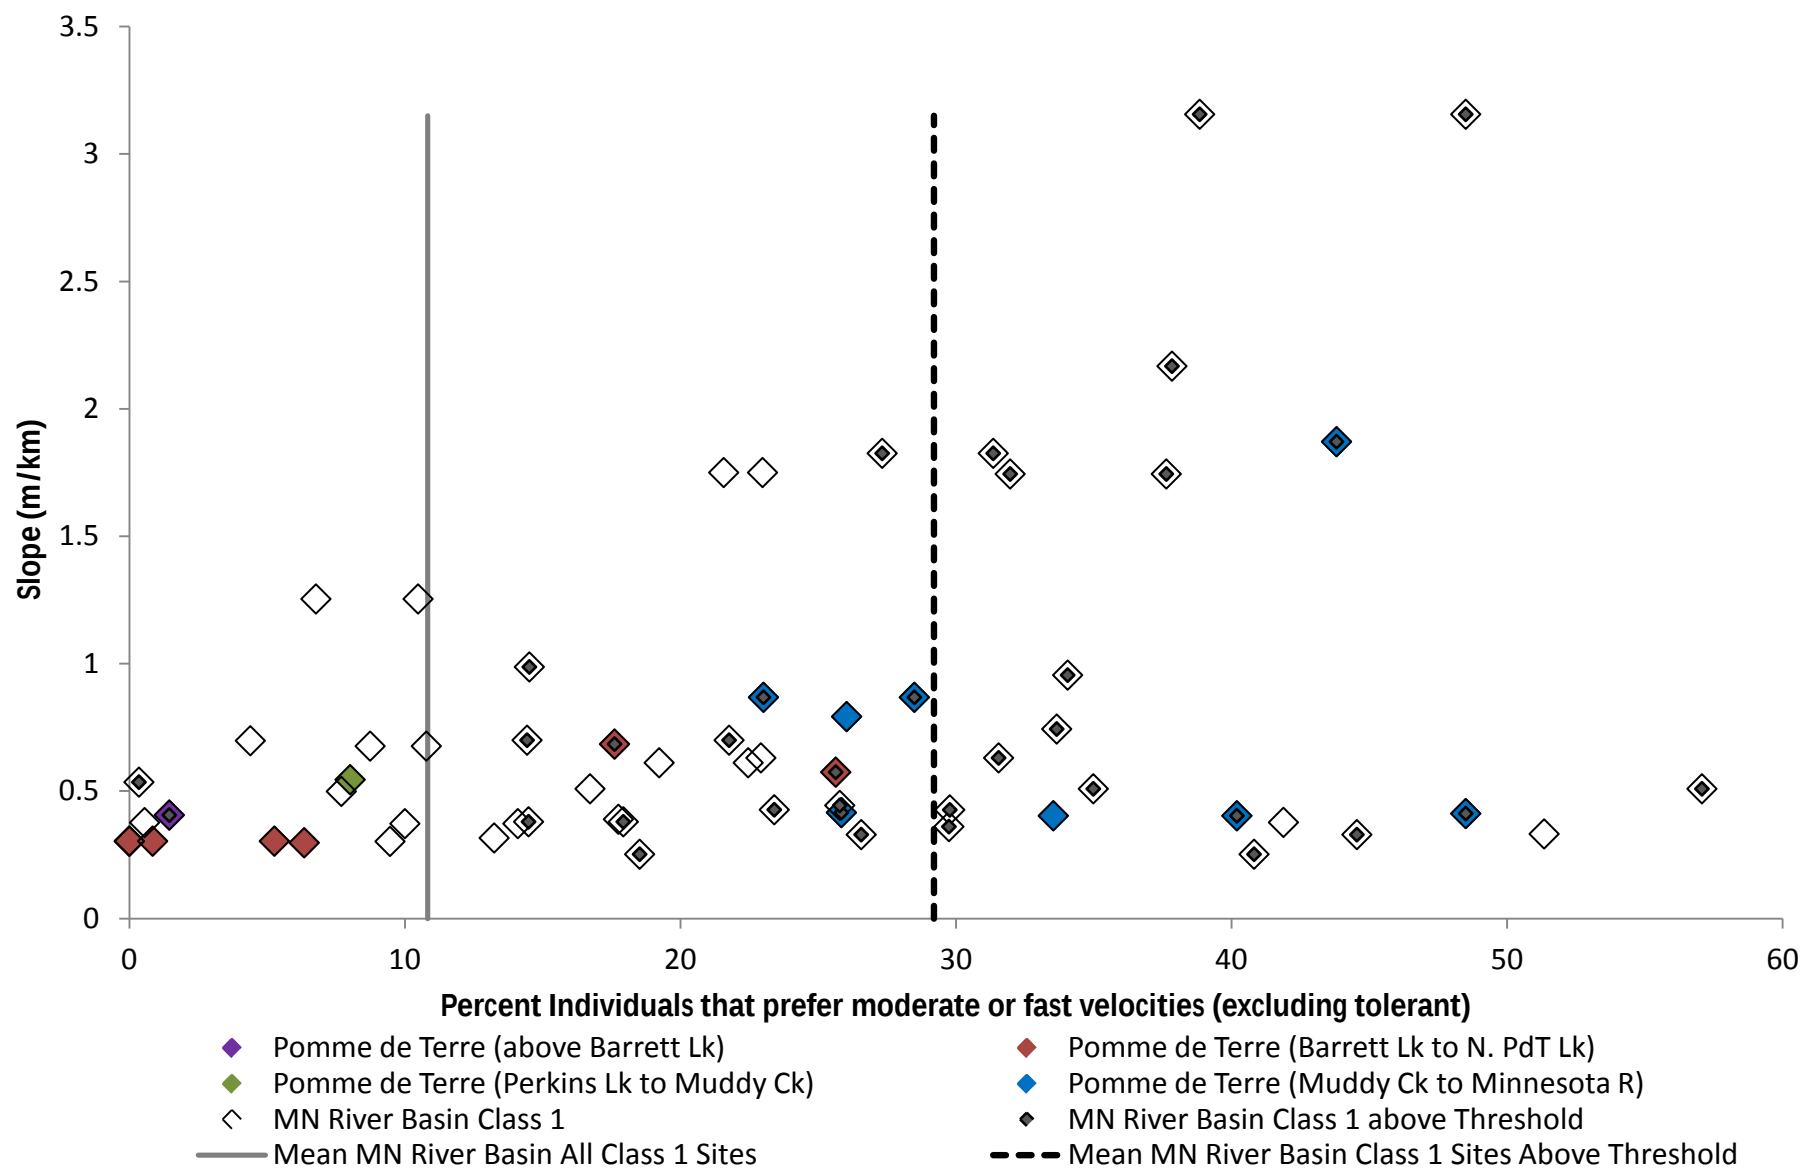
Figure 20. Fish individuals that prefer moderate or fast velocities (excluding tolerant) for reaches in the Pomme de Terre River watershed and MN River Basin Class 1 with means for all MN River Basin class 1 sites and for those above the threshold, as related to slope

Although there is a relationship between drainage area and the percent individuals that prefer moderate or fast velocities (excluding tolerant) for the Pomme de Terre River mainstem, the relationship does not exist when considering the MRB class 1 sites. The relationship with drainage area that is apparent on the mainstem of the Pomme de Terre River may be due to the migratory barriers present rather than truly drainage area since the relationship is not observed in a broader scope.

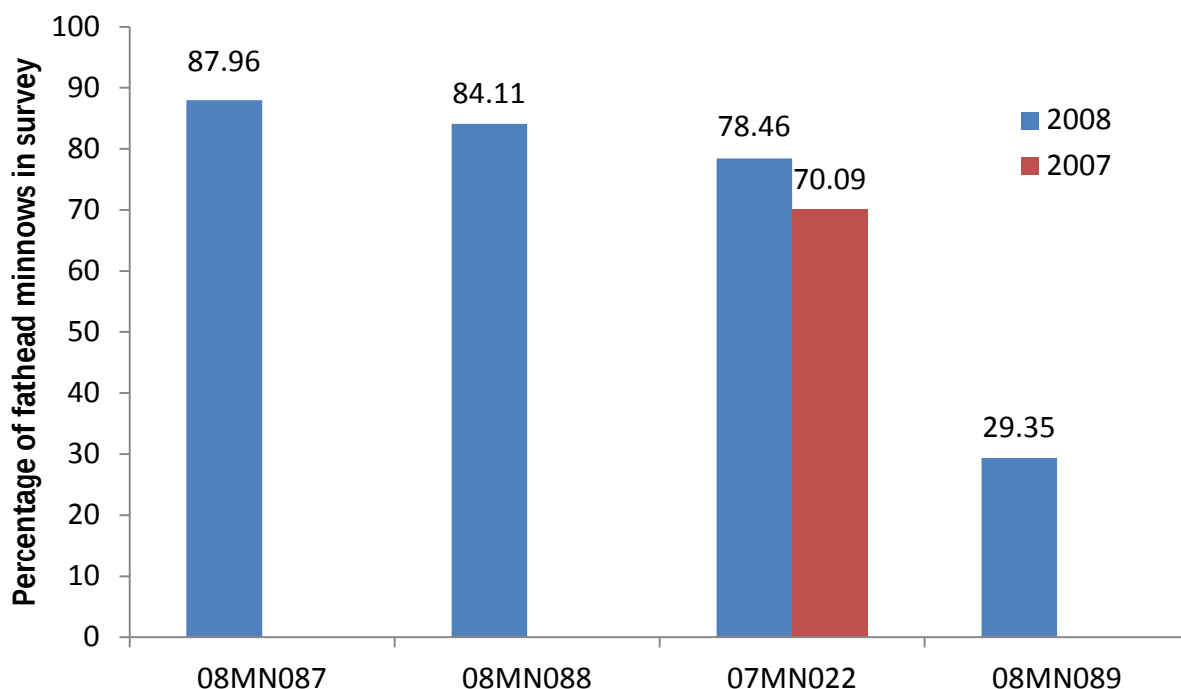
Figure 25. Percentage of fathead minnows in 2007 and 2008 fish surveys on Dry Wood Creek

Throughout Dry Wood Creek, fathead minnows dominated the fish communities surveyed in 2007 and 2008 (Figure 25). Site 08MN089 had fewer fathead minnows, but it is the most abundant taxa. Fathead minnows are tolerant of low dissolved oxygen levels. The other high abundant taxa are orangespotted sunfish, white sucker, and common carp (22.8 percent, 17.9 percent, and 10.3 percent respectively). These taxa are also tolerant to adverse conditions. Very few EPT were found in the invertebrate communities of Dry Wood Creek which are intolerant to low dissolved oxygen (Table 9).

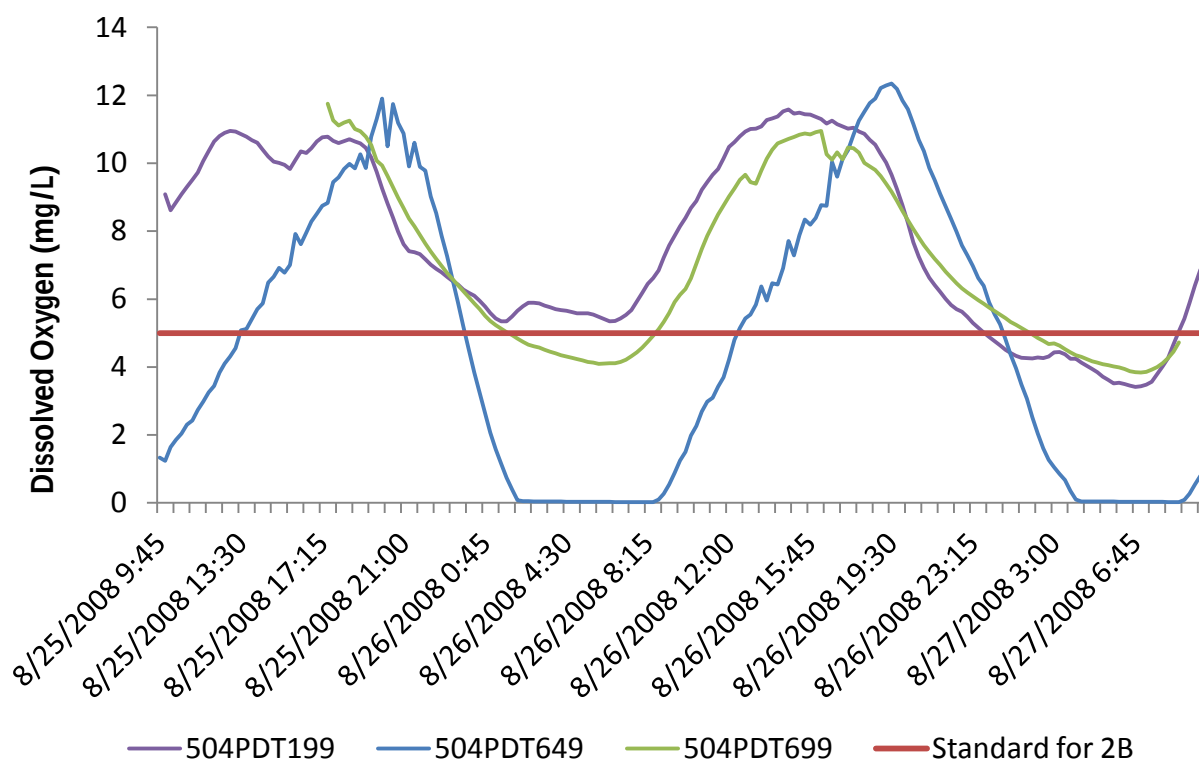
Figure 26. Measurements of dissolved oxygen from August 25 to 27, 2008 for three sites in Dry Wood Creek

In 2008, as a follow up to the 2007 condition monitoring in the Dry Wood Creek watershed, three YSI sondes were deployed for a short period from August 25 - 27 (Figure 26). All three locations measured below the standard for Class 2B streams at least one time during the deployment. At site 504PDT649, measured dissolved oxygen concentration was below 1 mg/L for 7.25 hours (32 measurements) during the early mornings of August 26 and 27.

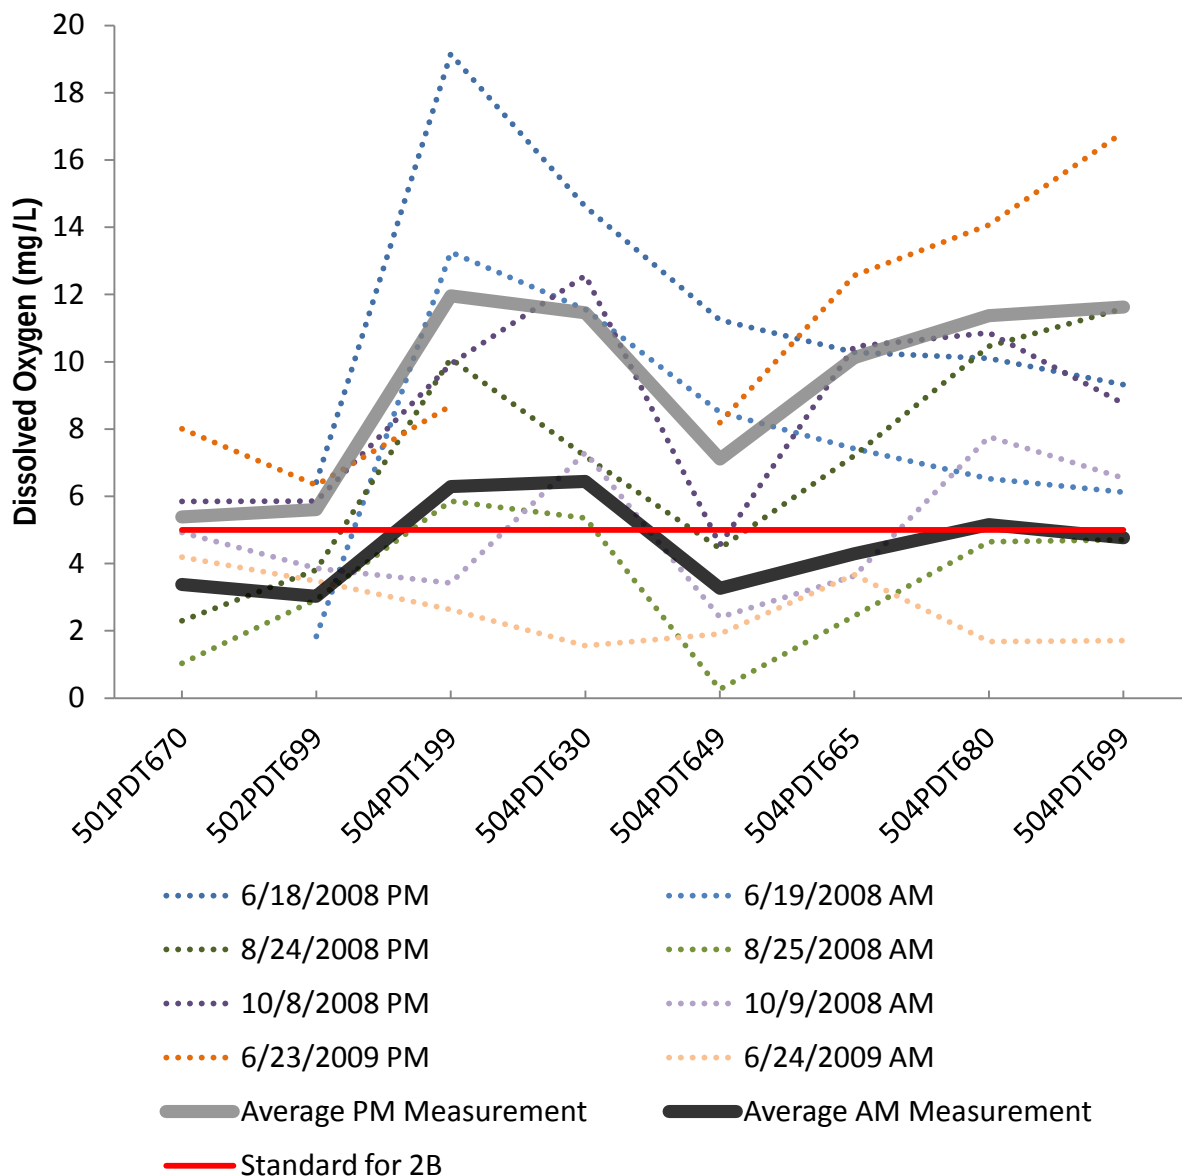
Figure 27. Dissolved Oxygen longitudinal synoptic measurements in Dry Wood Creek

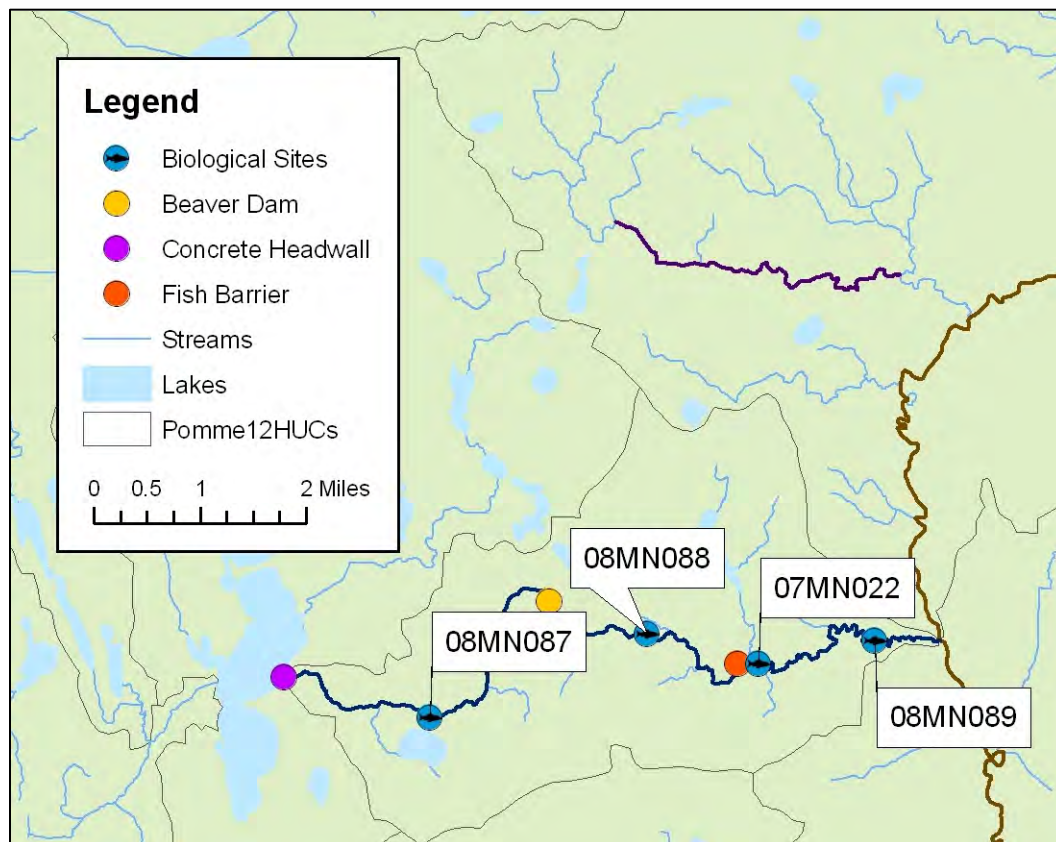
Figure 41. Biological sites on Dry Wood Creek with location of beaver dam, concrete headwall and fish barrier structures

Dry Wood Creek historically had a concrete headwall dam to control lake levels in North Dry Wood Lake with stop logs, and a dam to prevent fish passage approximately two miles from the confluence with the Pomme de Terre River (Figure 41). The fish passage dam is no longer acting as a fish barrier since erosion has occurred on both sides of the dam. In 2008, a beaver dam was identified as a potential fish barrier (Figure 42 and Figure 43). In the spring of 2009, the beaver dam was washed away, but rebuilt approximately 200 feet downstream later in the year. It is uncertain if the beaver dam or human made dams on Dry Wood Creek are barriers for longitudinal fish movement. The most migratory taxa are found in the downstream biological site 08MN089 (Table 10). The three upstream sites have less migratory species, but there is no potential barrier between 07MN022 and 08MN089 to account for the missing taxa.

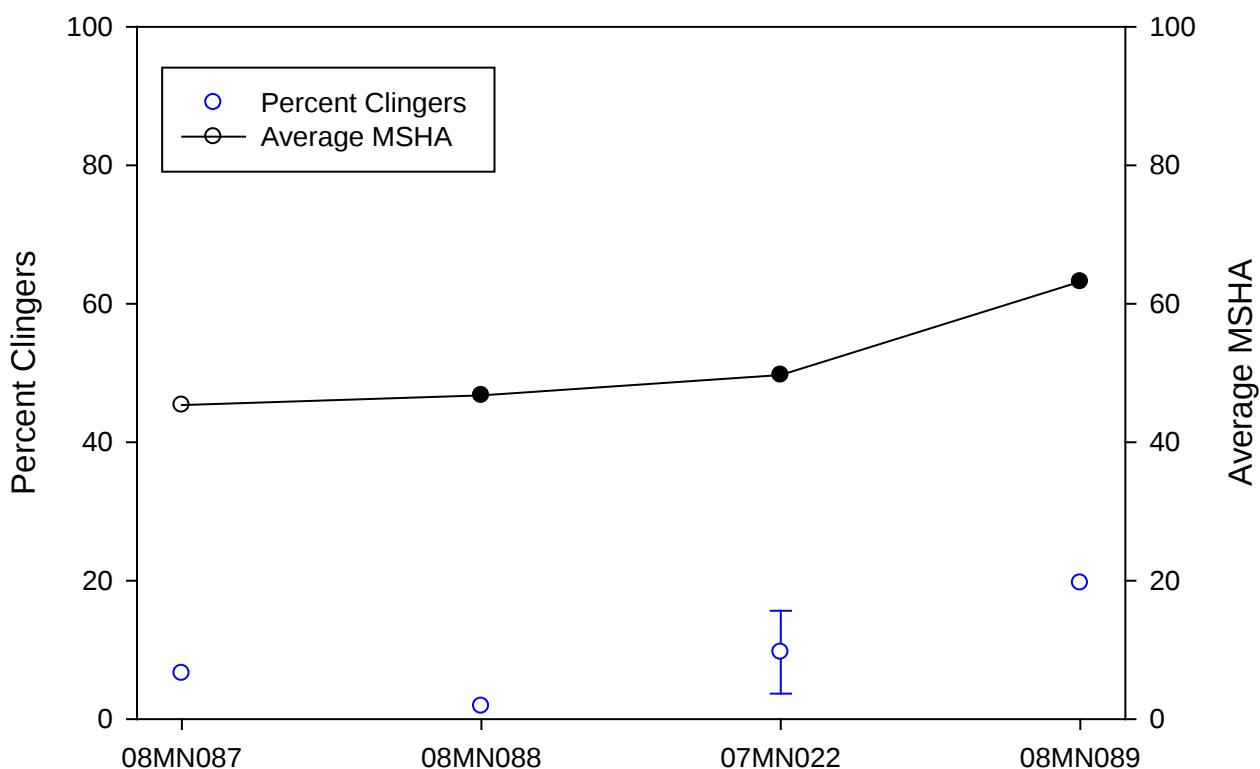
Figure 51. Percent clingers and average MSHA scores in Dry Wood Creek

The invertebrates are also depressed throughout Dry Wood Creek. Clingers show a similar pattern to the average MSHA scores, showing dependency of clingers to their habitat (Figure 51).

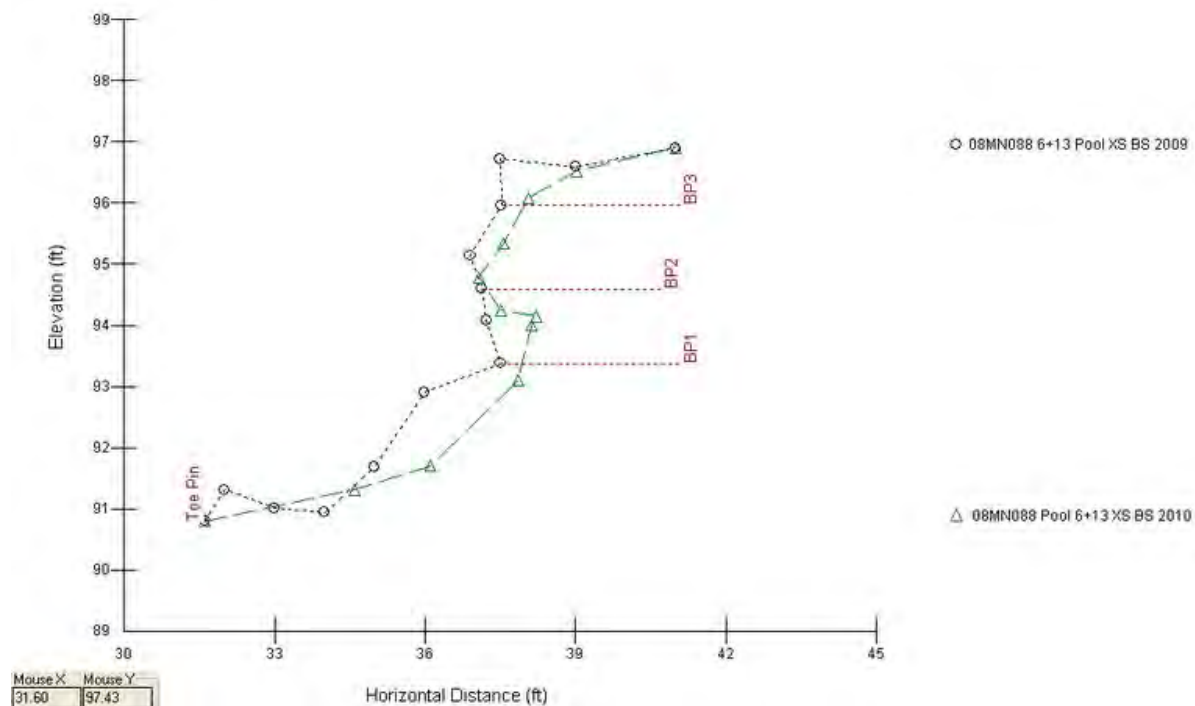
**Figure 55. Site 08MN088 study bank showing measured average erosion rate of 0.726 ft/yr from 2009 to 2010**

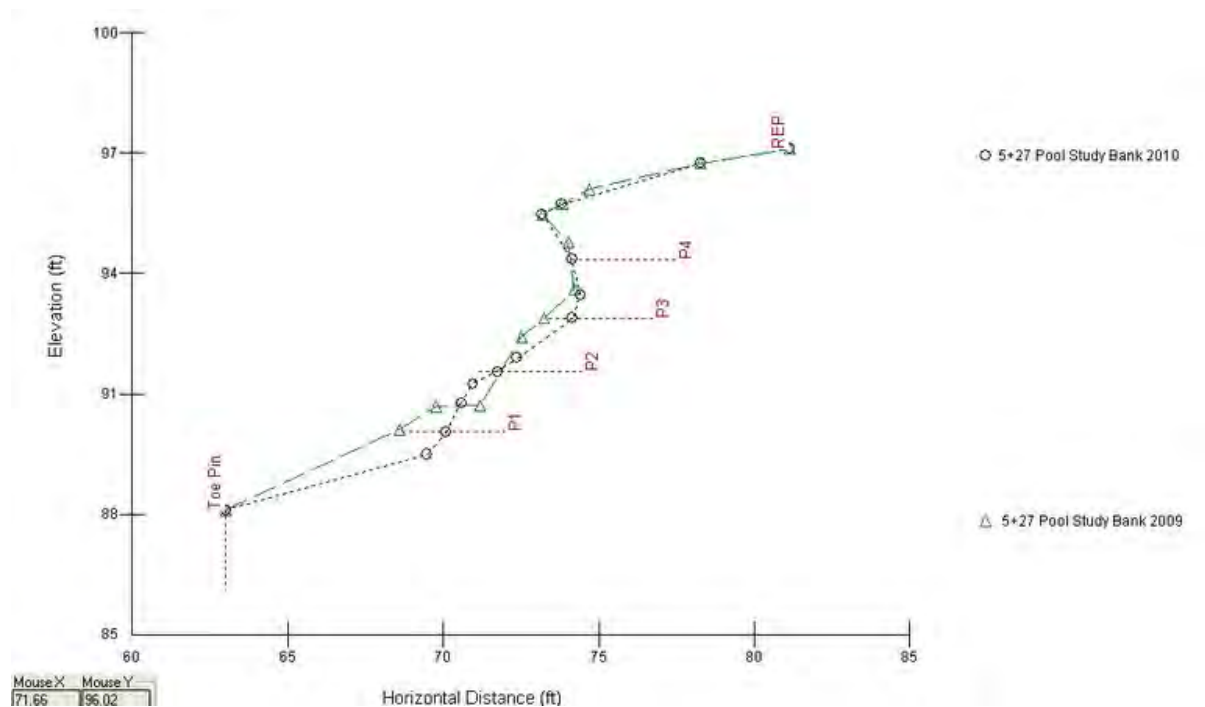
Figure 56. Site 08MN089 study bank showing measured average erosion rate of 0.533 ft/yr from 2009 to 2010

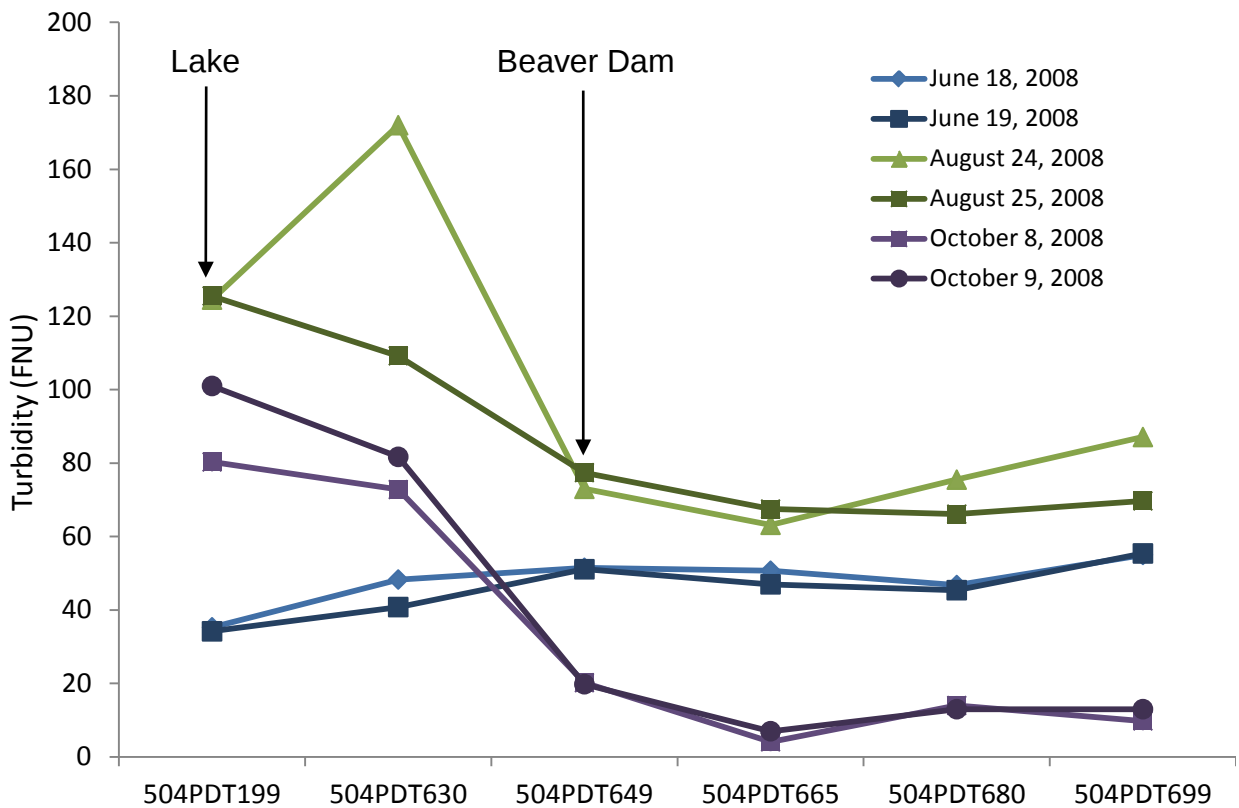
Figure 59. Turbidity (FNU), as measured longitudinally, in Dry Wood Creek from upstream to downstream on select days in 2008
