# Pomme de Terre River Watershed Biotic Stressor Identification

A study of local stressors limiting the biotic communities in the Pomme de Terre River Watershed.

Minnesota Pollution Control Agency

June 2012

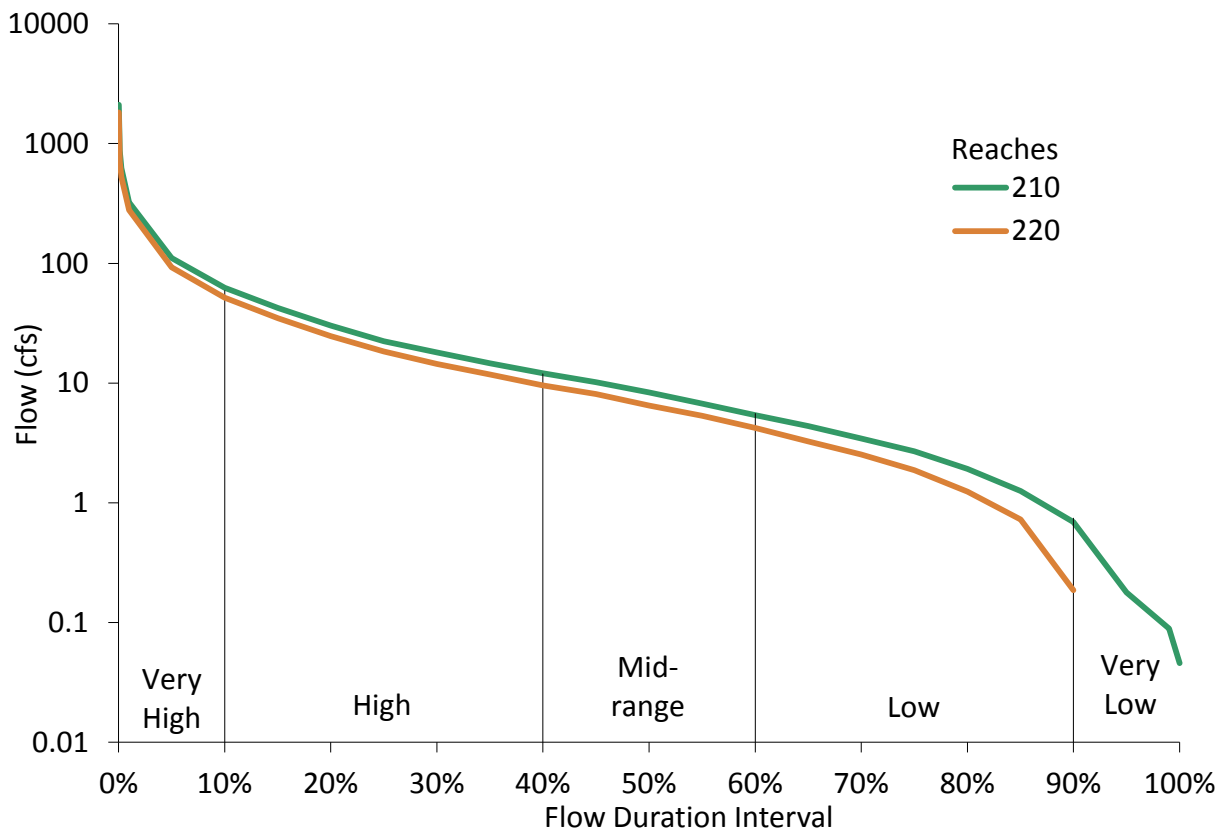
Figure 61. Flow duration curve for the outlet of North Dry Wood Lake (220) and the outlet of Dry Wood Creek (210)

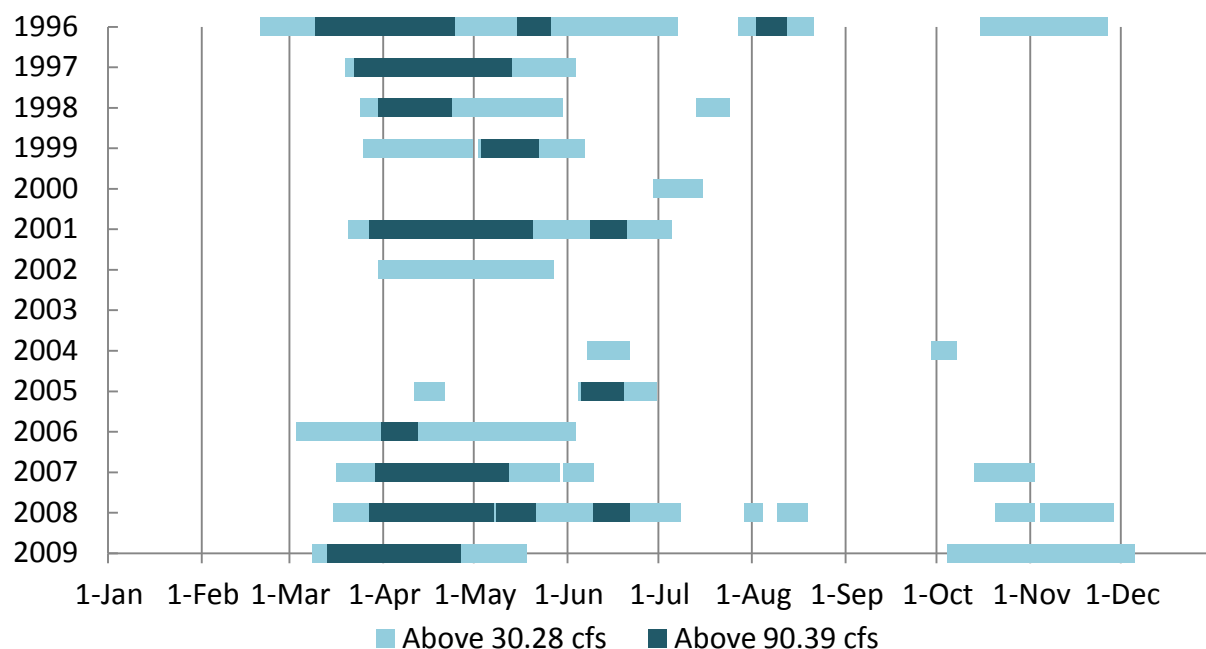
**Figure 62. Bankfull flow events and flows greater than 30.28 cfs (highest 20 percent flows) at the outlet of Dry Wood Creek from 1996 to 2009**

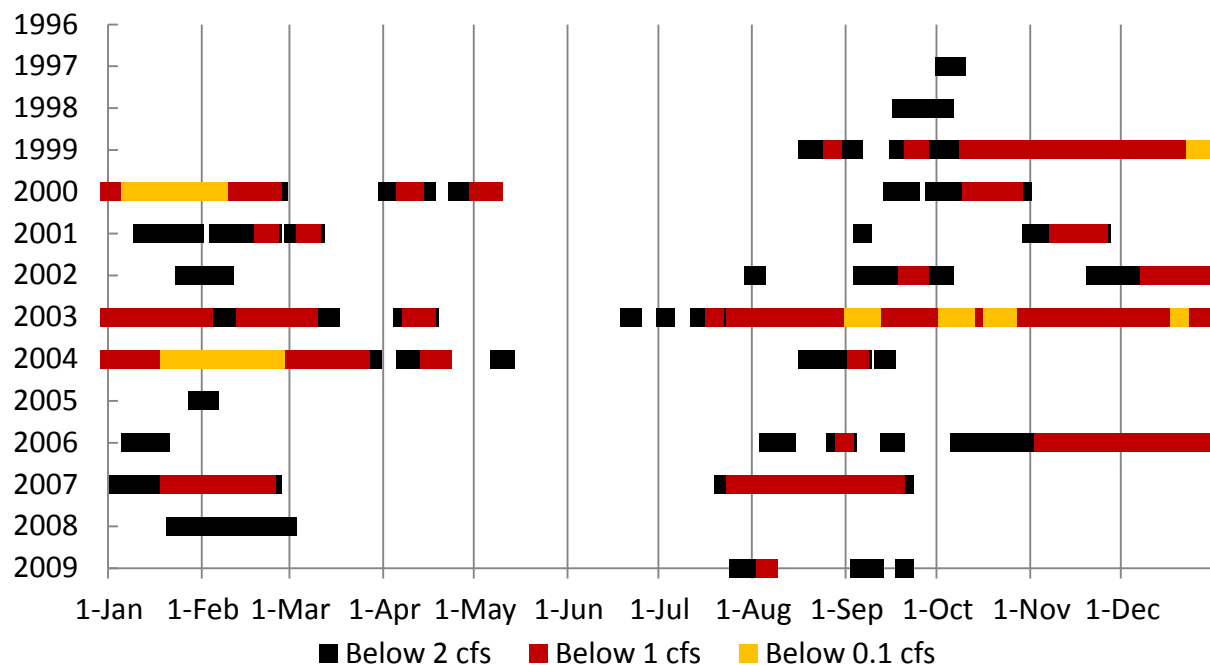
Figure 64. Low flow events at the outlet of Dry Wood Creek from 1996 to 2009

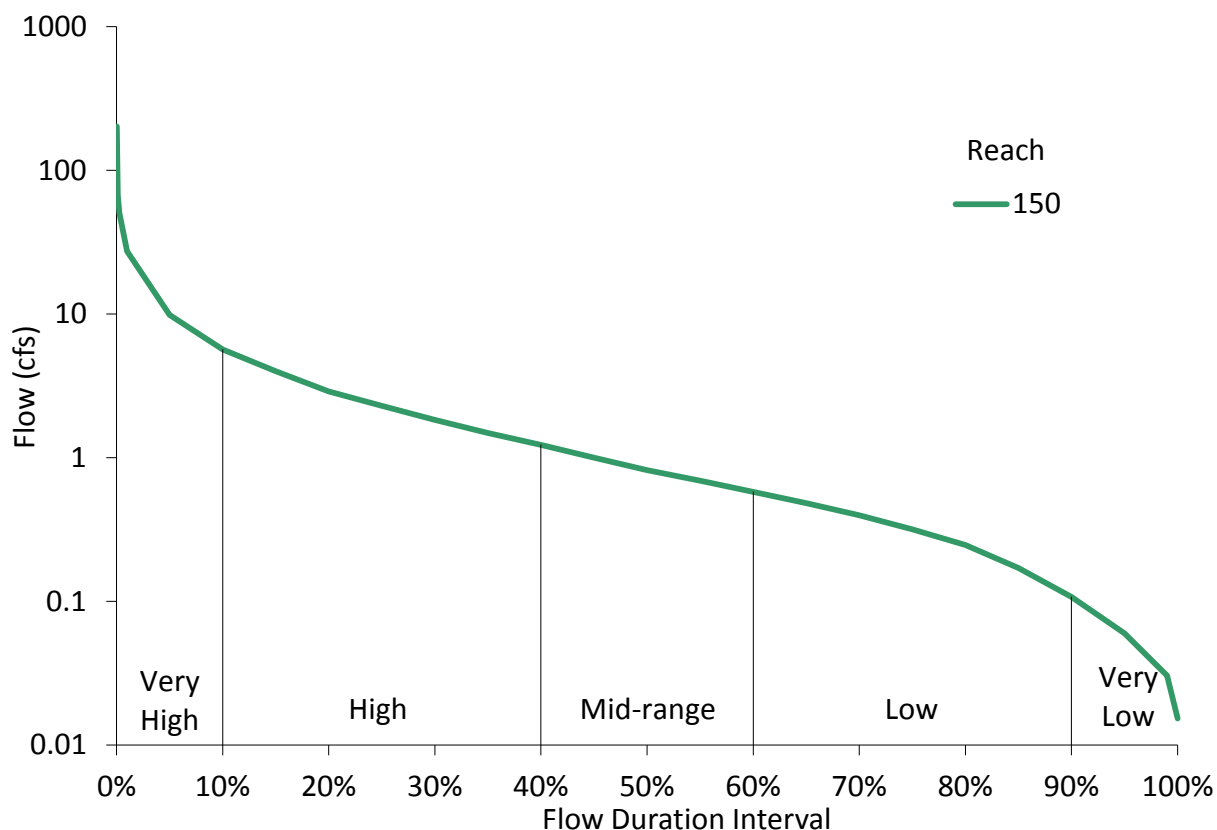
Figure 72. Flow duration curves for HSPF reach 150, unnamed creek

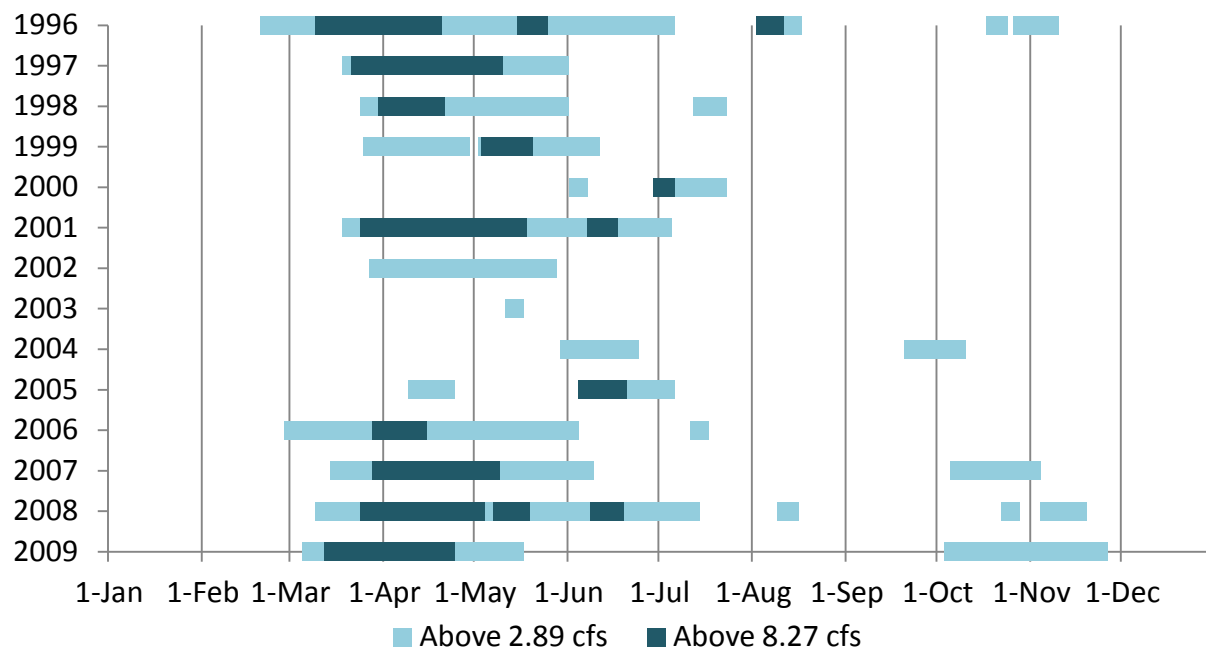
Figure 73. Bankfull flow events (above 8.27 cfs) and flows greater than 2.89 cfs (highest 20 percent flows) at the outlet of the unnamed creek, reach 150, from 1996 to 2009

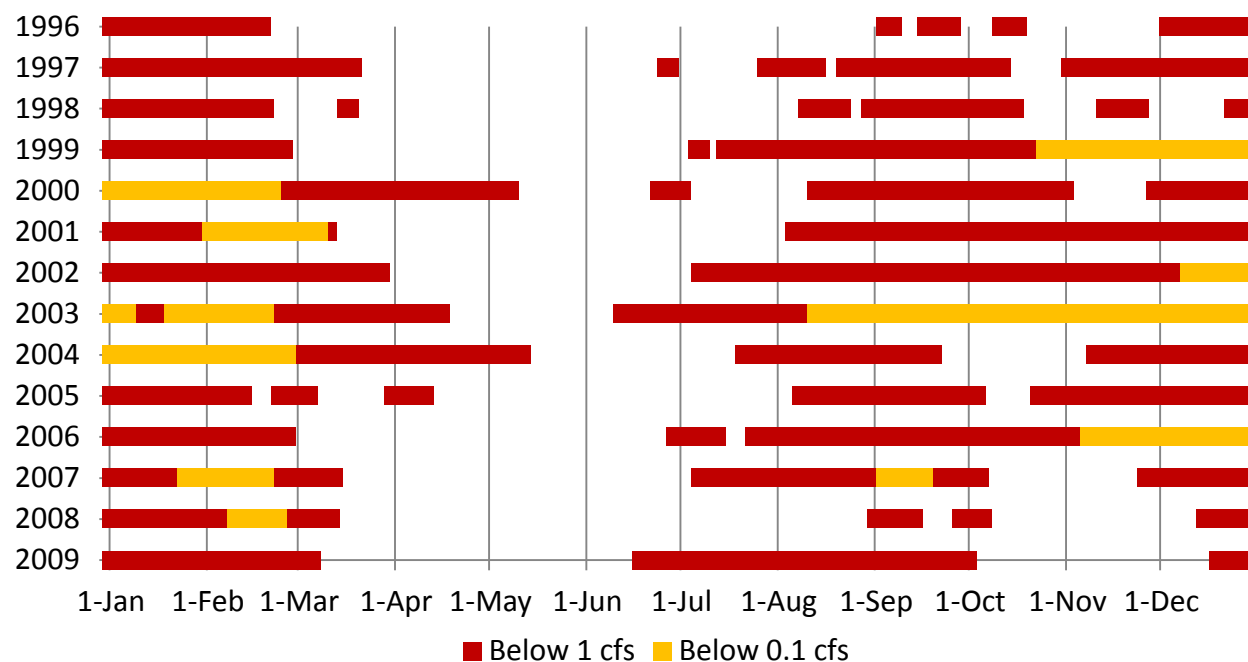
Figure 74. Low flow events, below 1 cfs and below 0.1 cfs at the outlet of Unnamed Tributary, reach 150, from 1996 to 2009

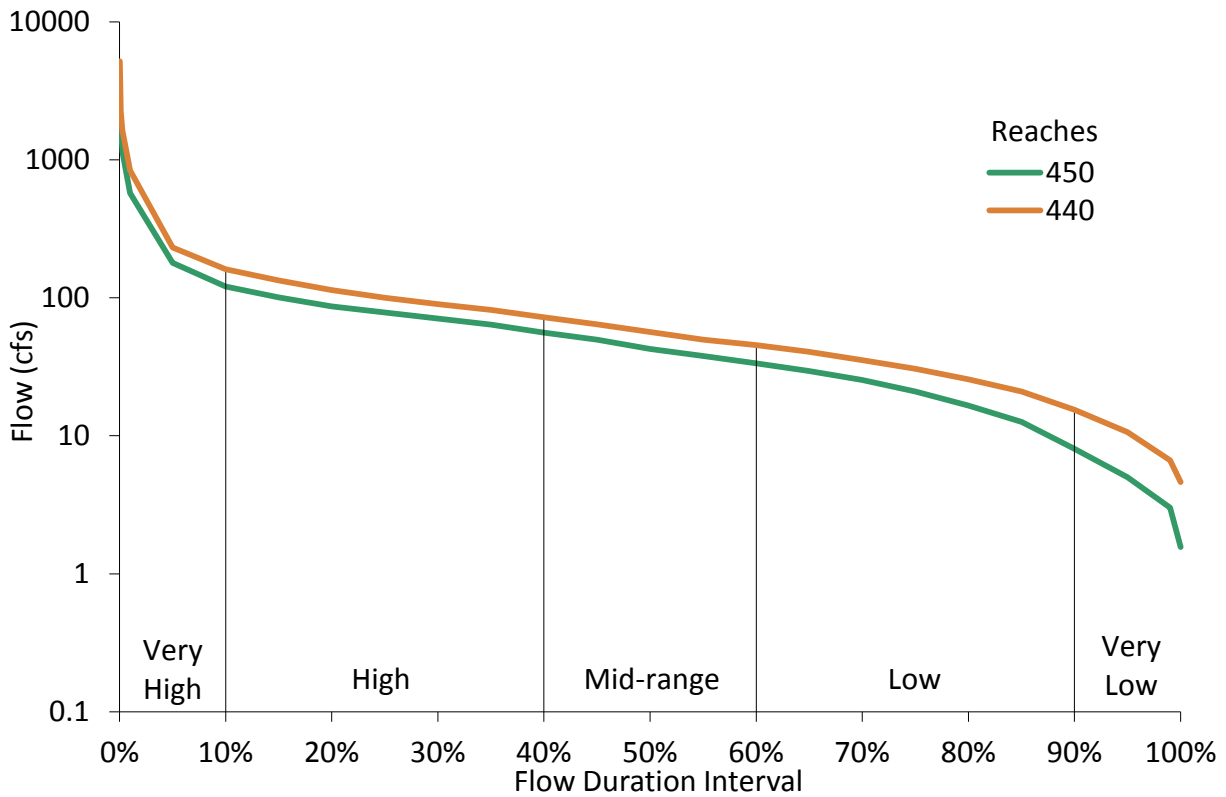
Figure 86. Flow duration curves for HSPF reach 450 and 440

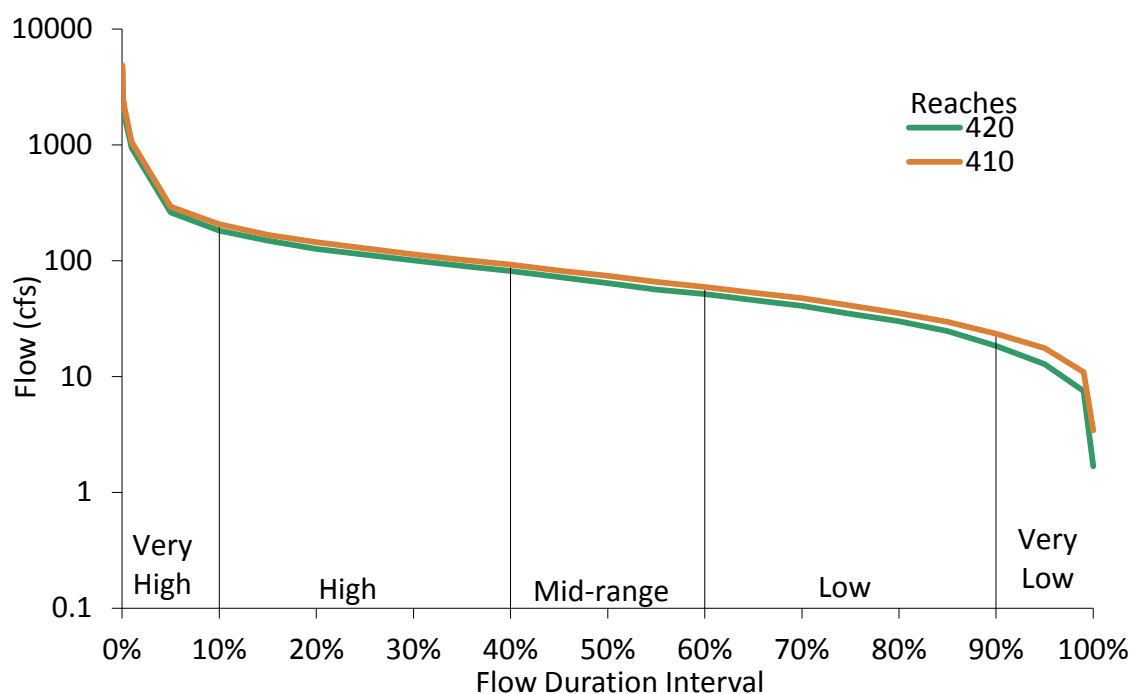
Figure 93. Flow duration curves for HSPF reach 420 and 410

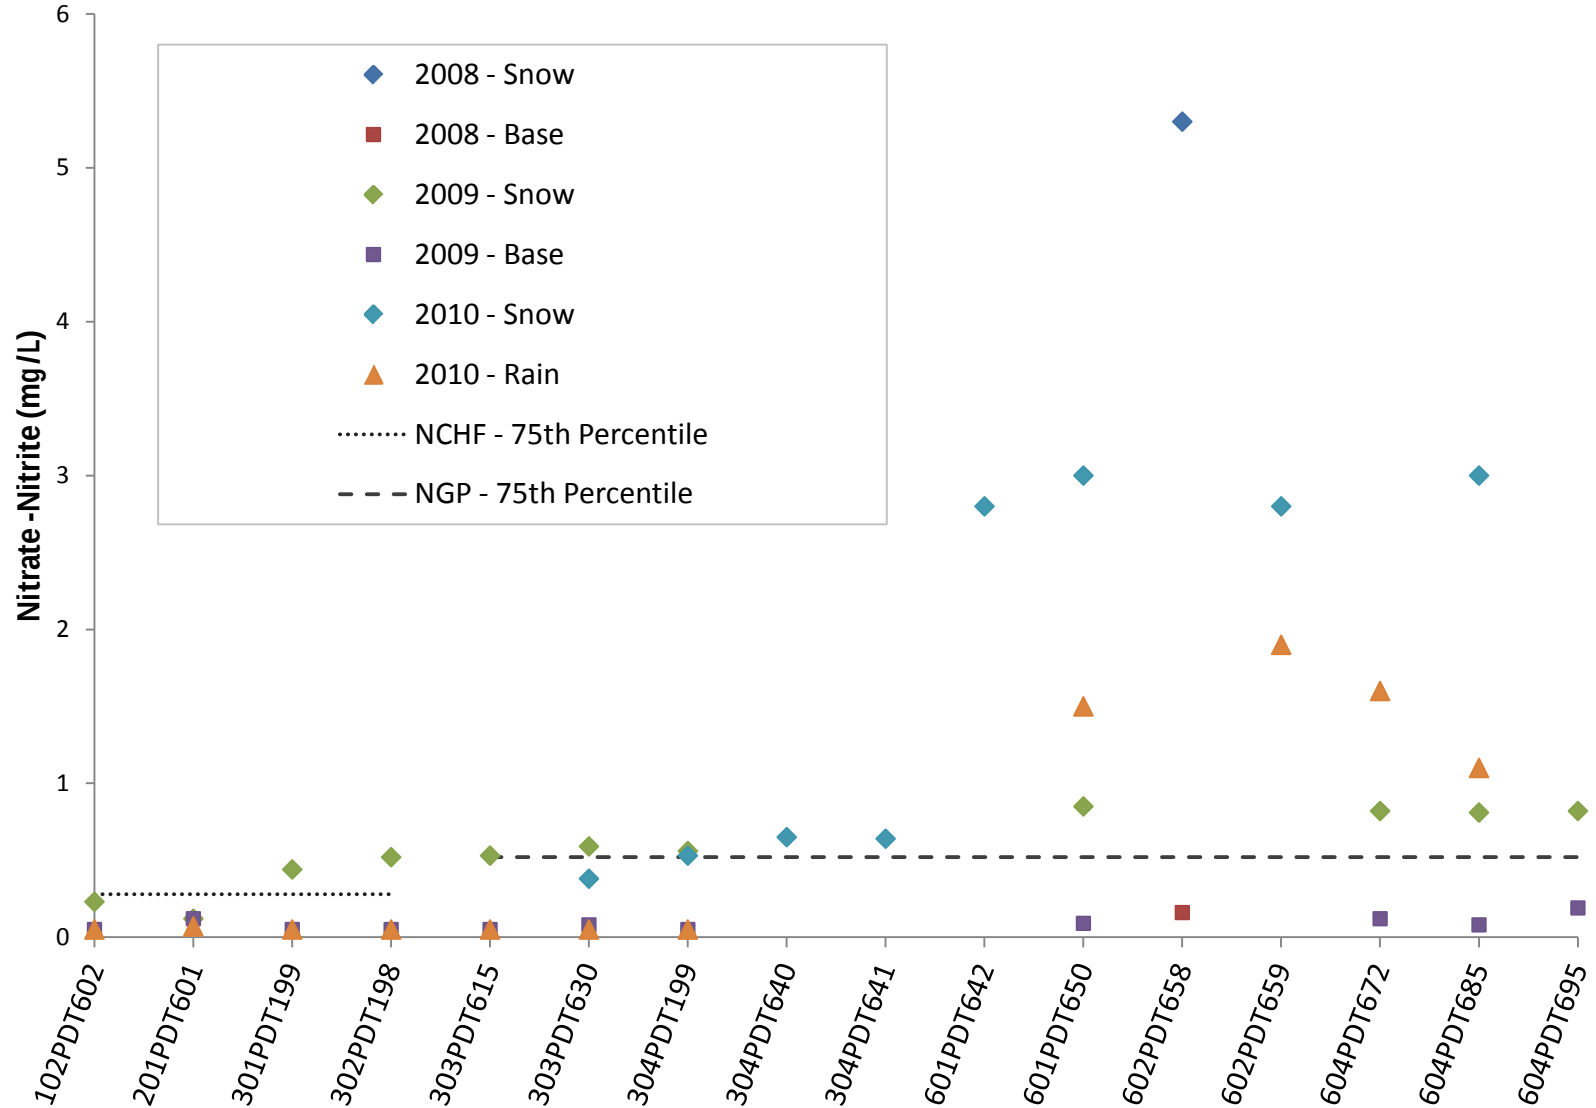
Figure 96. Nitrate-N measurements collected in the Pomme de Terre River, a longitudinal view from headwaters to downstream

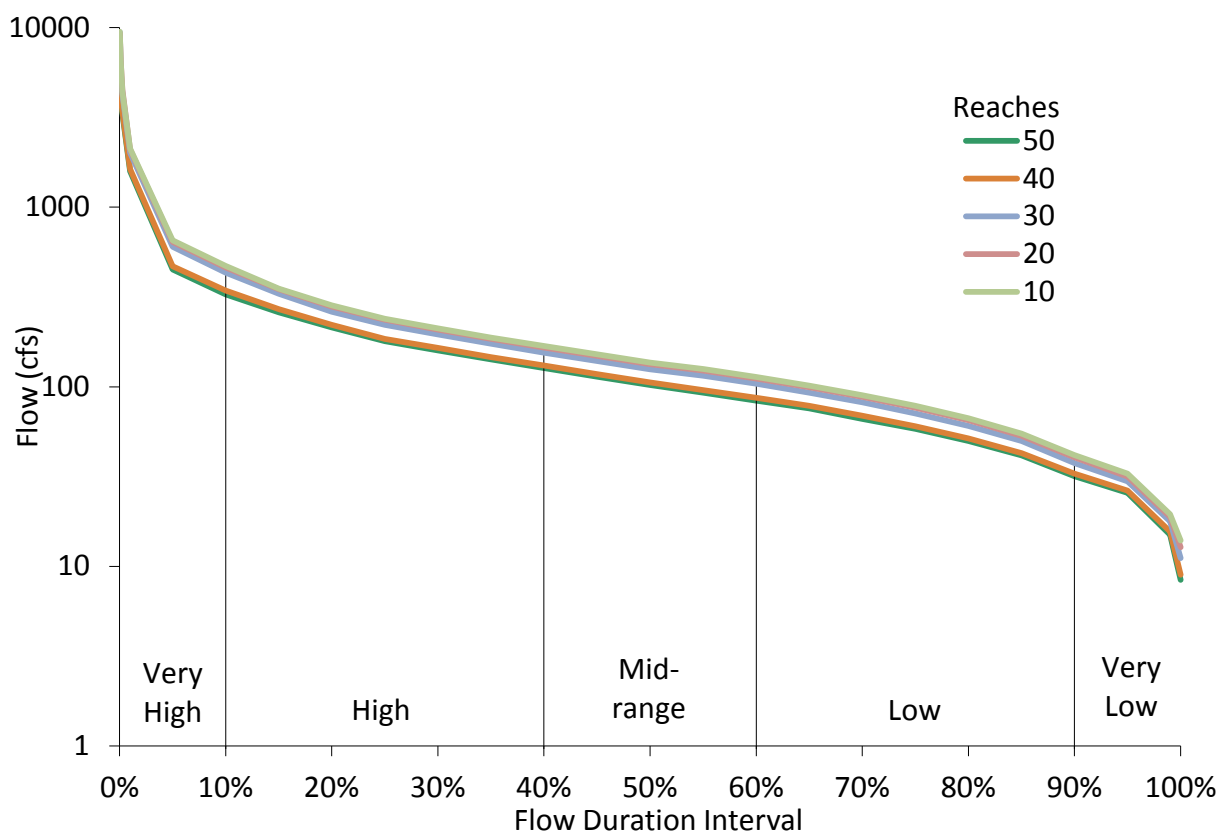
Figure 113. Flow duration curves for HSPF reaches 50, 40, 30, 20 and 10
