# Crow Wing River

## Upper Mississippi River Basin

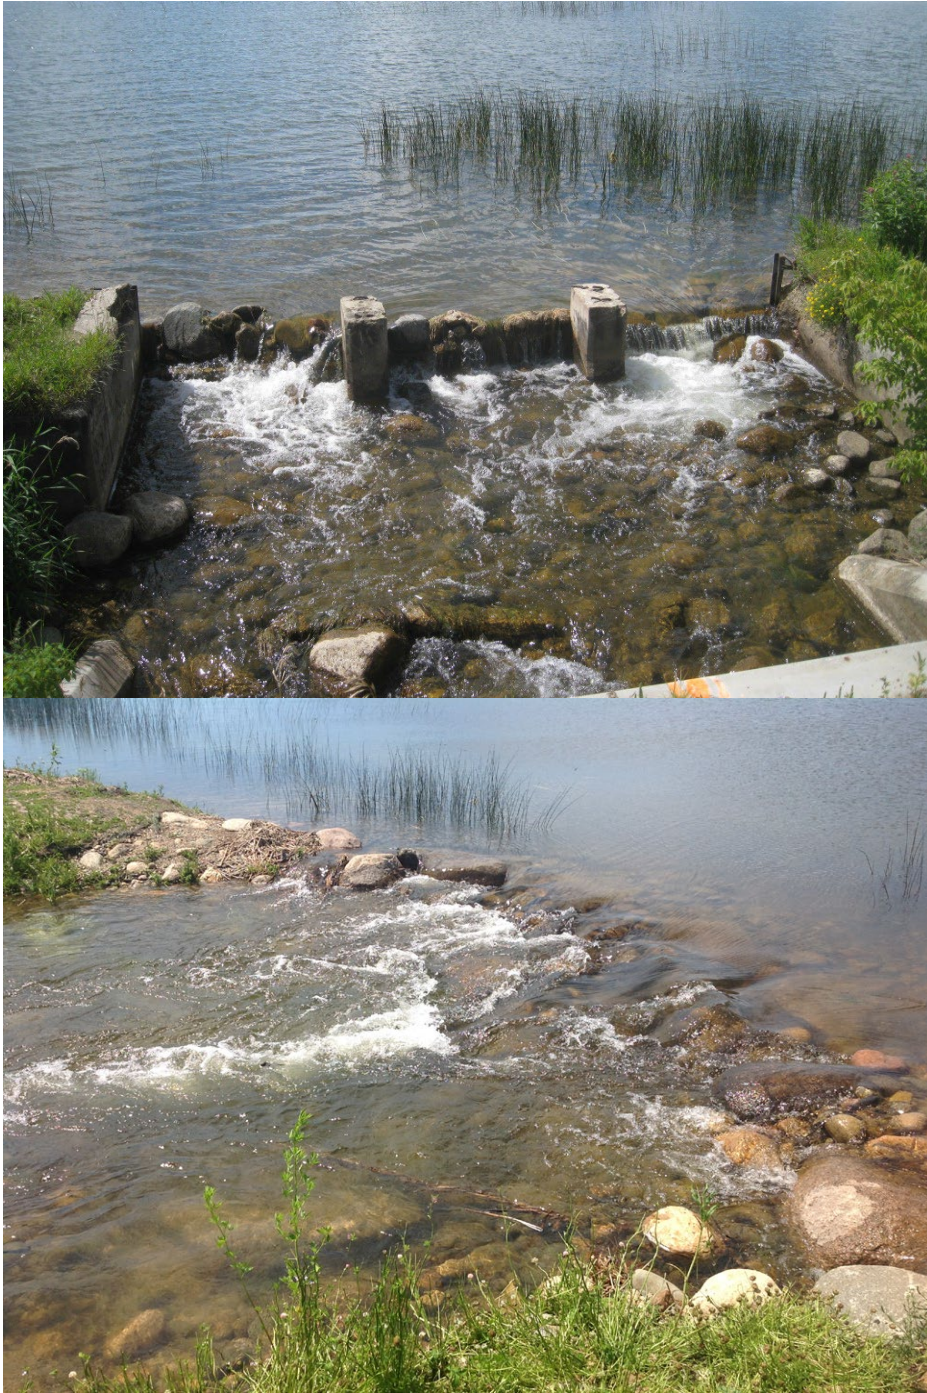
A Minnesota Department of Natural Resources (MNDNR) fisheries construction crew removed the low head dam at the outlet of Shell Lake that was blocking fish migration and replaced it with rock weirs to allow fish passage and aeration. Furthermore, MNDNR Fisheries obtained Lessard Sams Outdoor Heritage Funding (LSOH) to work with Carsonville Township and Becker County to improve fish passage at three road crossings. These improvements occurred at Smokey Hills Forest Road, Guyles Road (Twp 694) and 520<sup>th</sup> Avenue; with further anticipated improvements to also occur at several other crossings in the future. Recent biological fish surveys suggest that the

number of fish species and total numbers of fish are already increasing. Several partners cooperated on the dam removal project, which was funded through several state programs, including the Clean Water Fund.
