## Chippewa River

### Watershed Restoration and Protection Strategies (WRAPS) Report Summary

August 2016

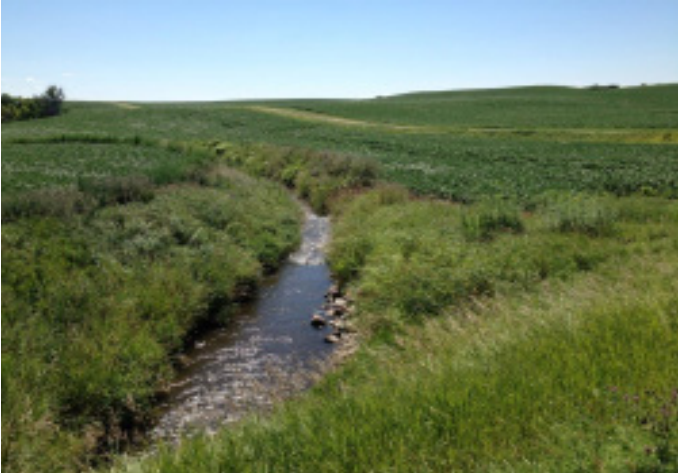
Typical small tributary ditch to the Chippewa River in the Western Corn Belt Plains Ecoregion.
