# Winnebago River Watershed

## Watershed approach

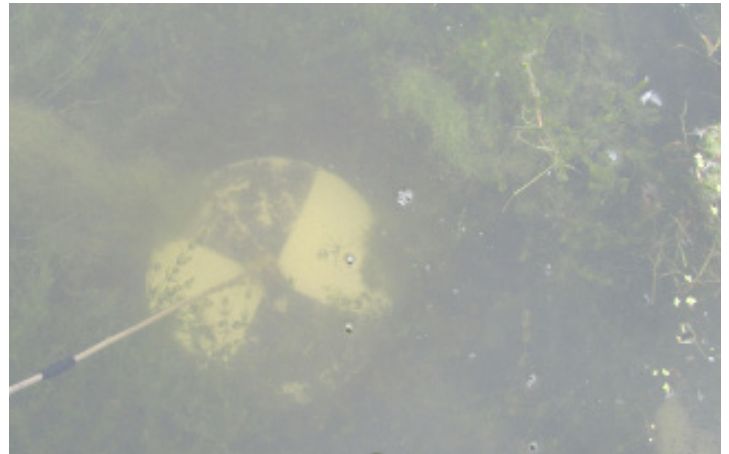
One way to measure clarity of water is to use a Secchi disk on a rope marked with centimeters, dropping the disk into the water until it can no longer be seen. Secchi readings in Bear and State Line lakes show low water clarity due to excessive algae and plant growth.

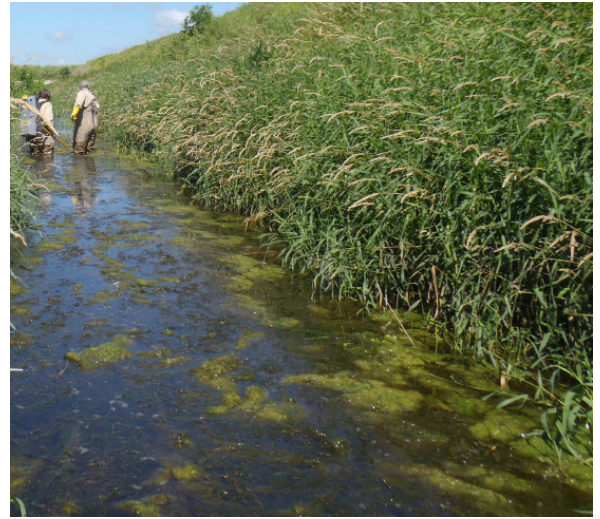
Water monitoring shows high levels of phosphorus that cause algae throughout waters in the Minnesota portion of the Winnebago River Watershed.
