# Snake-Middle Rivers Watershed

## Watershed approach

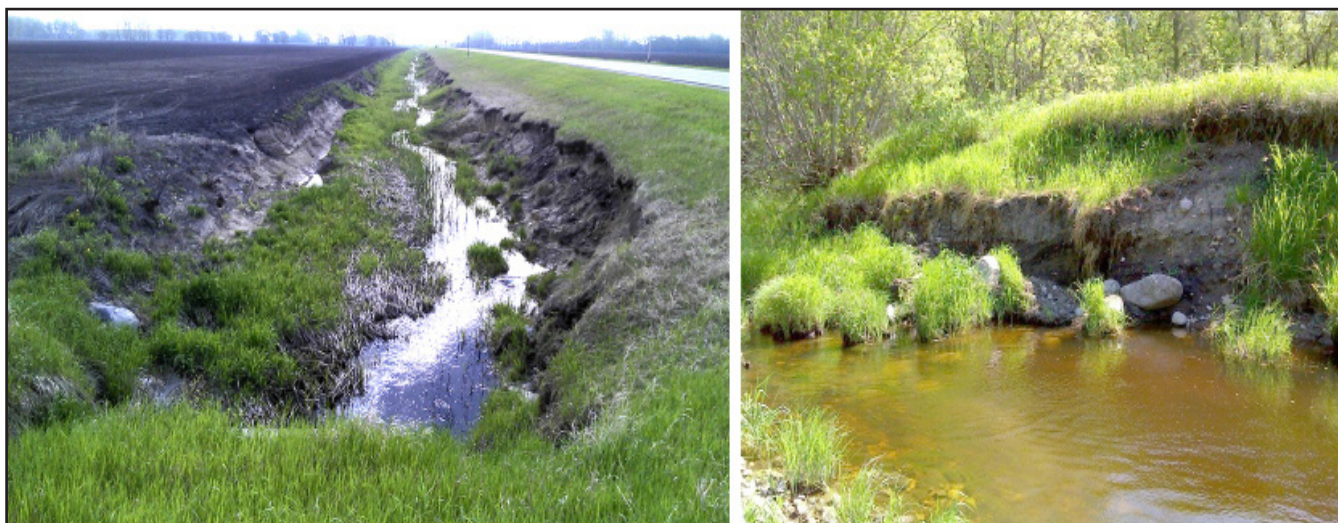
*Images of sediment sources, including bank slumping along an unnamed ditch at the 200th Avenue NW and CSAH 14 intersection on May 28, 2014 (left); and streambank erosion on May 29, 2014 (right).*
