# Crow Wing River Watershed Restoration and Protection Strategy Report Update 2023

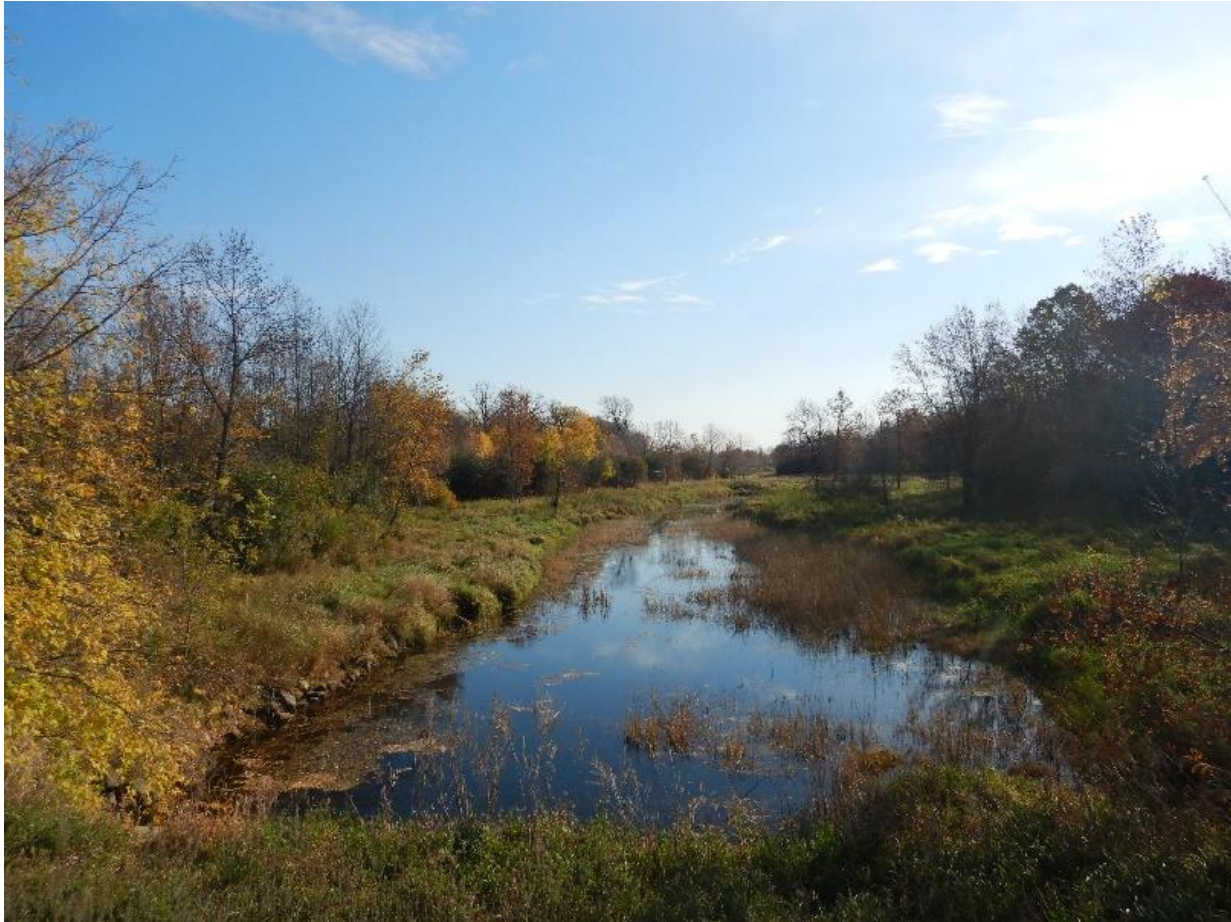
**Figure 18. The Partridge River with a wide riparian buffer.**

In the fall of 2022, SID staff traveled throughout the Partridge River Subwatershed, with a focus on areas that may be contributing to the *E. coli* issues within the Little Partridge River and the Partridge River. The river has a good riparian buffer throughout most of the length of the Partridge River (Figure 18).

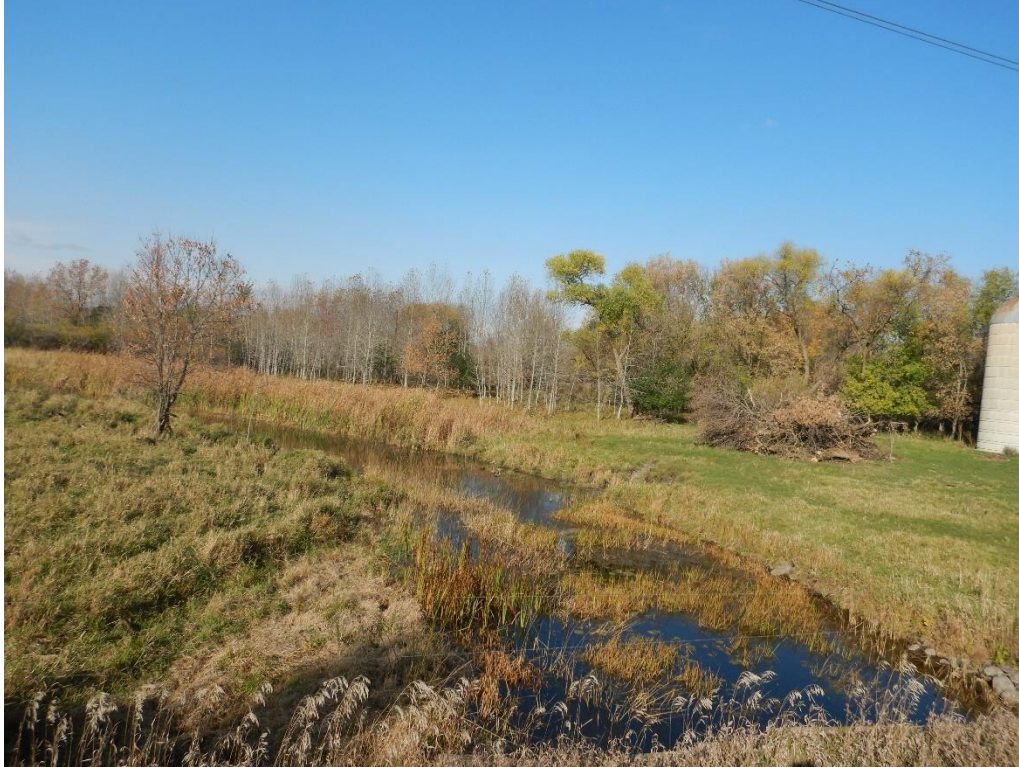
**Figure 19. The 195<sup>th</sup> Ave crossing on the Partridge River with direct cattle access to the river.**

However, there are some areas such as the upstream side of the 195<sup>th</sup> Ave (Figure 19) and the downstream side of the 231<sup>st</sup> Ave (Figure 20) crossings where cattle are still allowed access to the river, which impacts the habitat for AQL, and creates a source for *E. coli*.

The 195<sup>th</sup> Ave crossing on the Partridge River, with direct cattle access to the river.

Fencing cattle out of the Partridge River and Little Partridge River will benefit the AQL within the rivers and reduce the amount of *E. coli*. Focusing on the larger operations that still have cattle with access to the river, on the Little Partridge River, would have the biggest impact. Limiting the cattle access to small access points or finding alternative ways to water the cattle in these areas would make the biggest impact to the subwatershed. Although there are some small areas that are still in need of attention on the Partridge River, focusing on the Little Partridge River seems prudent.
