# Crow Wing River Watershed Stressor Identification Report

Determination of stress factors affecting aquatic biological communities

Minnesota Pollution Control Agency

April 2014

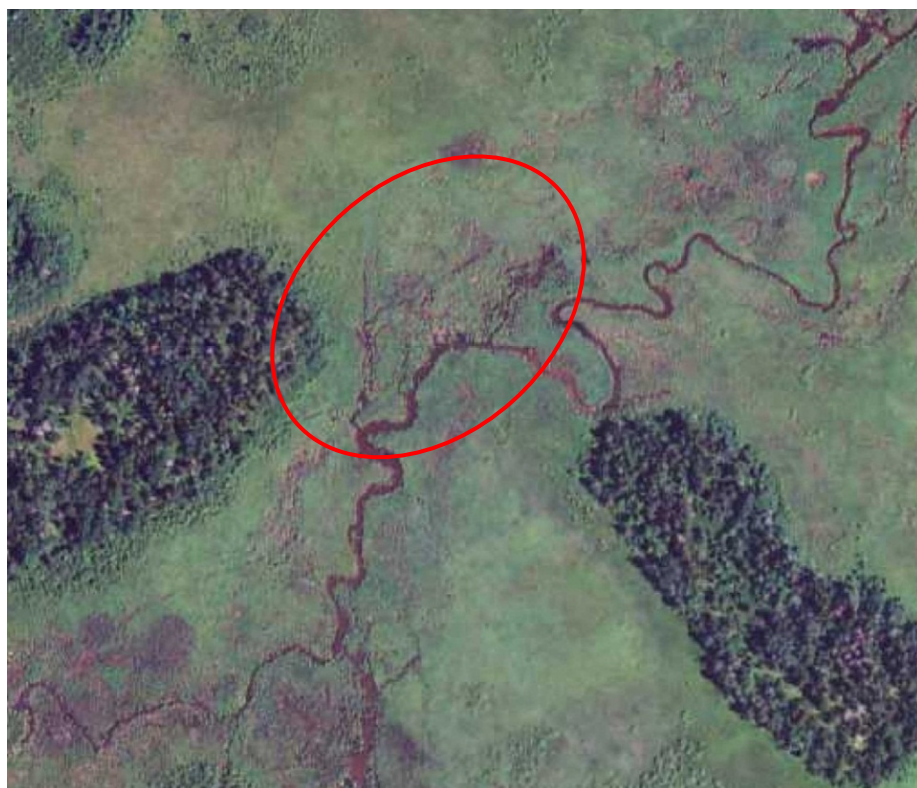
Photo 3. Farnham Creek groundwater seeps. The circled area shows shallow groundwater seeps emerging within the sedge meadow and entering Farnham Creek. Also note the orange color seen in many places along the channel due to iron inputs from groundwater.

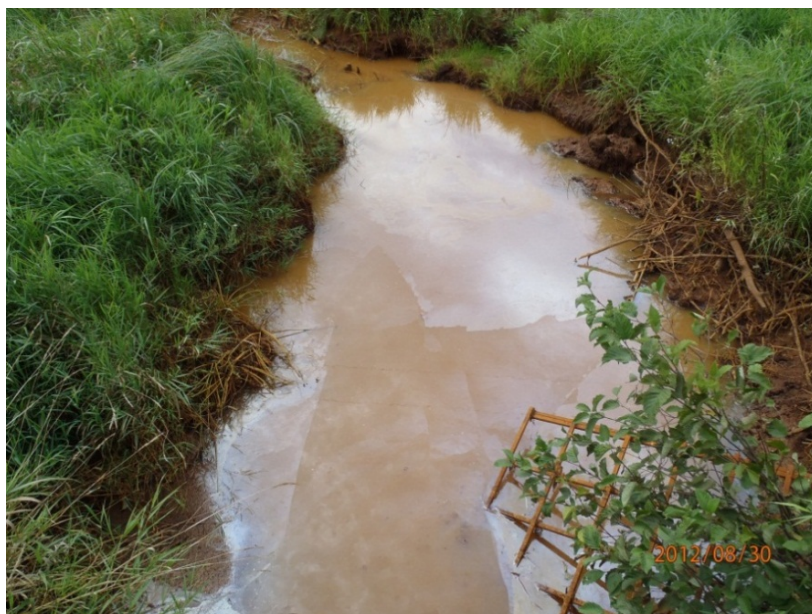
**Photo 4.** Iron Creek, a tributary to Swan Creek, north of Staples, MN. The water is turbid orange from the high iron content. Note the oily sheen on the surface, which is commonly seen in these high-iron waters.

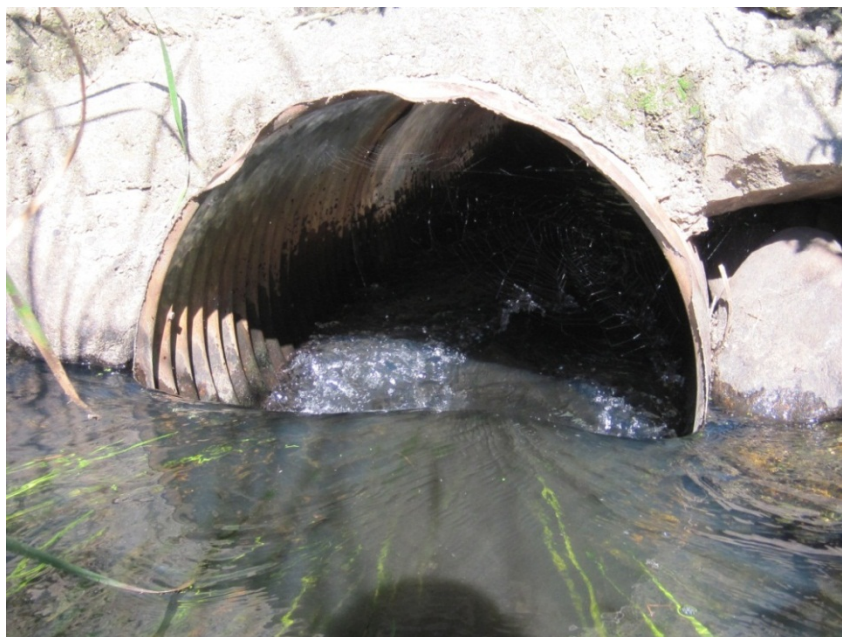
**Photo 5. Upstream entrance to the Aspen Lane culvert. The culvert elevation is not correct, and it is also undersized, causing the flow to be quite swift.**

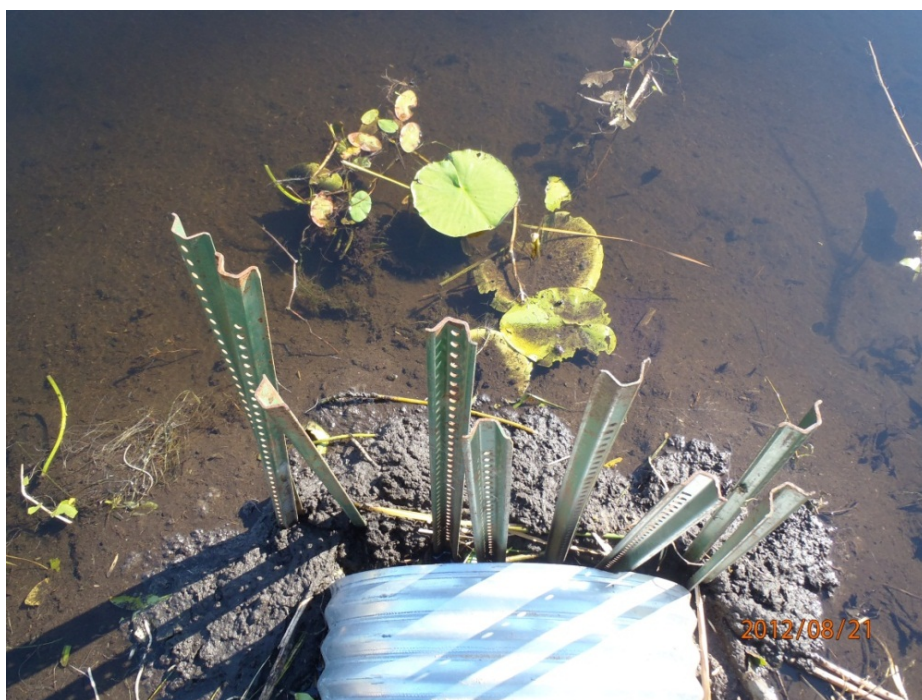
**Photo 6.** Outlet of Tripp Lake wetland, blocked by a mud beaver dam. There was evidence here of repeated attempts to maintain open flow in this culvert (debris pile, stakes over culvert opening).

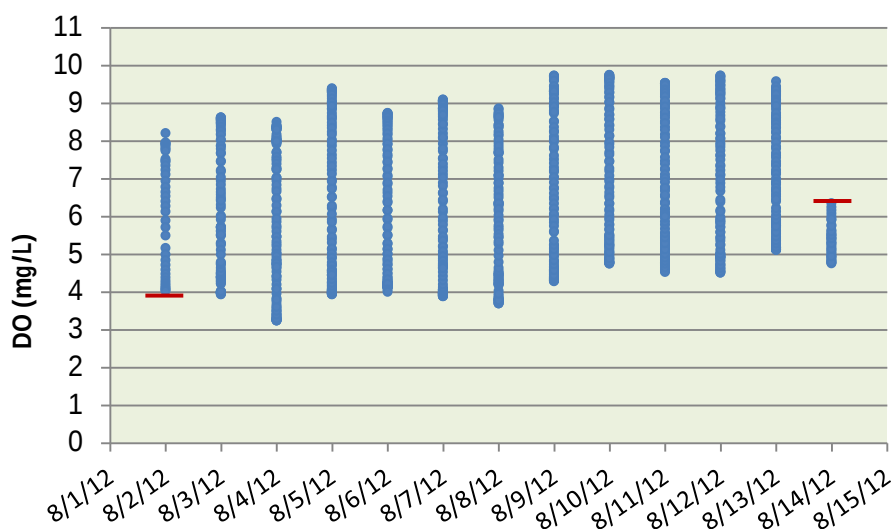
Figure 11. DO readings from the Sonde at Bender Cr. Rd

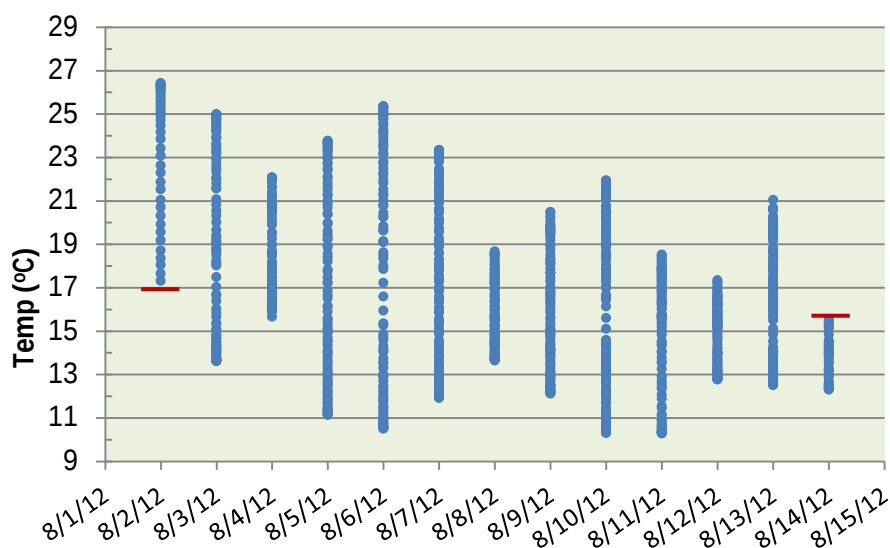
Figure 12. Temperature readings from the Sonde at Bender Cr. Rd

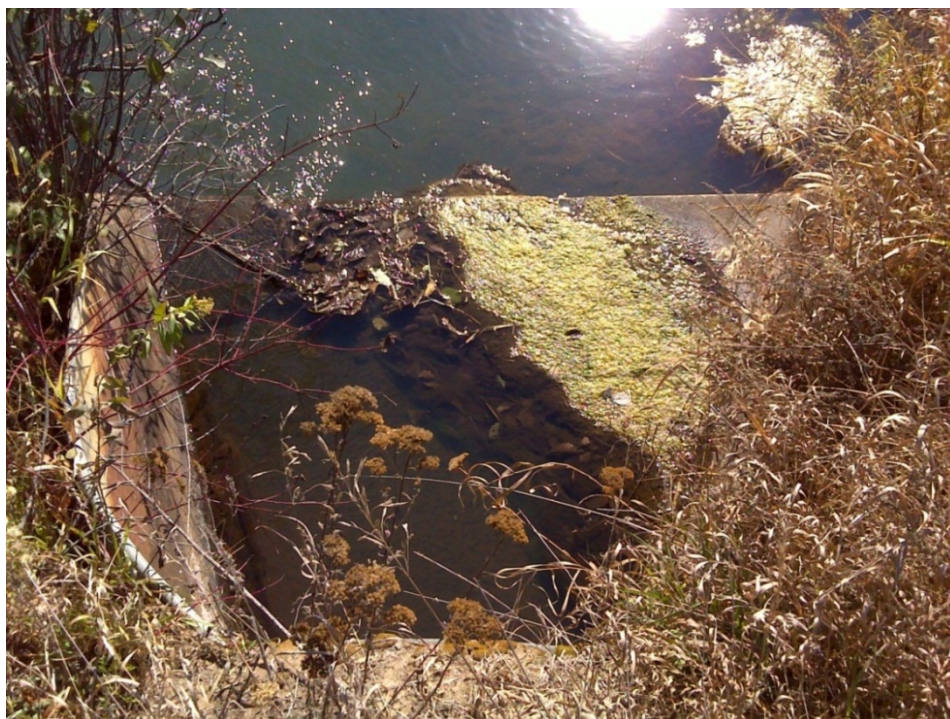
**Photo 7. Culvert outfall at 294<sup>th</sup> Street, fall 2012. The algae here is not representative of the stream in general - this is just a warm, full sun exposure, damp microhabitat.**

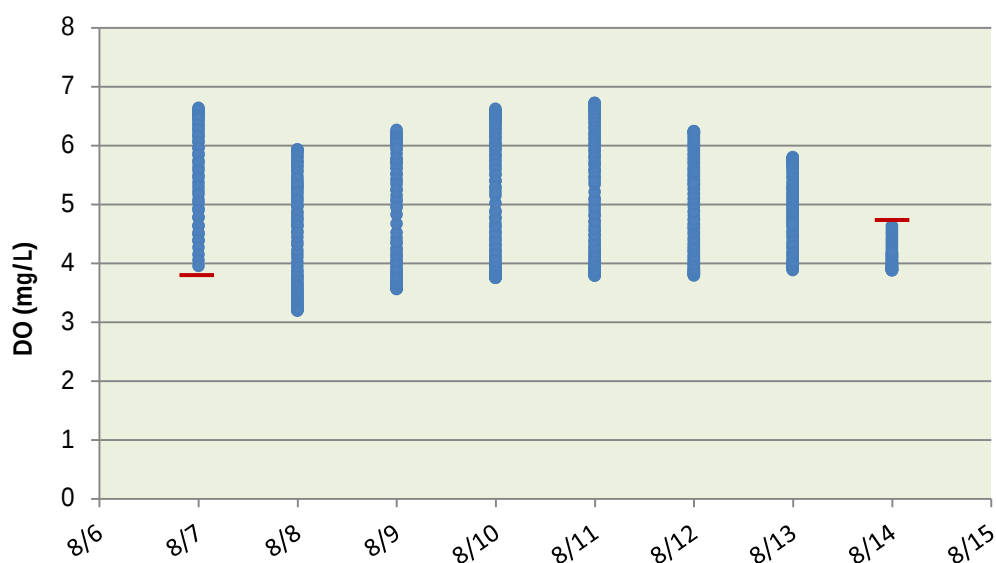
**Figure 15. DO readings from the Sonde at 87<sup>th</sup> Ave. SW (10UM078)**

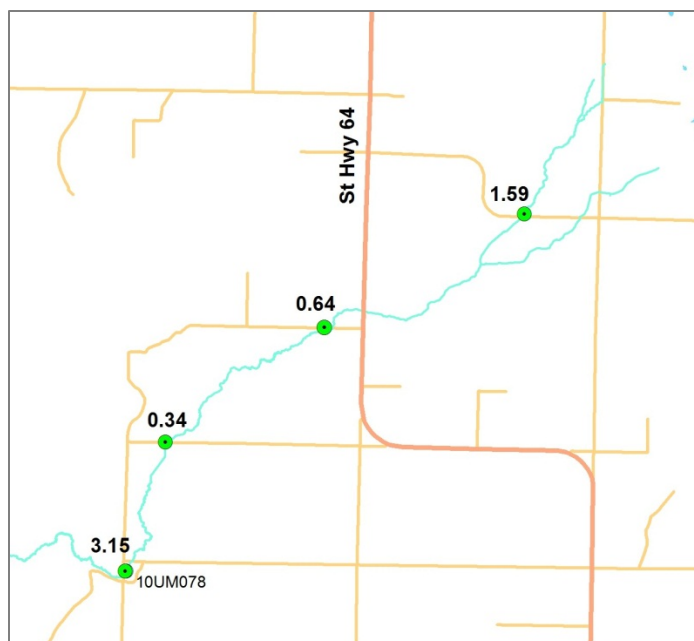
**Figure 16. Longitudinal DO readings (in mg/L), collected July 17, 2012. Collection times (DS to US): 7:53, 8:04, 8:54, and 9:15 am.**

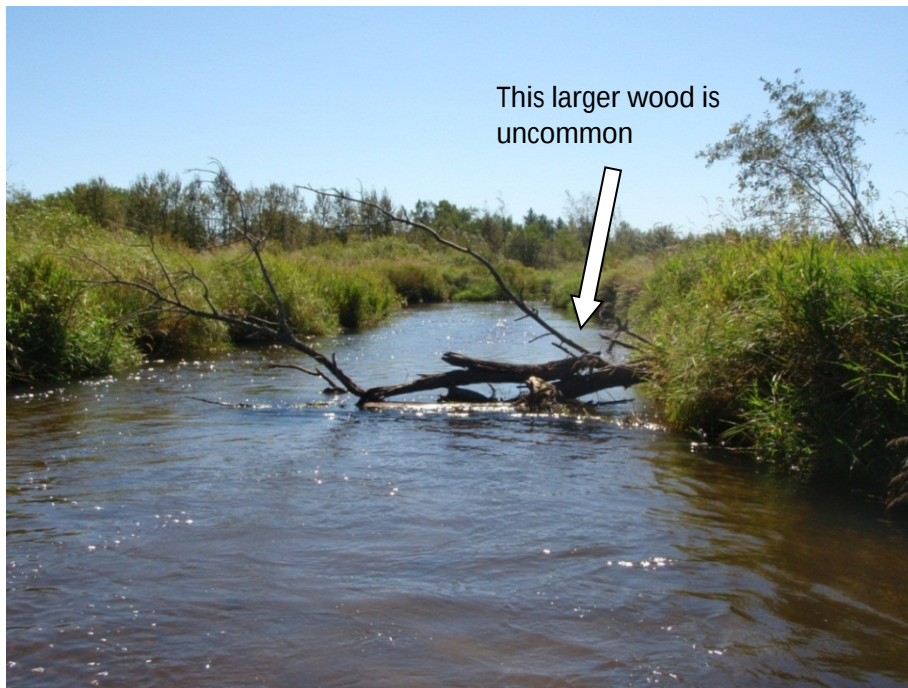
**Photo 9. Mid-reach photo from 10EM133. Photo depicts the typical sandy, shallow, uniform depth, exposed, canopy-lacking, non-woody riparian condition common (and natural) throughout this AUID. Large pieces of downed wood are uncommon in this AUID.**

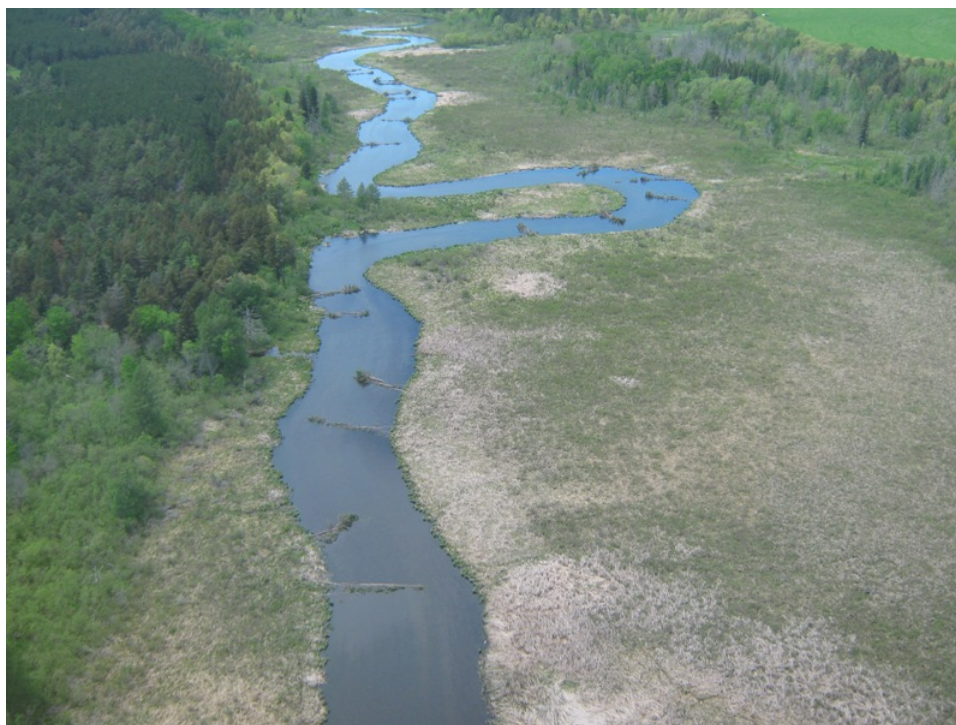
**Photo 14.** Placement of imported trees intended to deepen the thalweg, narrow the channel, add sinuosity, and add cover for fish. Again note the natural wide sedge meadows that occur in this region. *MDNR Photo*

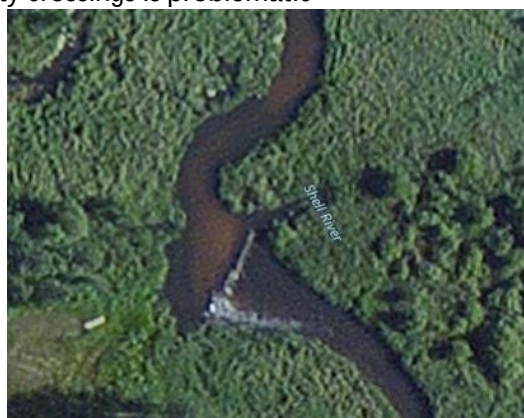
**Photo 15: Possible barrier with turbulent overflow**

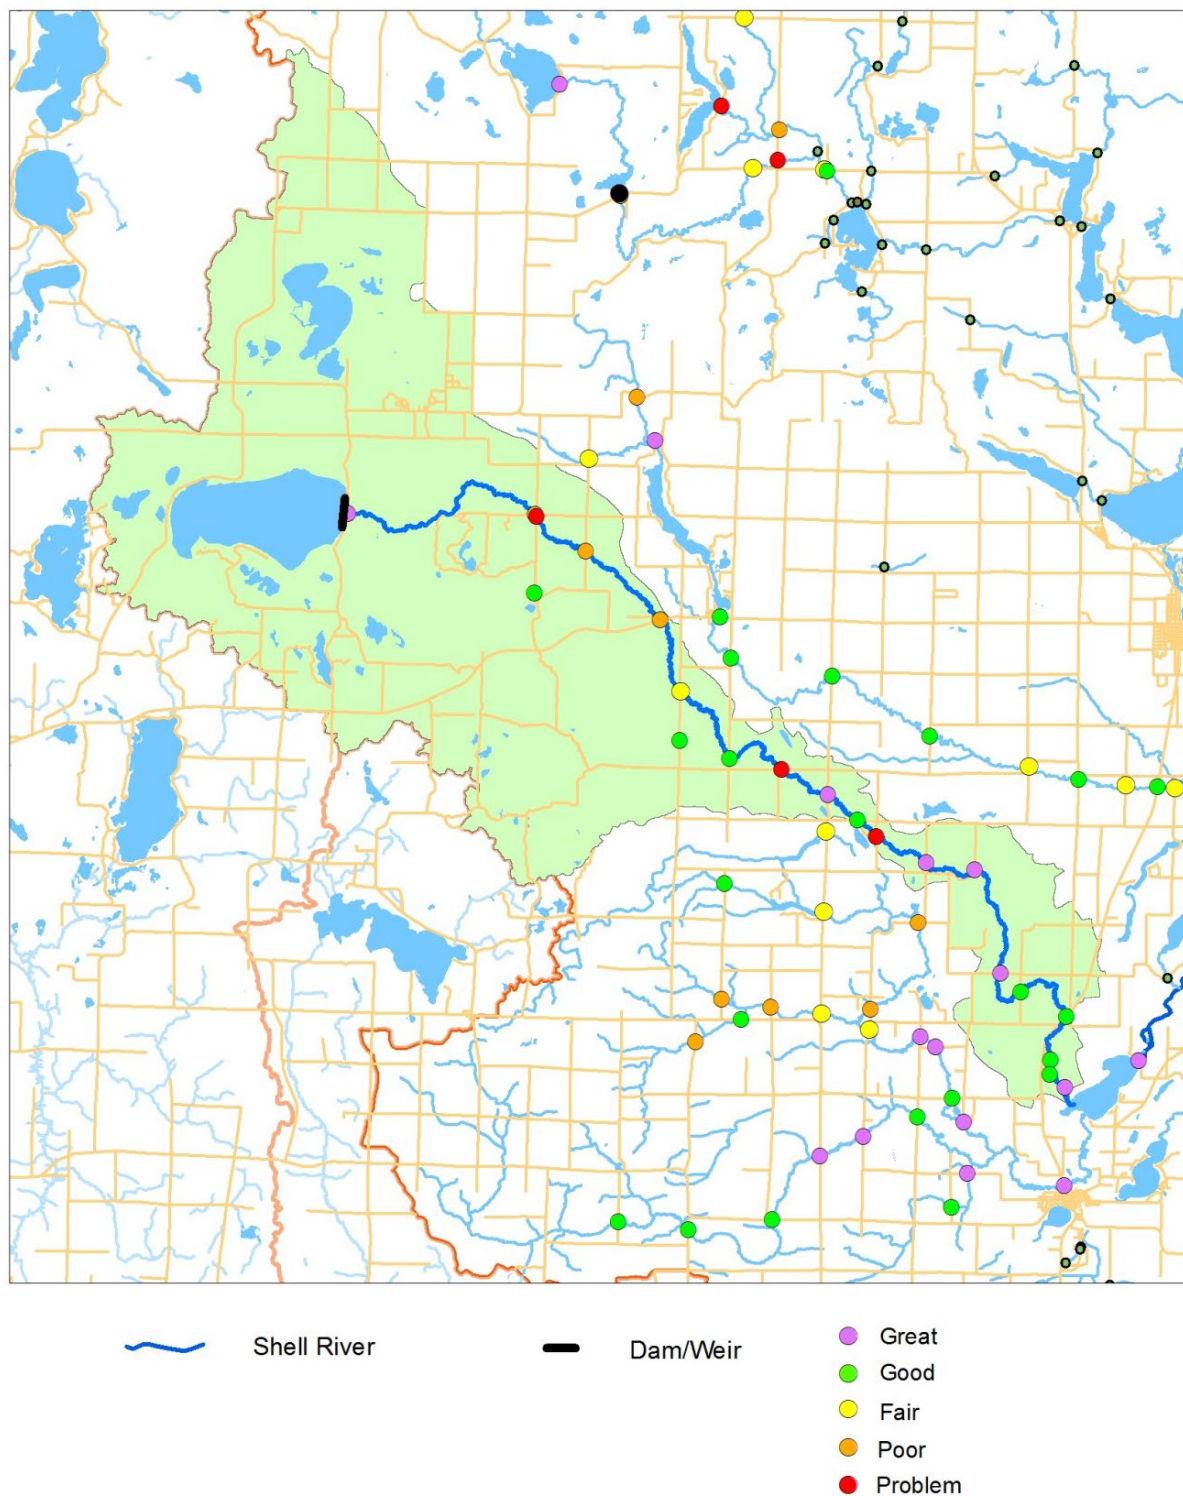
**Figure 20. Upper Shell River Connectivity Assessment.** MDNR performed as assessment of the road crossing structures, denoting their effect on the channel and fish passage. *Survey and map by Mike Kelly, MDNR.*

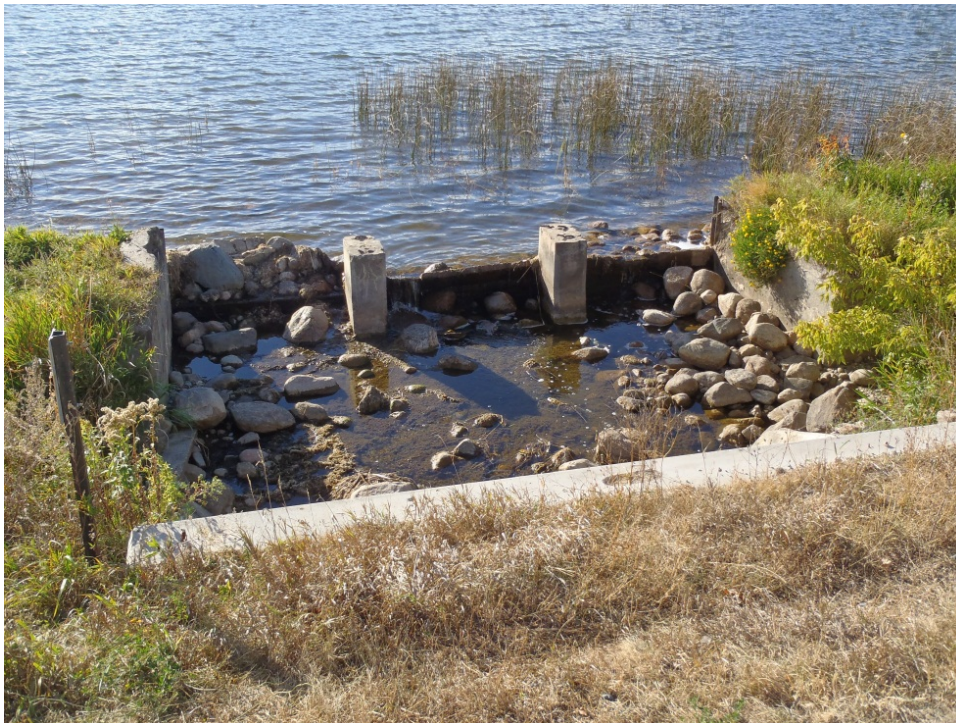
**Photo 16. The small dam at outlet of Shell Lake (beginning point of AUID - 537) in fall 2012 - blocks fish movement between the lake and river, possibly restricting access to winter refuge habitat**

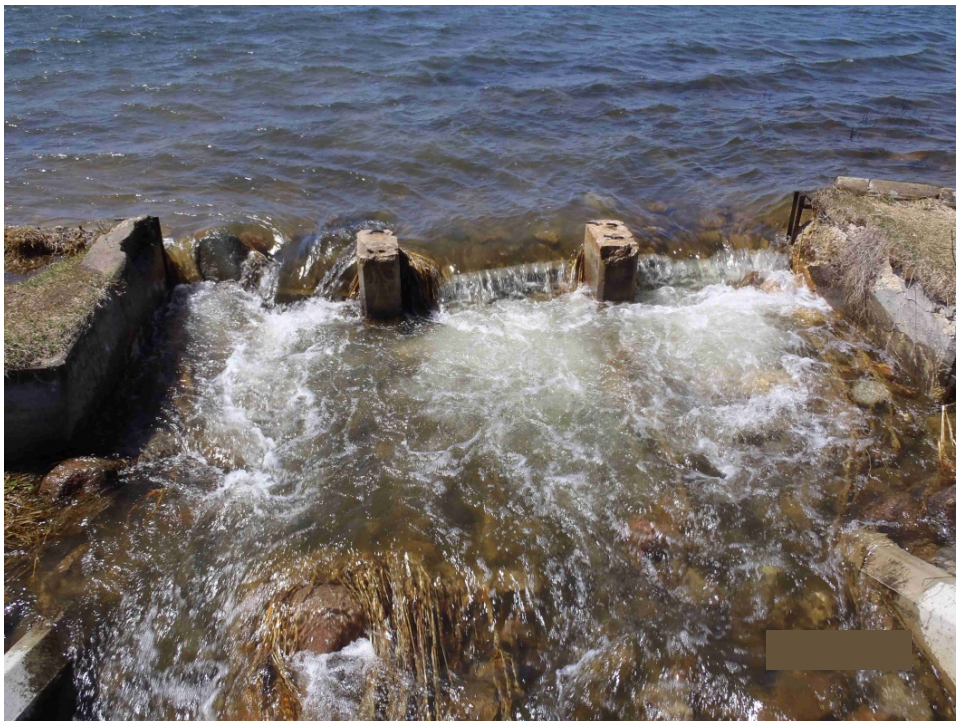
**Photo 17. Dam at outlet of Shell Lake a week after lake opened, May 2013**

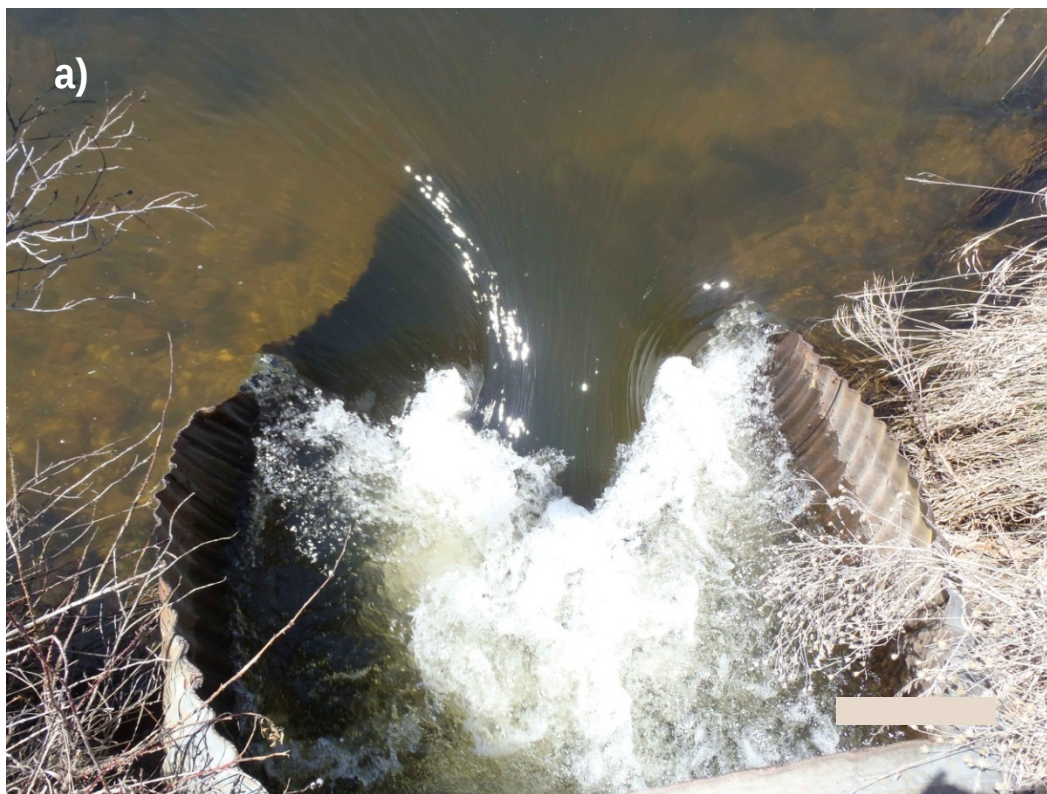
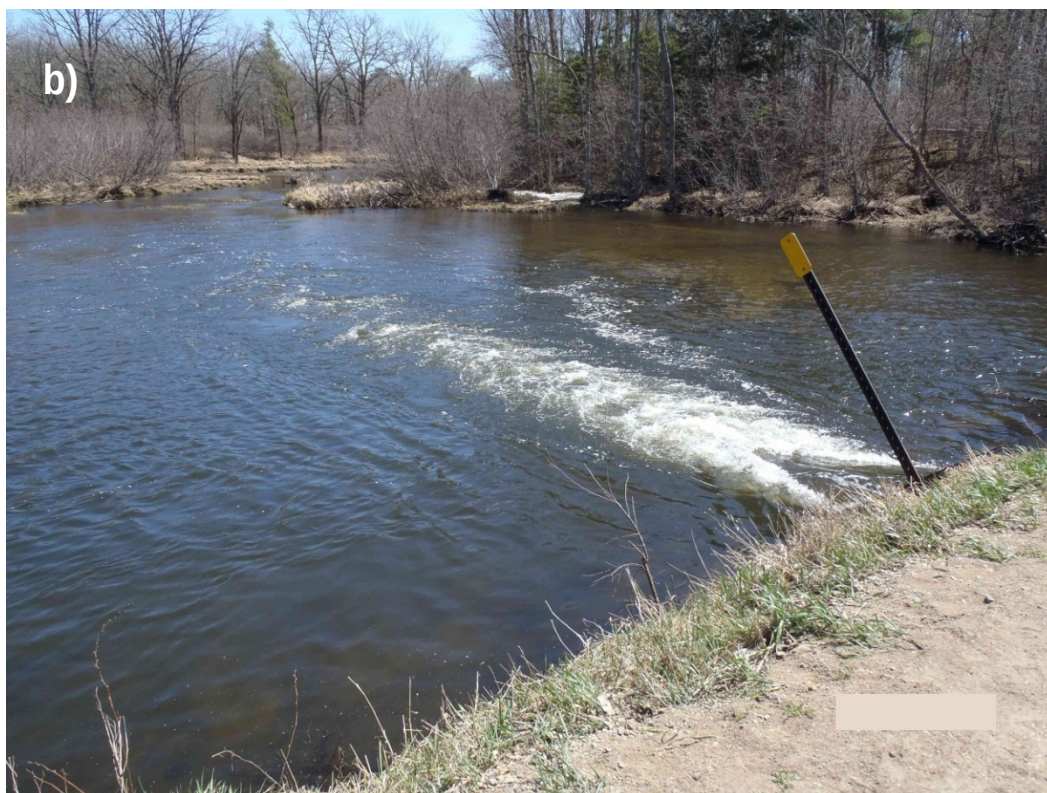
**Photo 18. Culvert at Guyles Road, a) intake of culvert, b) outfall of culvert**

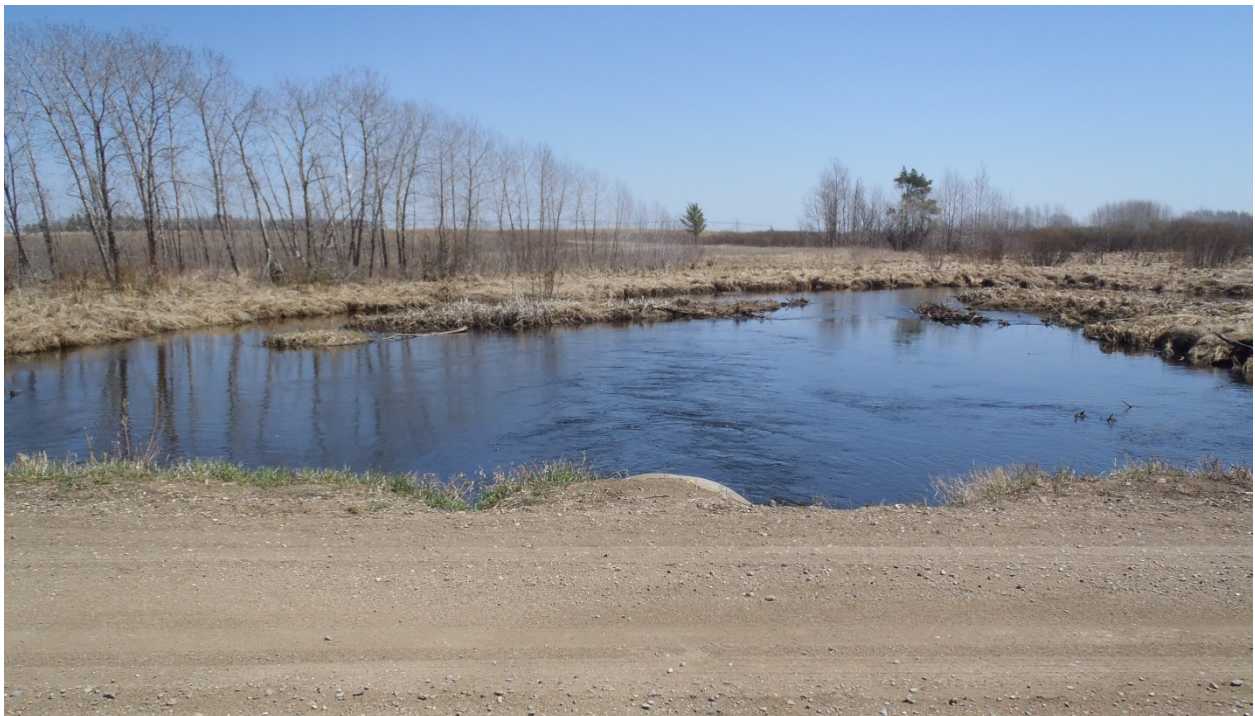
**Photo 20. Culvert at 520<sup>th</sup> Ave. Strong velocity was observed coming from the culvert, which is undersized, and this large scour pool is the result of these more-erosive flows.**

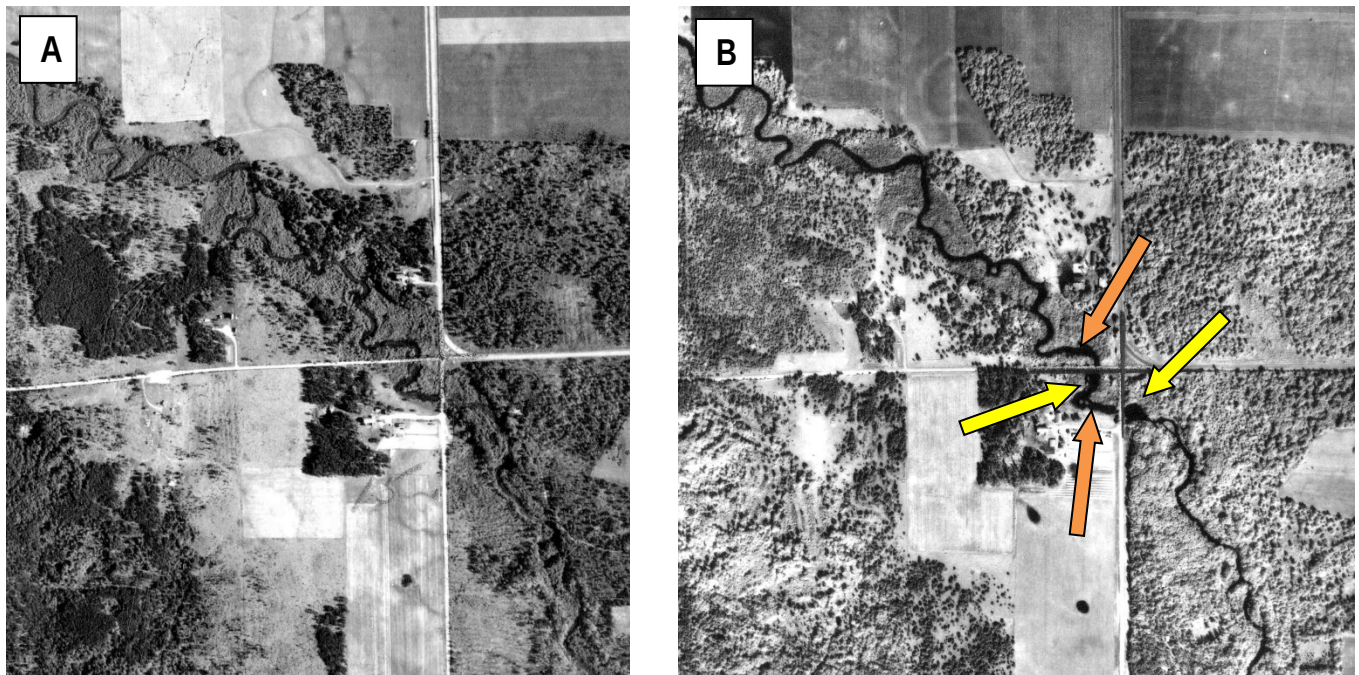
Photo 21. Historic aerial photos of site 10UM053. A. 1953 aerial photo, B. 1973 aerial photo. Yellow arrows point to new scour pools and orange arrows to widened channel.

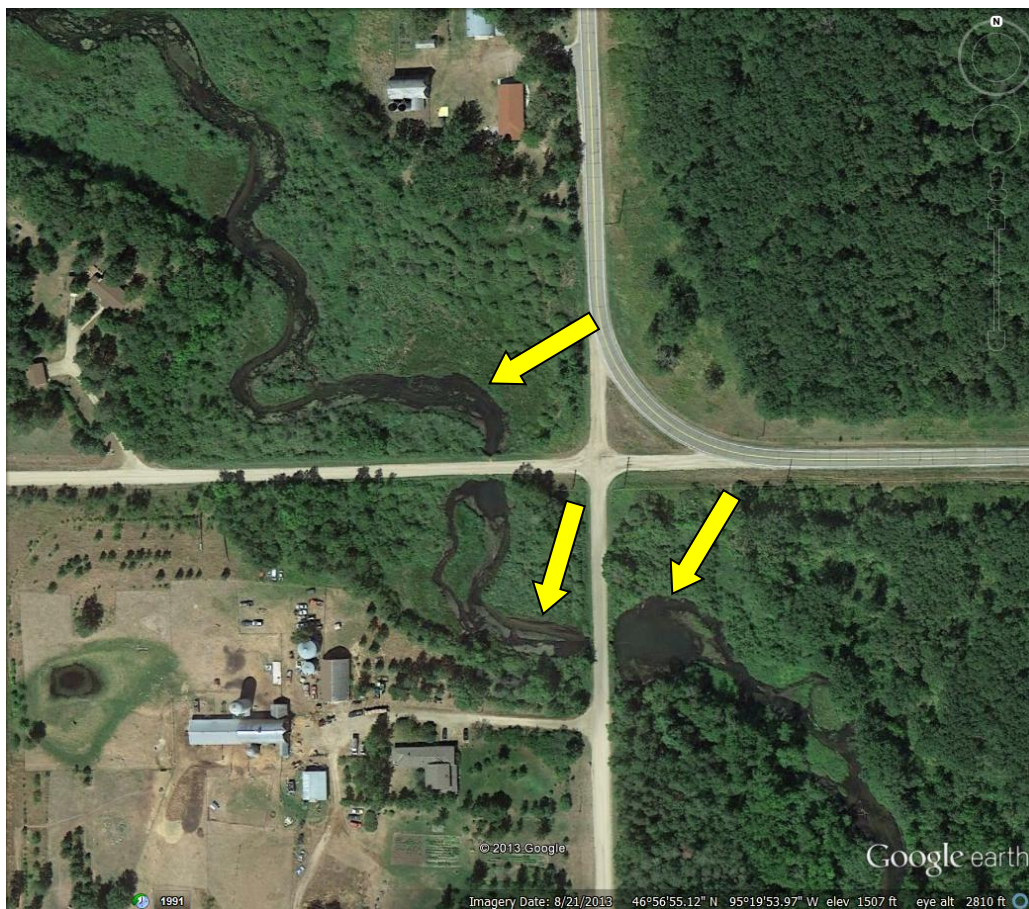
**Photo 22. 2013 Aerial photo of site 10UM053. This is a low-flow period. Arrows point to detritus deposition areas.**

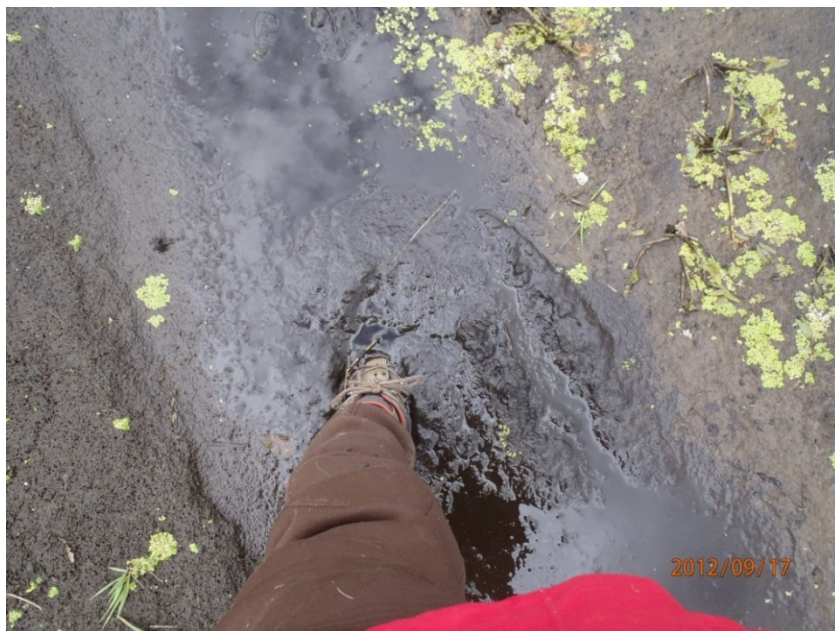
**Photo 23. Muck at site 10UM053. Culvert downstream is set too high, decreasing gradient, and likely causing deposition of this organic material here. This organic sediment likely adds to the DO sag that occurs here.**

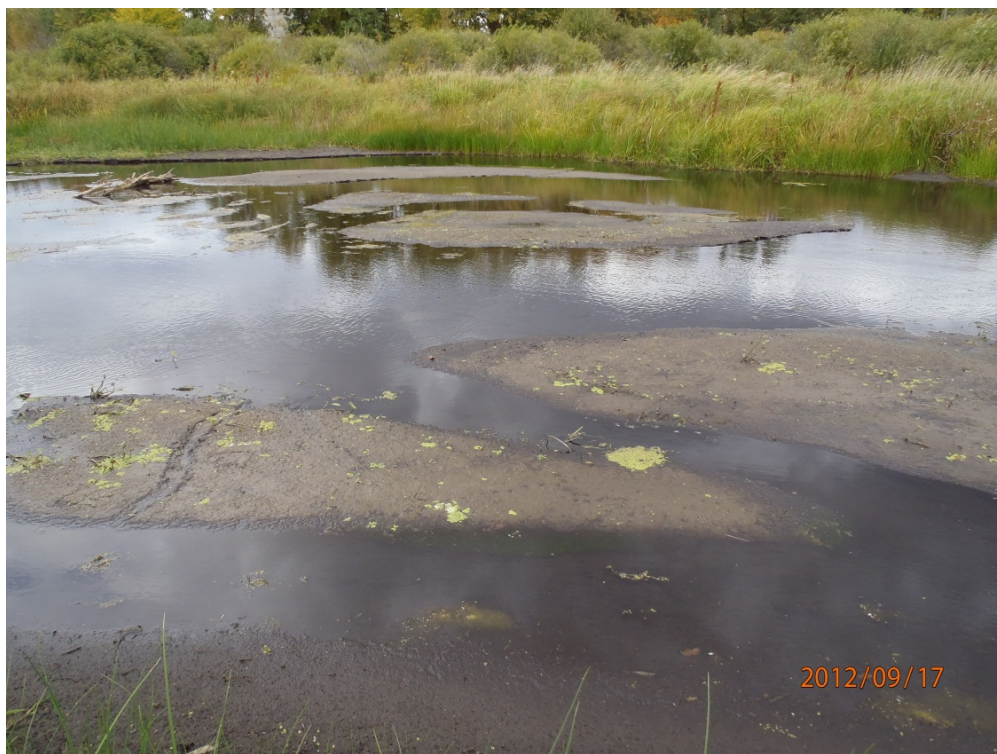
**Photo 24. Sediment deposition at 10UM053 just above the Smokey Hills Road culvert**

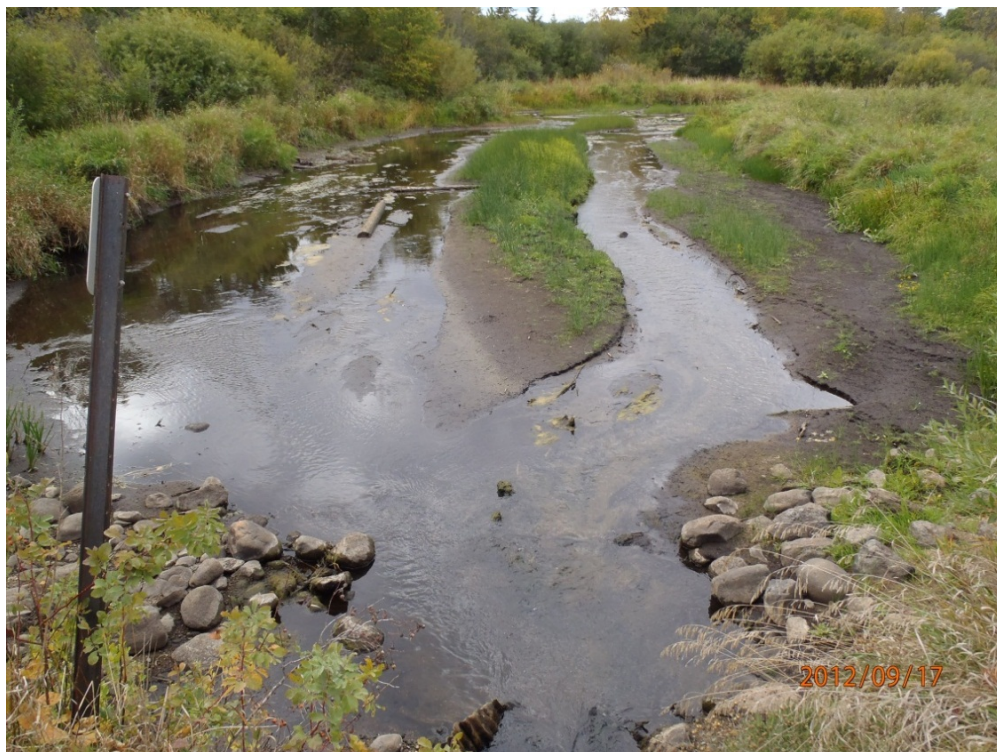
**Photo 25. Sediment deposition just above the Guyles Road culvert**

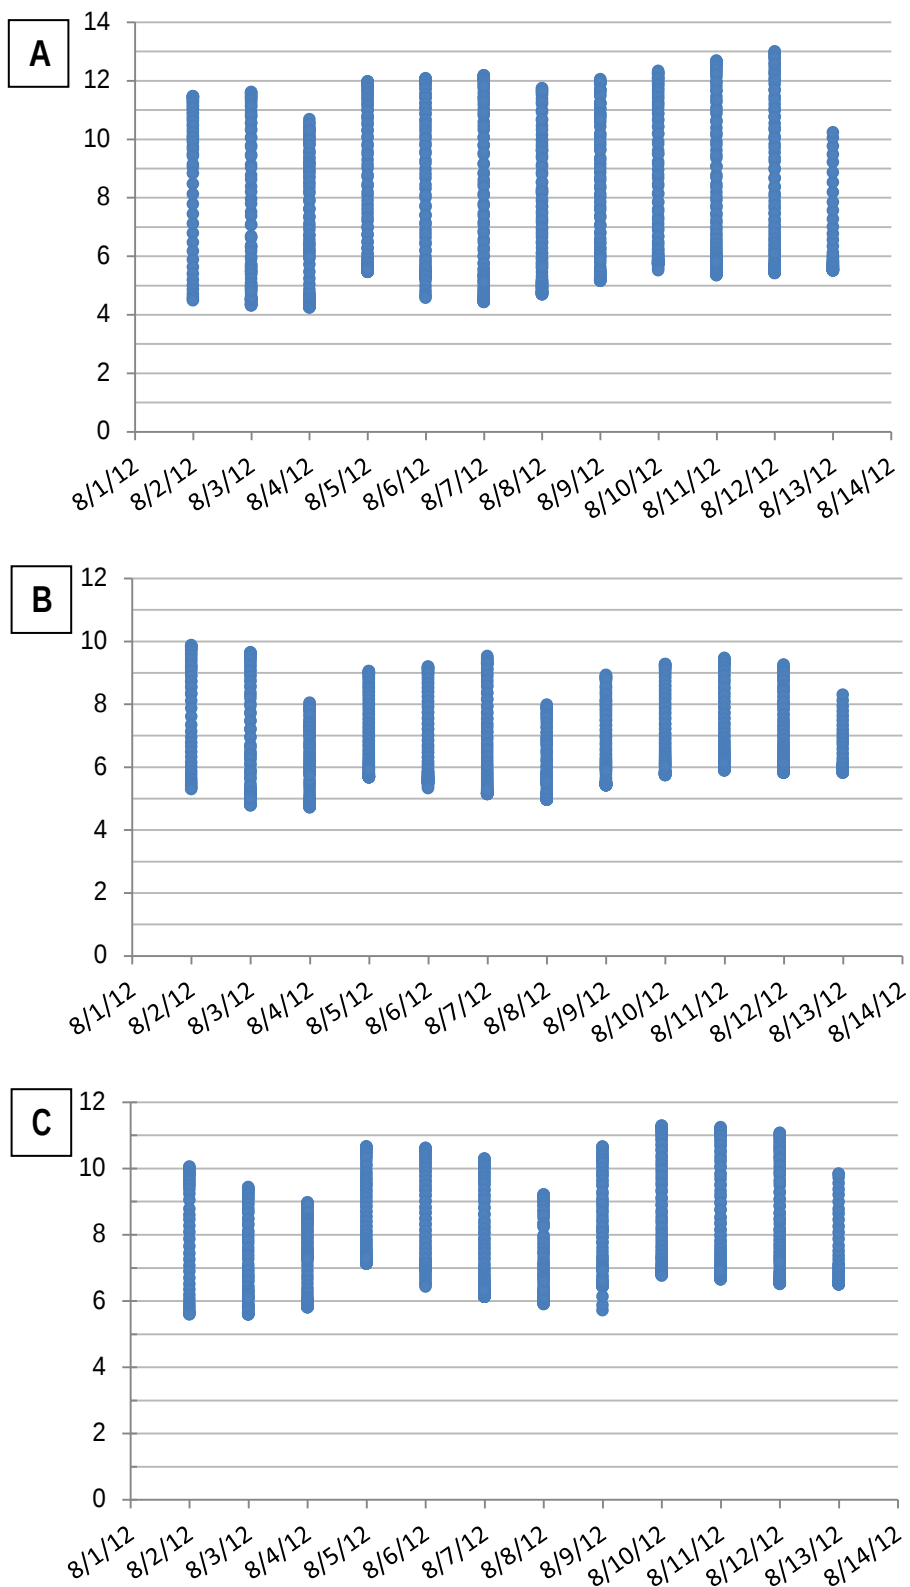
**Figure 21. Sonde DO data from the upper Shell River AUID. A. Smokey Hills Road (10UM053), B. CSAH 47, C. CR 111**

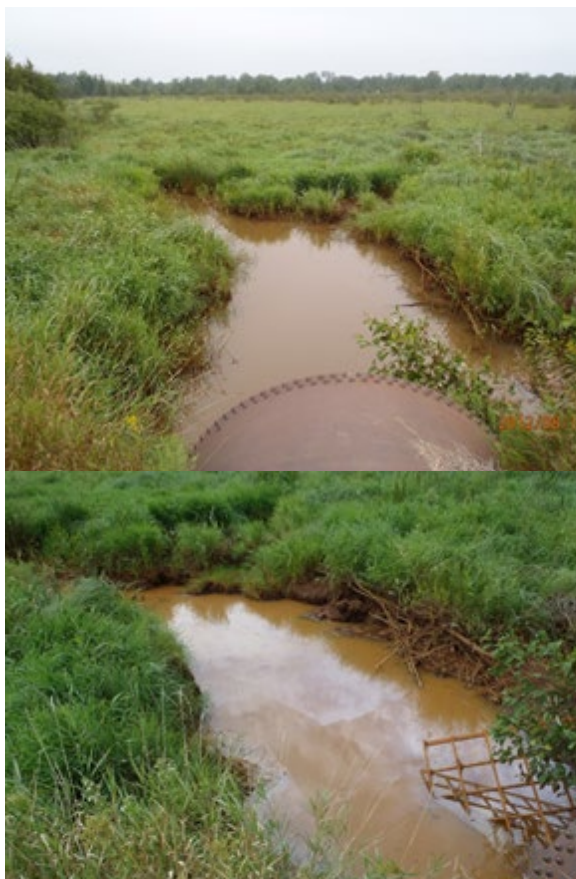
**Photo 26. Iron Creek, showing the extreme iron conditions found in area tributaries, which are also found in the CWRW in the adjacent area north of Swan Creek. This iron is a sign that there is significant groundwater entering the creek.**

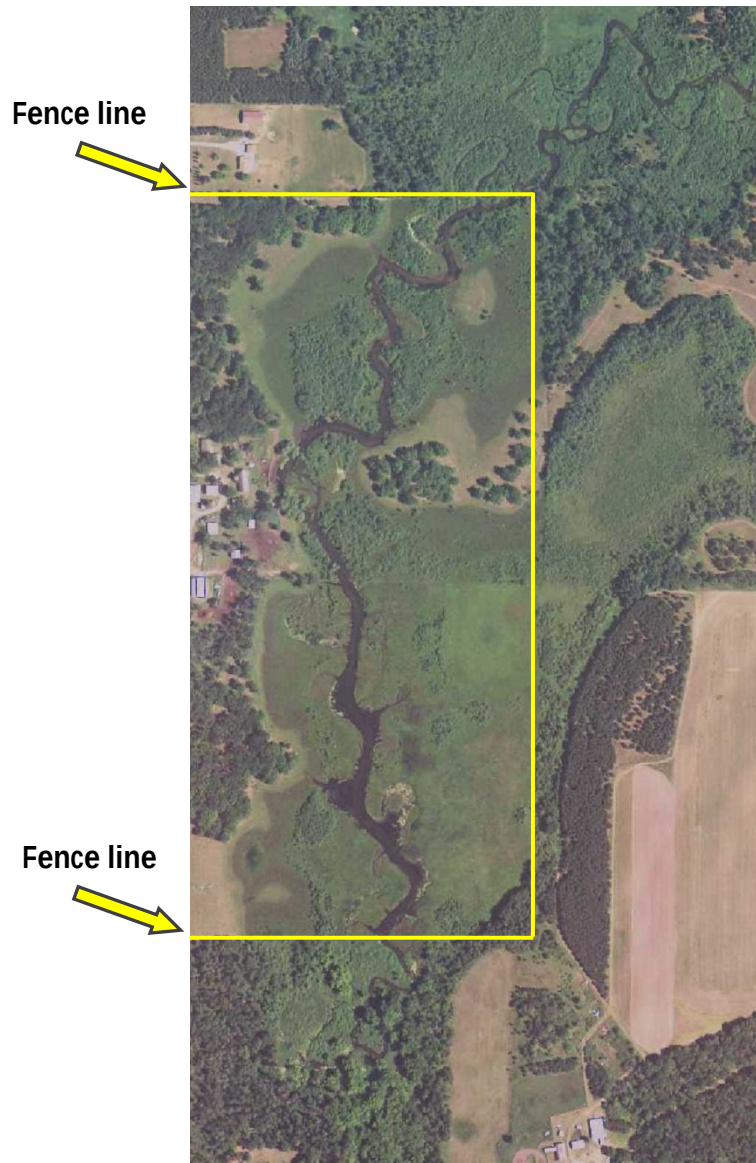
**Photo 28. Recent aerial photo of the 10EM086 reach. Note how much wider the stream is in the pastured area versus the natural areas up and downstream.**

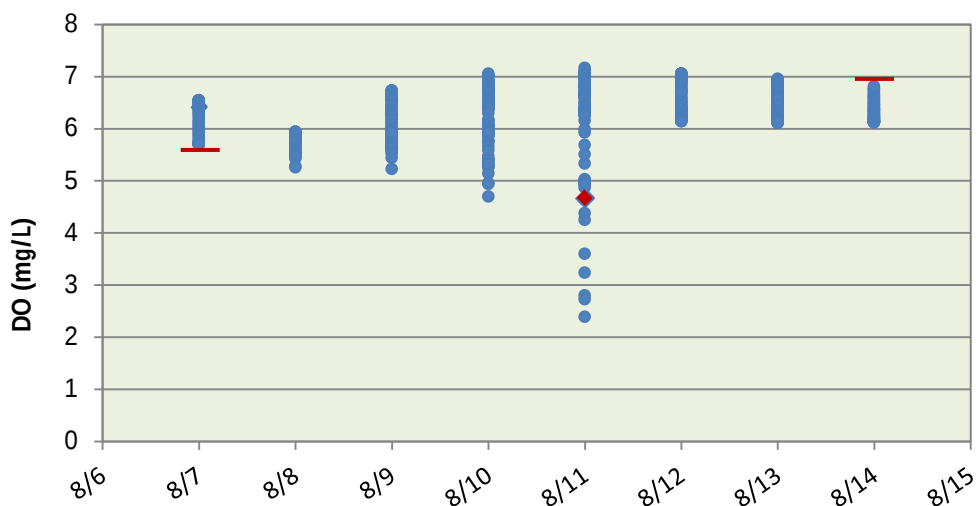
Figure 26. Sonde readings during August 2012 at 80<sup>th</sup> St. SW. On August 11, 2012, there was a temporary issue with the Sonde where a drifting leaf or other material caught on the Sonde. The red diamond represents the approximate low value for the day derived from a linear plot of the data.

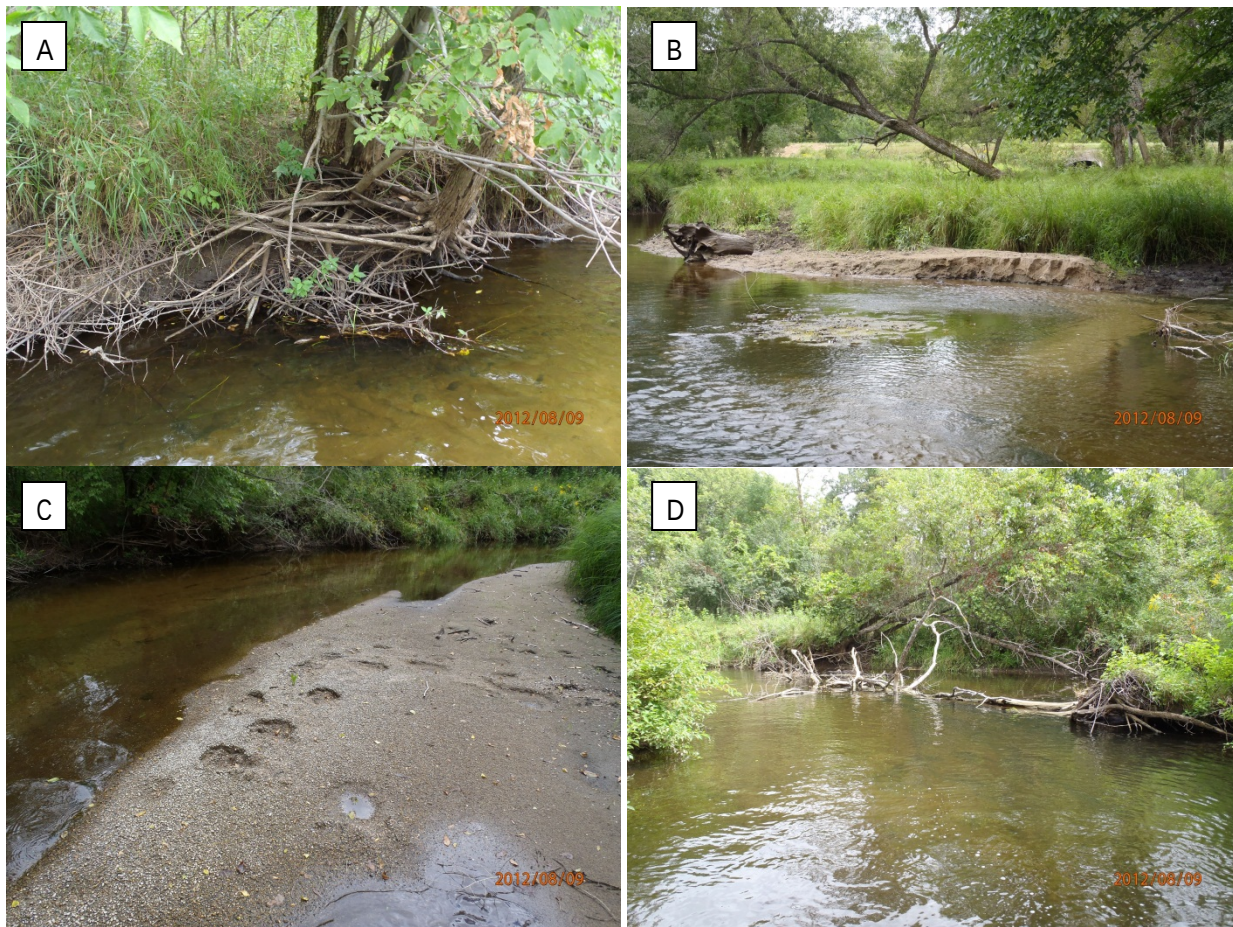
**Photo 29. Goemorphology of Partridge River. A. Bank erosion exposing roots, B. Thick, recent sand deposition, C. Excess sediment filling channel, D. Toppling of bank trees**

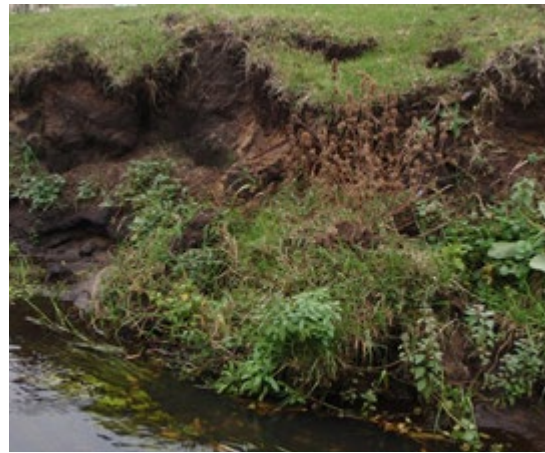
**Photo 30. Riparian grazing damage to CWRW streams**

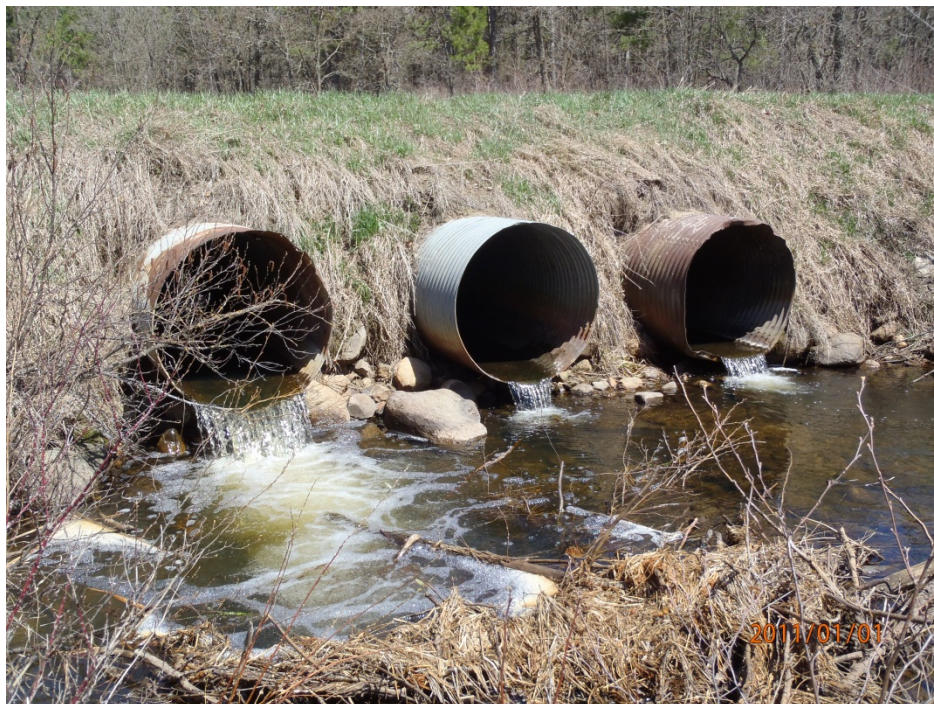
Photo 31. Perched culverts on the Blueberry River on Little Long Lake Road
