# Bois de Sioux River Watershed

## Watershed Restoration and Protection Strategy

### Stressor Identification Report

Assessment of stress factors affecting aquatic biological communities

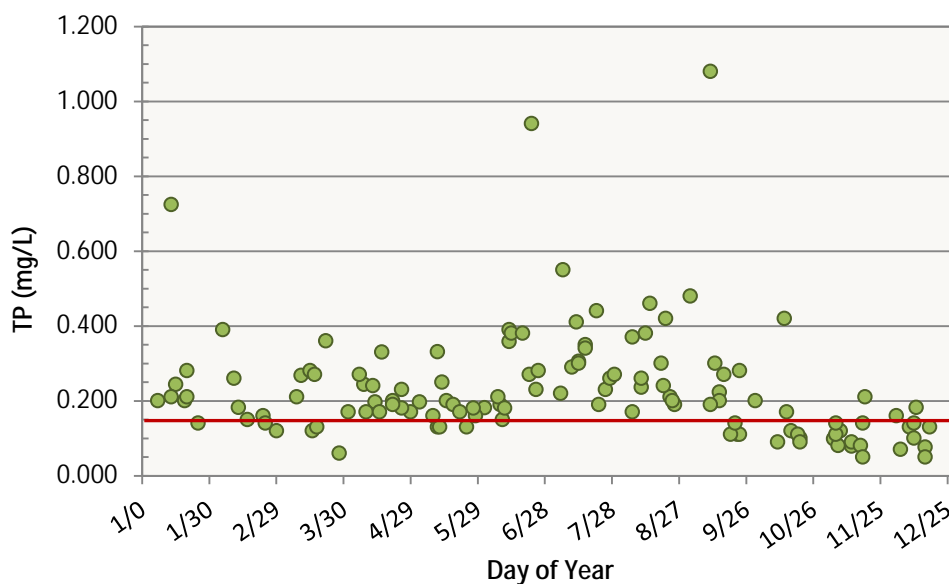
Figure 9. Historical TP data for site S000-089, from 1962-1977. The red line is the TP regional standard.

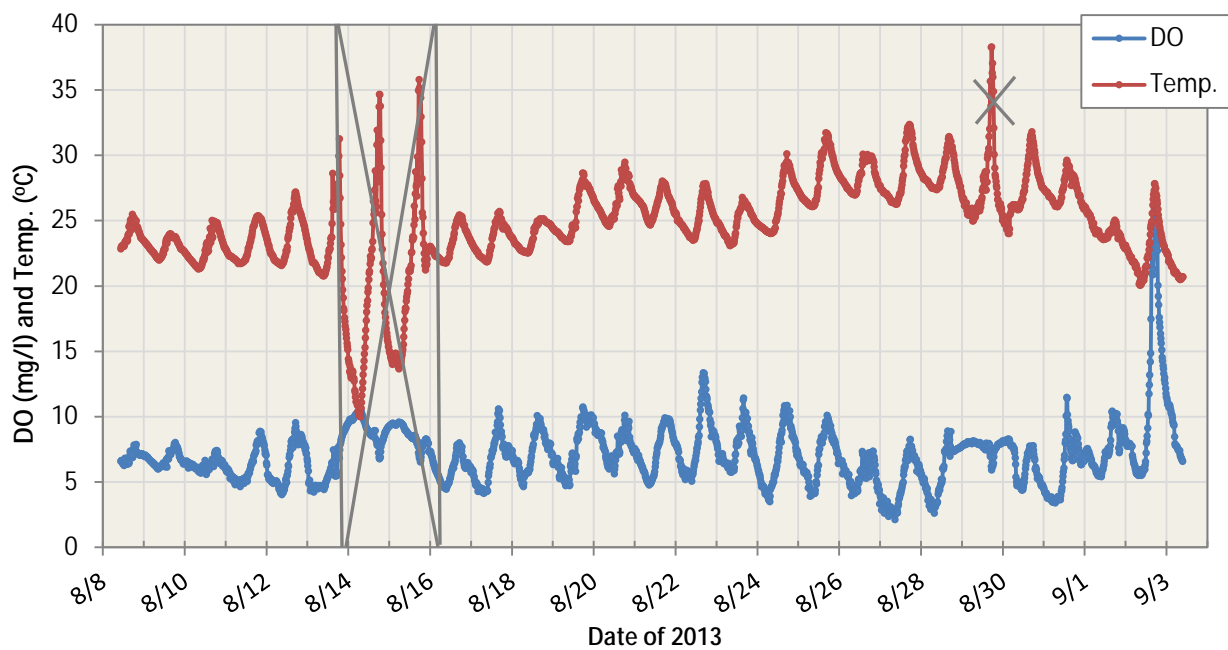
Figure 10. Sonde readings during the August 8 - September 3, 2013 deployment in the Bois de Sioux River near Breckenridge. The periods crossed out are suspected to be incorrect readings, perhaps due to vegetation caught on the sonde's probes.

During the 2013 deployment, DO levels typically dipped to the 4.5 mg/L range, though minimum levels on some nights were slightly above 5 mg/L. The minimum level recorded for this period was 2.12 mg/L, certainly a stressful concentration for fish and other aquatic organisms. The DO conditions were better (comparing almost the same dates of the year) in 2014, where the DO minimums in early August were always above 6 mg/L. However, the DO flux on most days was approximately 5-6 mg/L, a level that has been shown to correlate with impaired Minnesota biological communities (Heiskary et al., 2013). The dissolved oxygen saturation levels were also significantly above 100%, meaning there was excessive algal abundance (almost no macrophytes exist in AUID-501) pumping in large amounts of oxygen during sunlight hours. The maximum DO saturation level was approximately 200%, a potentially-problematic level for aquatic organisms (Marking, 1987, Weitkamp and Katz, 1980). In 2015, the DO levels generally stayed above 5.0 mg/L, though on two days the minimums dropped below 4, with one of them as low as 1.72 mg/L. The DO flux was more problematic. On four days, the DO flux was about 8 mg/L. These high-flux days were associated with the lowest flows that occurred during this deployment period. These same days experienced the highest DO concentrations. Many of the days experienced peak DO percent saturation levels of 130% or higher, and several exceeded 160, with the maximum reading of 201.9% occurring on July 19 at 7:00pm.

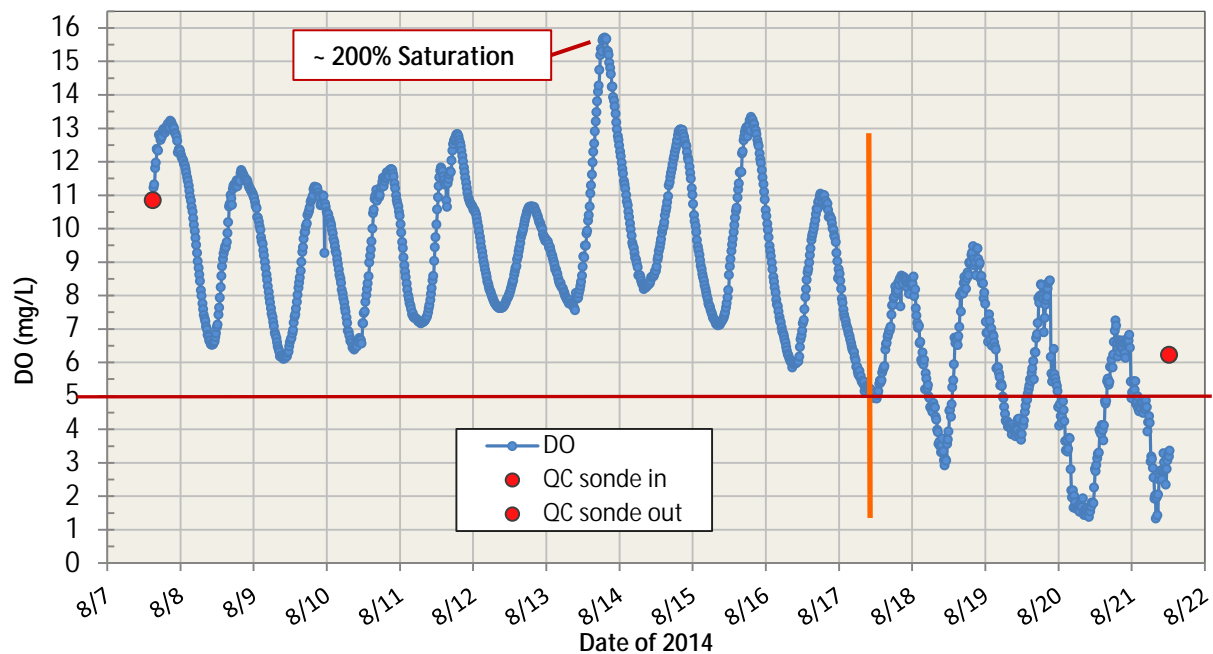
Figure 11. Sonde deployment during August 7 - August 22, 2014 in the Bois de Sioux River at CSAH-6. Data to the right of the orange bar appears to be compromised (calibration drift of instrument).

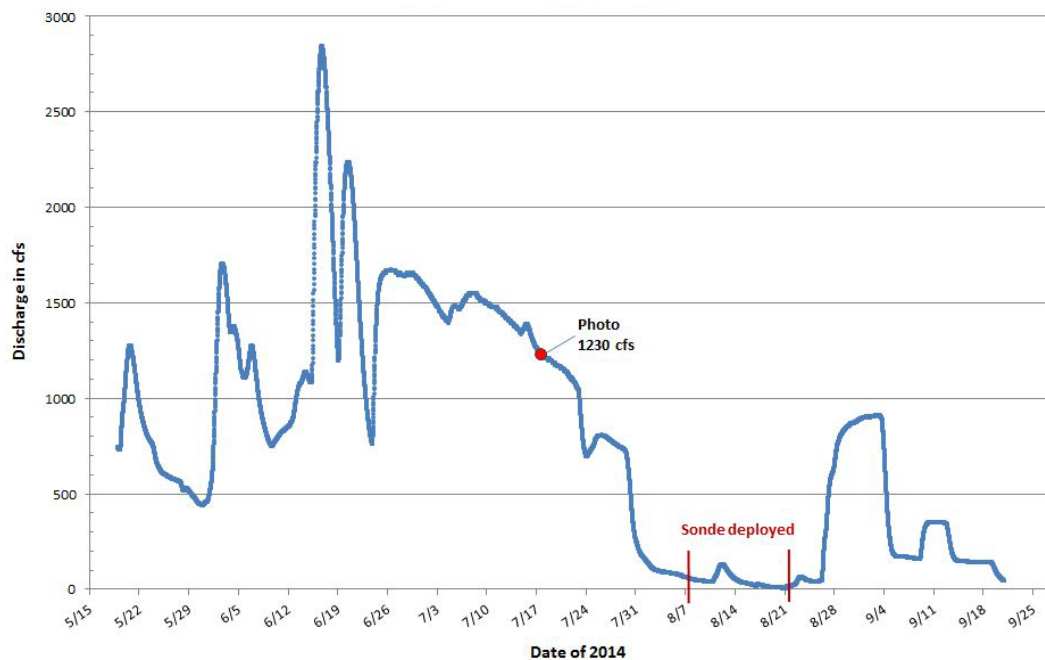
Figure 12. Flow conditions at the 2014 CSAH-6 sonde deployment station. This site is also a USGS gaging station site.

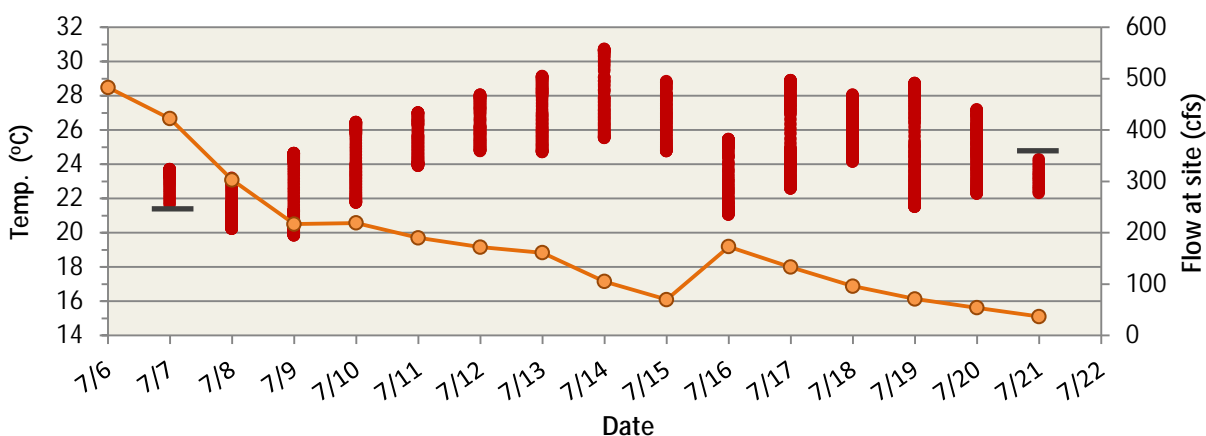
Figure 19. Water temperature readings (in red) and flow volumes (in orange) from 2015 sonde deployment at S000-553 (CSAH-6).

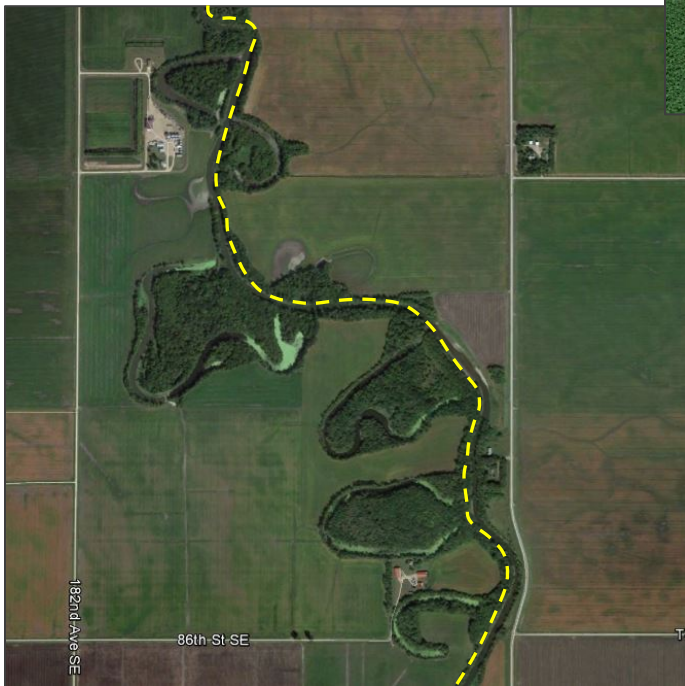
Photo 3. Channelization to remove meanders from the river's pathway. The yellow line traces the current altered channel path.

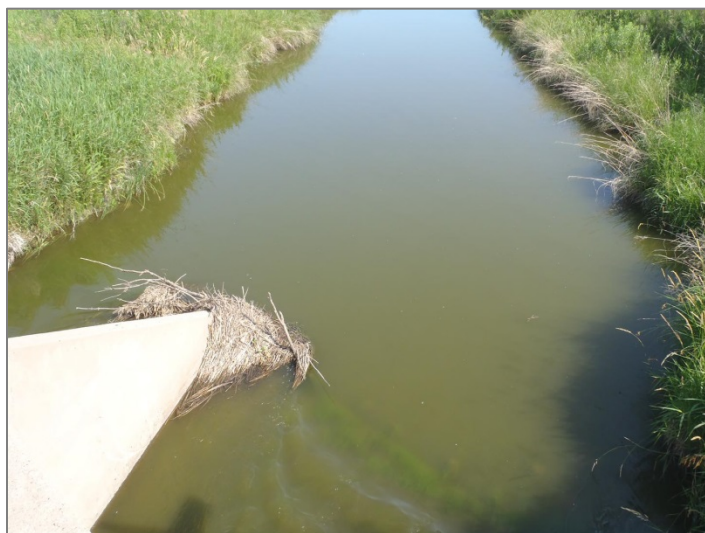
Photo 4. Looking upstream on JD-12 at CR-2, showing the green color of the water on July 7, 2015 when the Chl-a sample was collected.

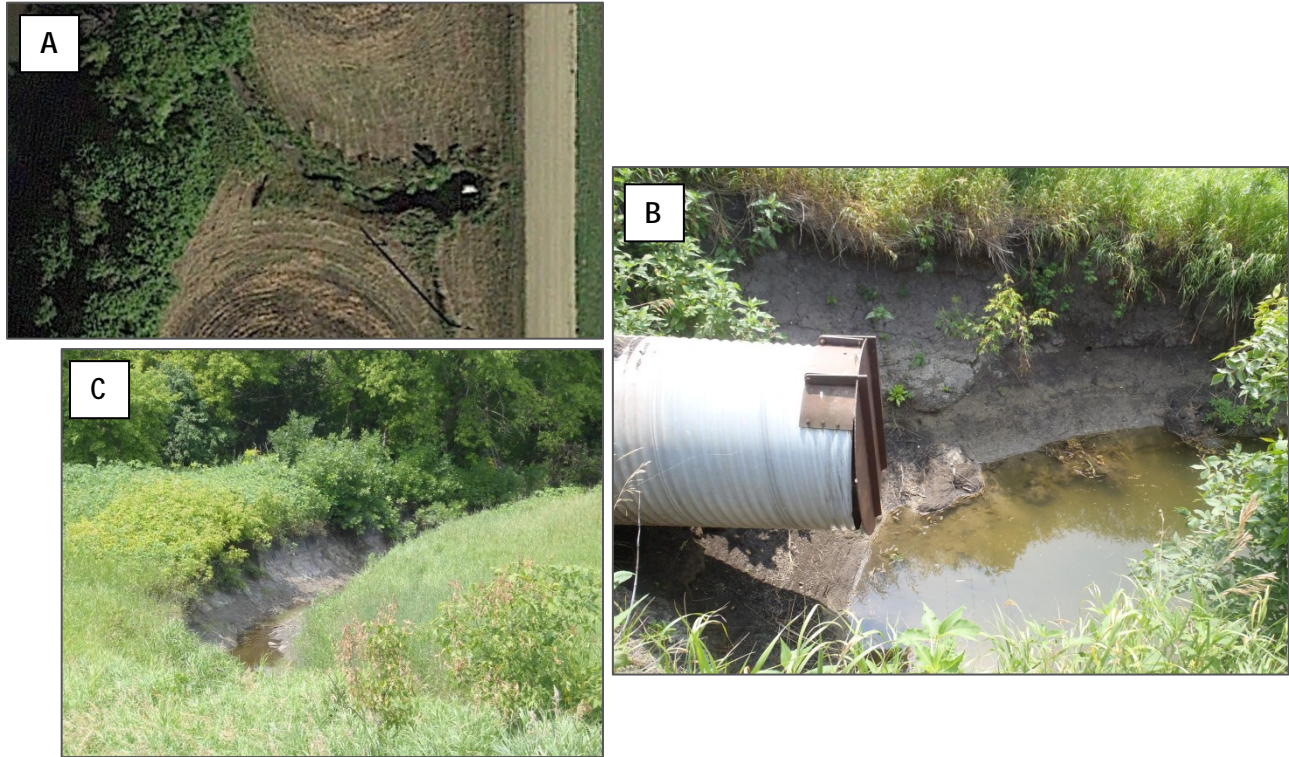
Photo set 5. A large road culvert on Township 140 was found that is installed such that it is creating a very large, eroded scour pool, and the channel below continues with raw, eroding banks. A) Aerial view – the trees on the left are growing on the bank of the Rabbit River, B) Ground photo of the scour pool. The culvert bottom is about six feet above the water surface, and erosion has occurred back almost to the road bed, C) The raw channel below the culvert.

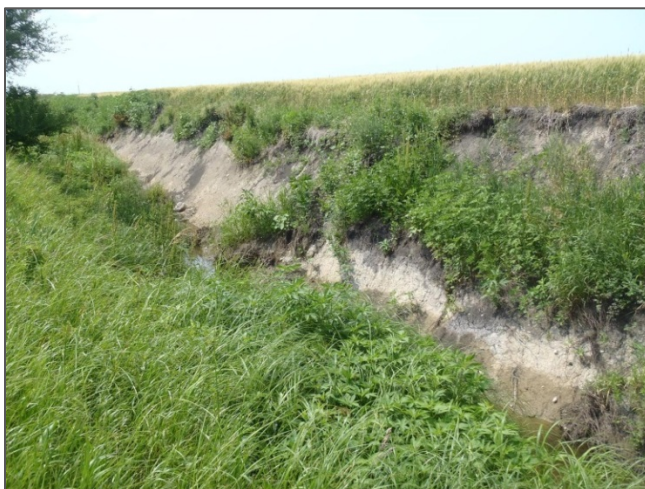
Photo 6. A ditch that is too narrow and deep to be stable. Clods of soil are falling down from the field edge, contributing topsoil into the ditch that will be washed into streams. There is also no buffer along this field edge.

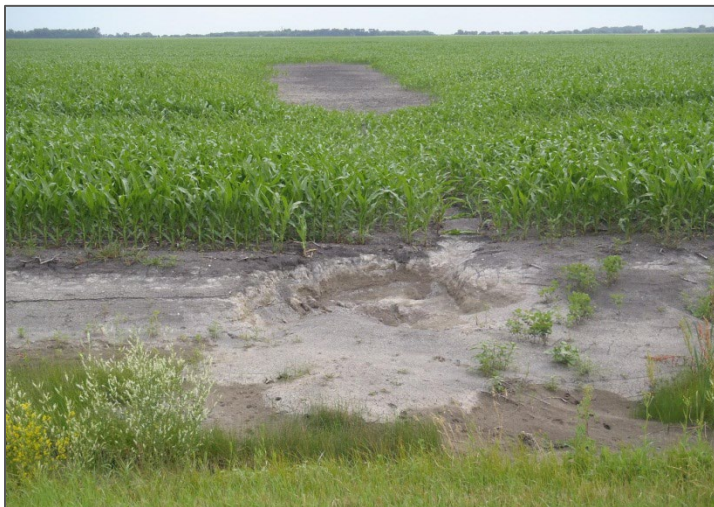
Photo 9. Other fields with similar unprotected drainage topography were found while driving throughout the BdSRW.

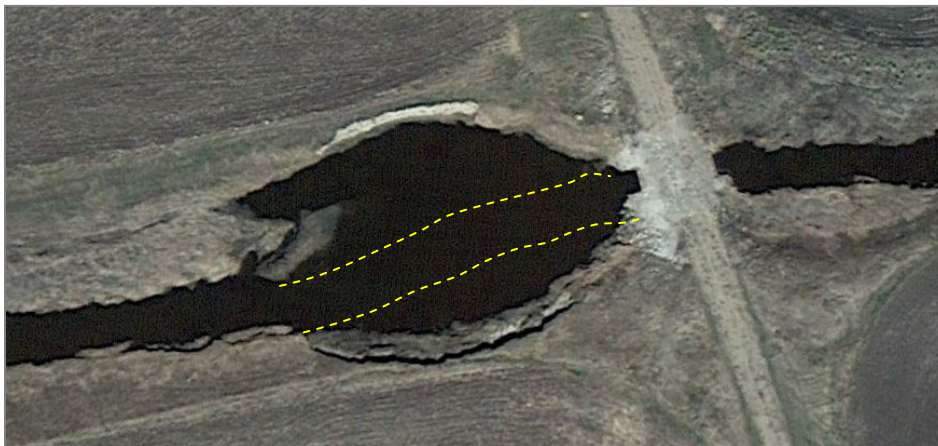
Photo 10. This culvert on AUID-502 (along CSAH-2) is undersized, and during times of higher flow volumes, it constricts flow, increasing the velocity and erosive forces of the water as it exits the culvert, causing a large scour pool. The banks of this pool are raw and steep, and the southern bank has eroded right up to the edge of the cultivated field surface. Many truckloads of soil have eroded from this scoured area. The yellow dotted lines delineate the width of the channel as it should be here.

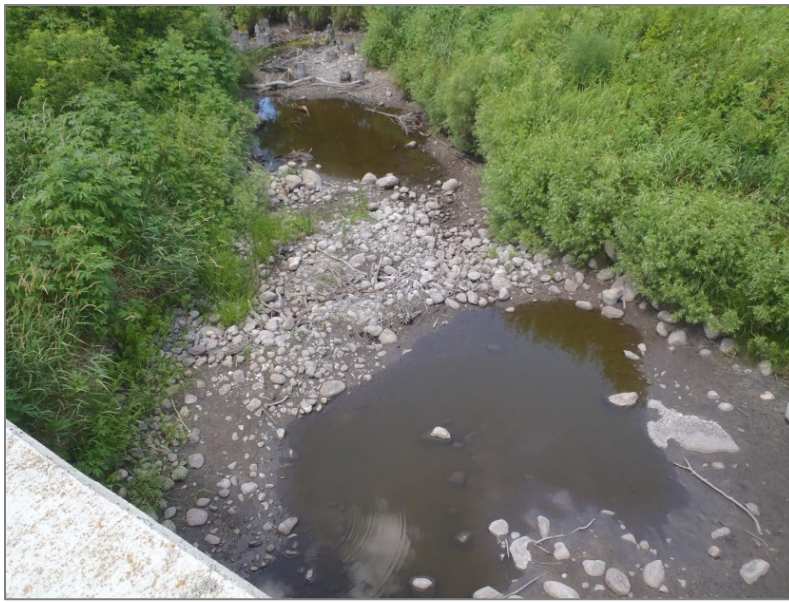
**Photo 13. South Fork Rabbit River at 490<sup>th</sup> Street on July 21, 2015. Water only was found ponded in the deeper areas of the channel.**

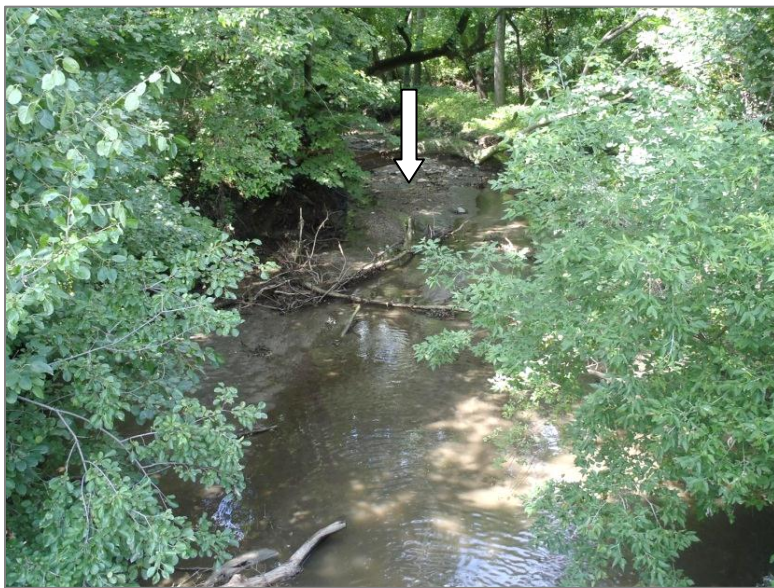
Photo 17. The view from Highway 27 looking downstream. On the left side of the channel, deposition of sediment is occurring (arrow). The whole “pool” in the foreground is only about 5cm deep, though perhaps 15m wide.

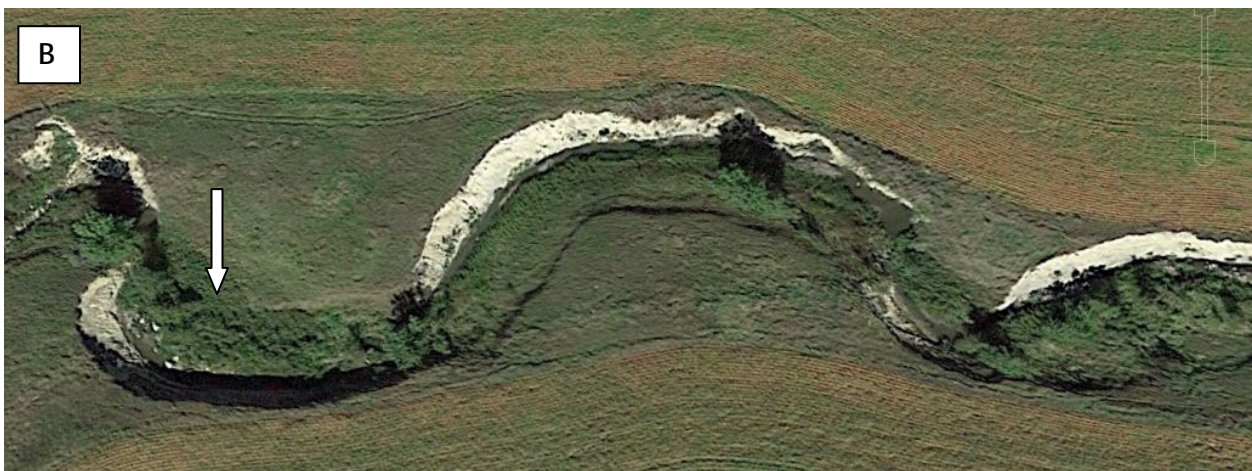
Photo 21. This location is about 1/2 to 3/4 miles upstream of Township Road 18. A) The whitish areas along the channel are raw soil banks that are eroding, which is occurring on both the ditched section on the right and the non-ditched section on the left side. B) A closer view of part of photo A, showing the steepness and height of the raw banks. Note the small size of the baseflow channel (arrow) relative to the actively-eroding valley.
