June 2018

Roseau River Watershed Stressor Identification Report

Document number: wq-ws5-09020314a

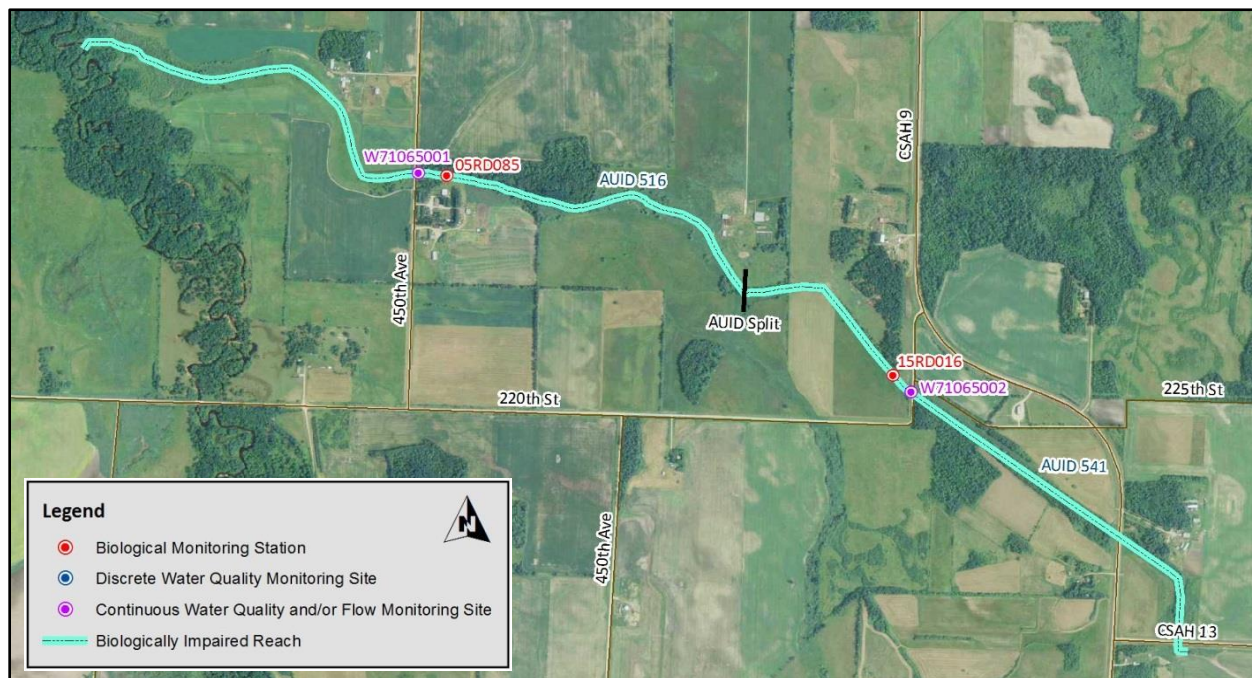
Figure 5. Map of Upper (AUID 541) and Lower (AUID 516) Severson Creek and associated biological monitoring stations and water quality monitoring sites (2013 National Agriculture Imagery Program [NAIP] aerial image).

Severson Creek/County Ditch (CD) 23 was split into two reaches ([Figure 5](#)) for the purposes of biological monitoring. The first reach (AUID 541; herein referred to as “Upper Severson Creek”) extends from the CSAH 13 crossing, to its confluence with an unnamed creek, located approximately 0.4 mile downstream of the County Road (CR) 9 crossing; a total length of one mile. The second reach (AUID 516; herein referred to as “Lower Severson Creek”) extends from the end of Upper Severson Creek, to the confluence with the Roseau River, located approximately 0.8 mile downstream of the 450th Avenue crossing; a total length of two miles. Severson Creek has a total subwatershed area of 24 square miles (15,215 acres). The subwatershed contains 24 miles of intermittent stream, 20 miles of intermittent drainage ditch (e.g., Upper Severson Creek), two miles of perennial drainage ditch (i.e., Lower Severson Creek), and one mile of perennial stream (DNR, 2003). According to the MPCA (2013), 45% of the watercourses in the subwatershed have been physically altered (i.e., channelized, ditched, or impounded), including the entire lengths of Upper and Lower Severson Creek. The NLCD 2011 (USGS, 2011) lists wetlands (60%) as the predominant land cover in the subwatershed. Other notable land cover groups in the subwatershed included cultivated crops (14%), hay/pasture (12%), forest (5%), shrub/scrub (4%), developed (3%), and herbaceous (2%).

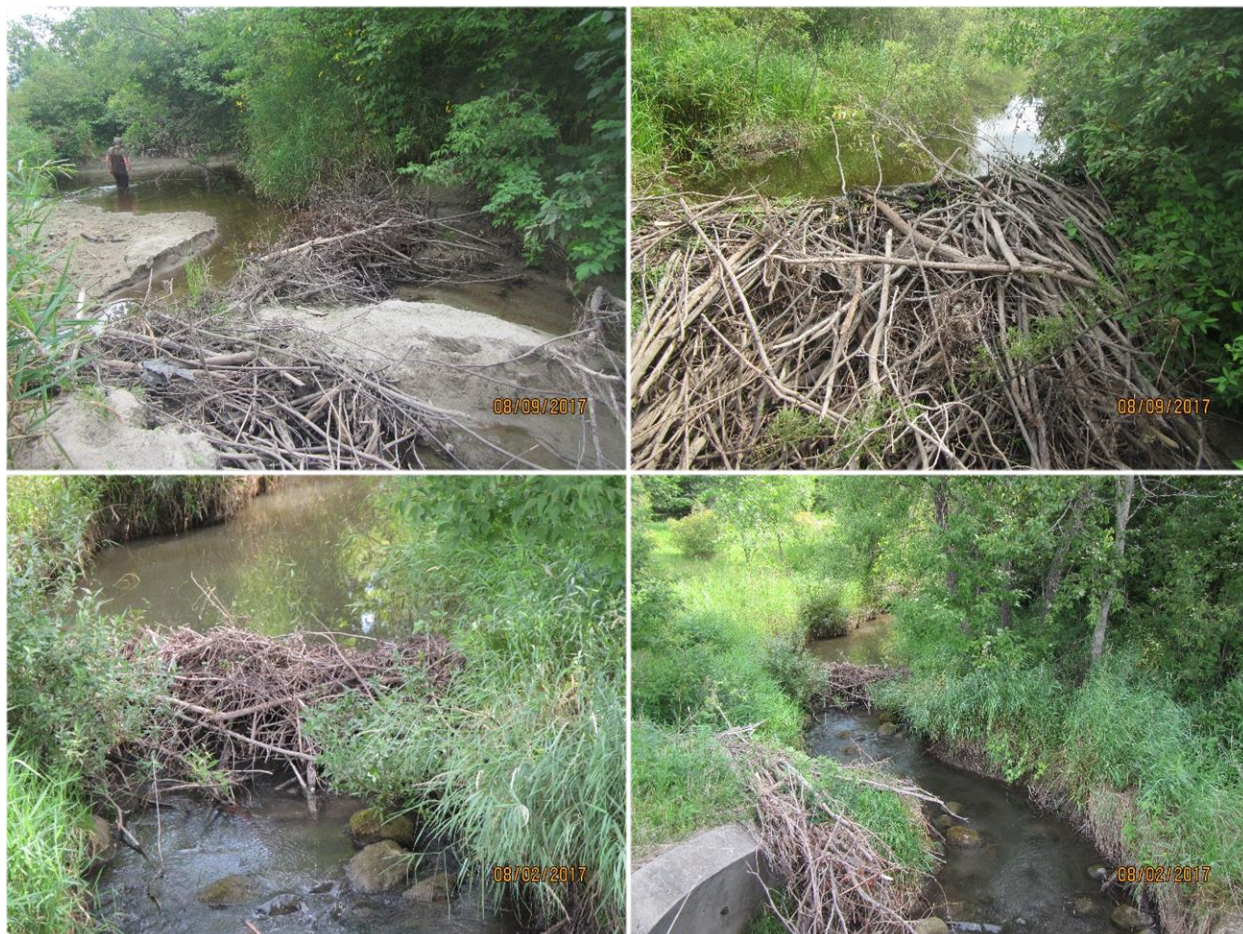
Figure 6. Photos taken by SID staff of beaver dams located on Severson Creek. The upper two photos were captured 30 feet (upper left) and 80 feet (upper right) upstream from the confluence with the Roseau River (Lower Severson Creek) on August 9, 2017. The lower two pictures were captured at Station 15RD016 just upstream of CR 9 road crossing (Upper Severson Creek) on August 2, 2017.

Severson Creek periodically experiences a loss of longitudinal connectivity due to beaver dams and other woody debris obstructions. The biological monitoring staff observed many logjams due to trees falling into the stream. According to the DNR (2014), there are no man-made dams along Severson Creek. The MPCA SID staff conducted a longitudinal assessment of Severson Creek on August 9, 17, 28, 2017 and September 28, 2017. Staff viewed all of the road crossing on the reach as part of the assessments. While no anthropogenic barriers (e.g. perched culvert) were found, two beaver dams were documented on Upper and Lower Severson Creek ([Figure 6](#)). In addition to the surveys, MPCA SID staff performed a detailed review of a May 8, 2013, aerial photo (courtesy of Google Earth) of the reach. No connectivity-related issues were identified in the photo. However, it is unknown whether velocity barriers caused by culverts or private road crossings impede passage along Severson Creek. Overall, Severson Creek periodically experiences a loss of connectivity.

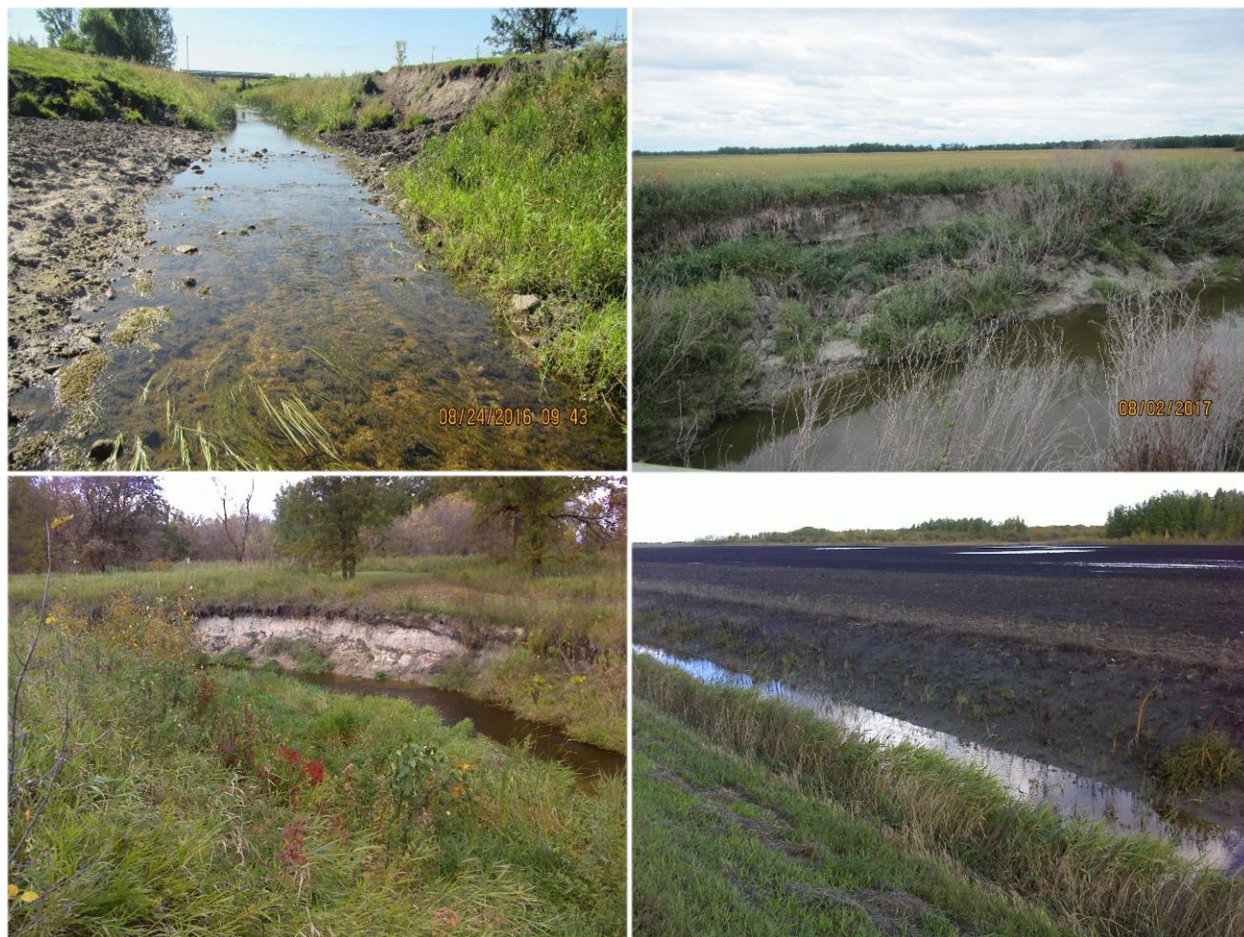
Figure 13. Images of sediment sources along Hay Creek, including bank erosion caused by cattle access at Station 05RD084 on August 24, 2016 (upper left); a slump at the CSAH 28 crossing on August 2, 2017 (upper right); bank erosion near the 510th Avenue crossing on September 28, 2017 (lower left); and a tributary ditch with no riparian buffer along CSAH 28 on September 28, 2017 (lower right).

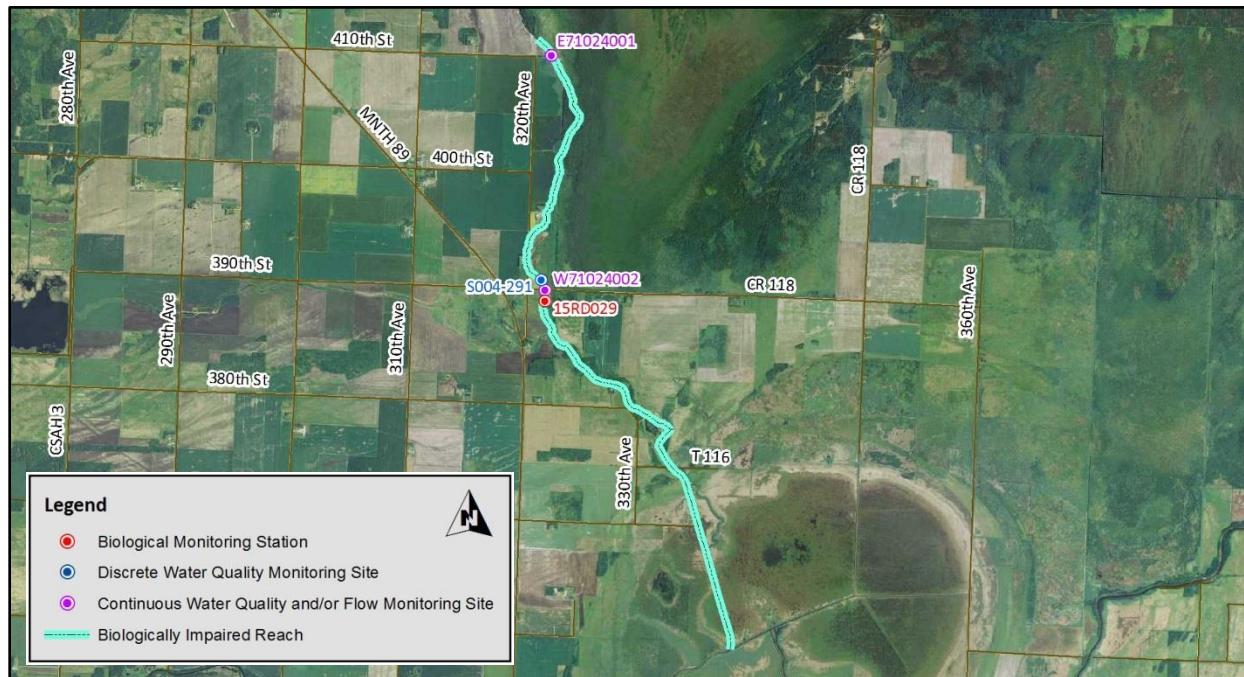
Figure 18. Map of Pine Creek and associated biological monitoring station and water quality/flow monitoring sites (2013 NAIP aerial image).

Pine Creek (AUID 542) ([Figure 18](#)) extends from its confluence with an unnamed creek, located near 410th Street, to its confluence with the Roseau River, located within the Roseau Lake Wildlife Management Area; a total length of six miles (herein referred to as “Pine Creek”). Pine Creek has a subwatershed area of 98 square miles (62,714 acres); however, 84% of the area lies in Canada. The United States (US) portion of the subwatershed contains 22 miles of intermittent drainage ditch, five miles of perennial stream (i.e., Pine Creek), two miles of perennial drainage ditch, and one mile of intermittent stream (DNR, 2003). According to the MPCA (2013), 91% of the watercourses in the subwatershed (US only) have been physically altered (i.e., channelized, ditched, or impounded), including 90% of Pine Creek. The NLCD 2011 (USGS, 2011) lists cultivated crops (45%) and wetlands (33%) as the predominant land covers in the subwatershed (US only). Other notable land cover groups in the subwatershed (US only) included hay/pasture (7%), open water (6%), forest (4%), developed (4%), and shrub/scrub (1%).

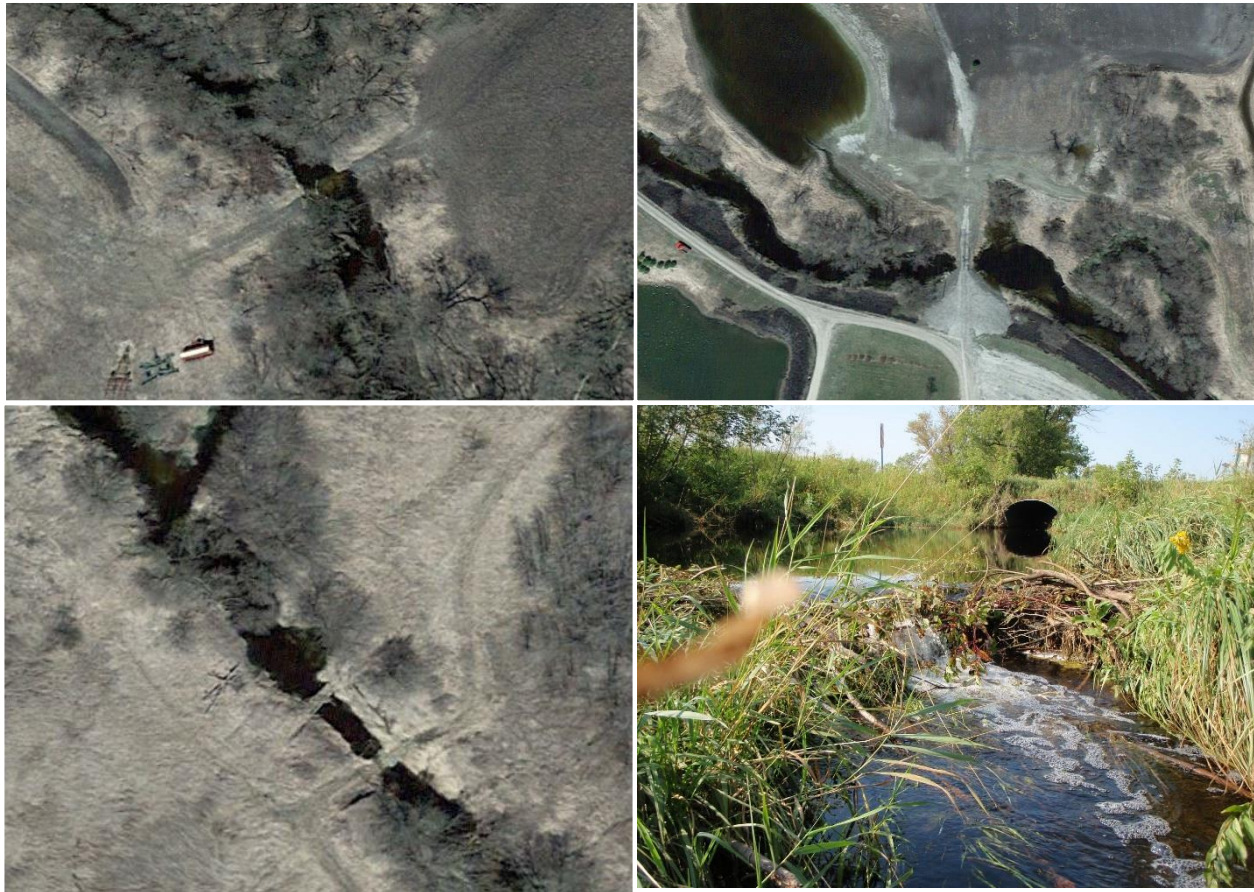
Figure 19. Bottom right photo taken by biological monitoring staff of a beaver dam located at Station 15RD029 on Pine Creek. Photo was captured on September 1, 2015. Top right and left and bottom left photos, created using Google Earth, documenting private road crossings located downstream of Station 15RD029 on Pine Creek. Photos were captured on May 8, 2013.

The biological monitoring staff observed a beaver dam while sampling at Station 15RD029 ([Figure 19](#)). According to the DNR (2014), there are no man-made dams along Pine Creek. The MPCA SID staff completed a longitudinal survey of Pine Creek on August 9, 17, 28, and September 28, 2017. Staff viewed all of the road crossing on the reach as part of the assessments. No obstructions to connectivity (e.g. perched culverts and beaver dams) were identified. However, staff documented barriers due to flow regime instability through the reduction of baseflow and associated impacts to sediment transport (see flow regime instability section). In addition to the surveys, MPCA SID staff performed a detailed review of a May 8, 2013, aerial photo (courtesy of Google Earth) of Pine Creek. Several private road crossings were identified that could potentially cause a disconnect in biological passage ([Figure 19](#)). However, it is unknown whether velocity barriers caused by culverts or private road crossings impede passage along Pine Creek. Overall, Pine Creek periodically experiences a loss of connectivity.

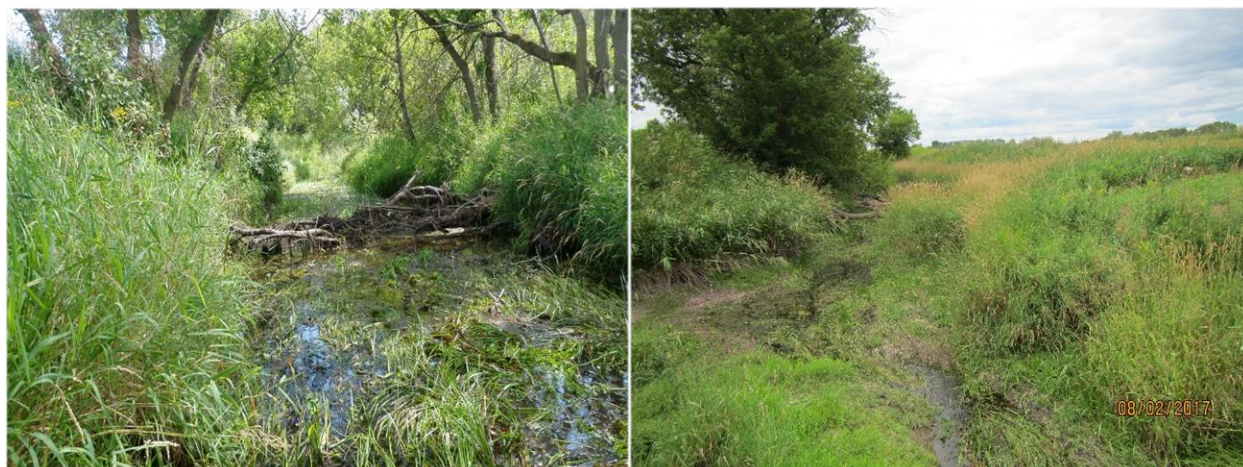
Figure 20. Images of low flow conditions along Pine Creek, including Station 15RD029 on August 17, 2016 (left) and Site S004-291 on August 2, 2017 (right).

According to the MPCA (2013), 91% of the watercourses in the subwatershed (US only) have been physically altered (i.e., channelized, ditched, or impounded), including 90% of Pine Creek. On August 17, 2016, the MPCA biological monitoring staff encountered “hardly any flow” at Station 15RD029 ([Figure 20](#)). The USGS conducted continuous flow monitoring at Site E71024001 (near 410th Street crossing) between 1928 and 1953; the location of the site is shown in [Figure 18](#). According to [Figure 21](#), there was a discernable increase in mean flow values starting in 1941. [Table 28](#) provides the percentile flow values for the site from 1928 to 1940, as well as 1941 to 1953. The percentile values for the latter period were substantially higher than the earlier period. Over the entire period of monitoring, the data suggests that Pine Creek had a relatively stable flow regime, with ample baseflow. Flow monitoring was discontinued after 1953. In 1953, the Canadian government completed the construction of the eight-mile-long Pine Creek Diversion. The channel, which was built under a joint agreement between the province of Manitoba and the state of Minnesota, diverts flow from approximately the uppermost two-thirds of the Pine Creek Subwatershed, to the Roseau River Wildlife Management Area. The original design plan included a dike across the inlet, with a 36-inch culvert and a control gate to regulate flow into the diversion. In an effort to quantify the impact of the diversion on the discharge of Pine Creek, MPCA staff conducted flow measurements on Pine Creek and the Pine Creek Diversion on October 19, 2017. Contrary to the design plan, there was no dike or control structure at the inlet of the diversion ([Figure 22](#)) and the diversion channel was capturing all of the flow from the Canadian portion of Pine Creek. The depth of water in the diversion channel would need to be approximately four feet in order for flow to spill into the original downstream channel of Pine Creek ([Figure 22](#)). The diversion channel had mean flow at the Road 1N crossing (0.7 mile downstream of the confluence with Pine Creek) of 16.4 cfs. Comparatively, Pine Creek had a mean flow at CR 118 (6.5 miles downstream of the confluence with the diversion channel) of 7.0 cfs. Therefore, the diversion channel was capturing approximately 70% of the discharge of Pine Creek. In addition, the MPCA SID staff conducted reconnaissance along Pine Creek on four separate dates (i.e., August 2, 2017, August 9, 2017, September 28, 2017, and October 19, 2017) and documented flow conditions. Minimal flow (≈0.1 cfs) was noted at Station 15RD029 on August 2, 2017 ([Figure 20](#)) and August 9, 2017. Overall, the available data suggest that Pine Creek is prone to extended periods of minimal to no flow.

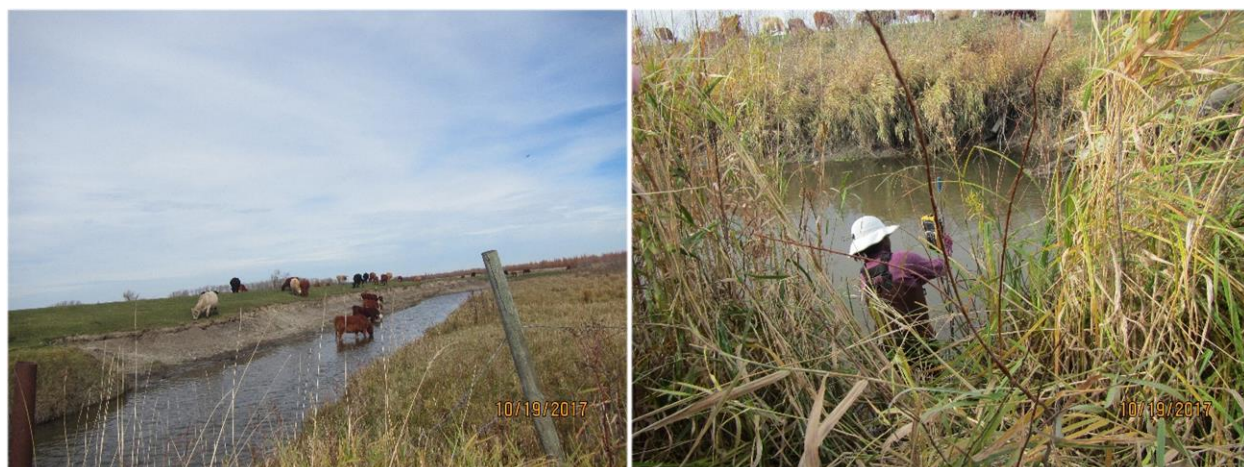
Figure 22. Images of Pine Creek (left) and the Pine Creek Diversion (right) on October 19, 2017.
