July 2019

Rainy River Headwaters Stressor Identification Report

A study of local stressors limiting the biotic communities in the Rainy River Headwaters Watershed

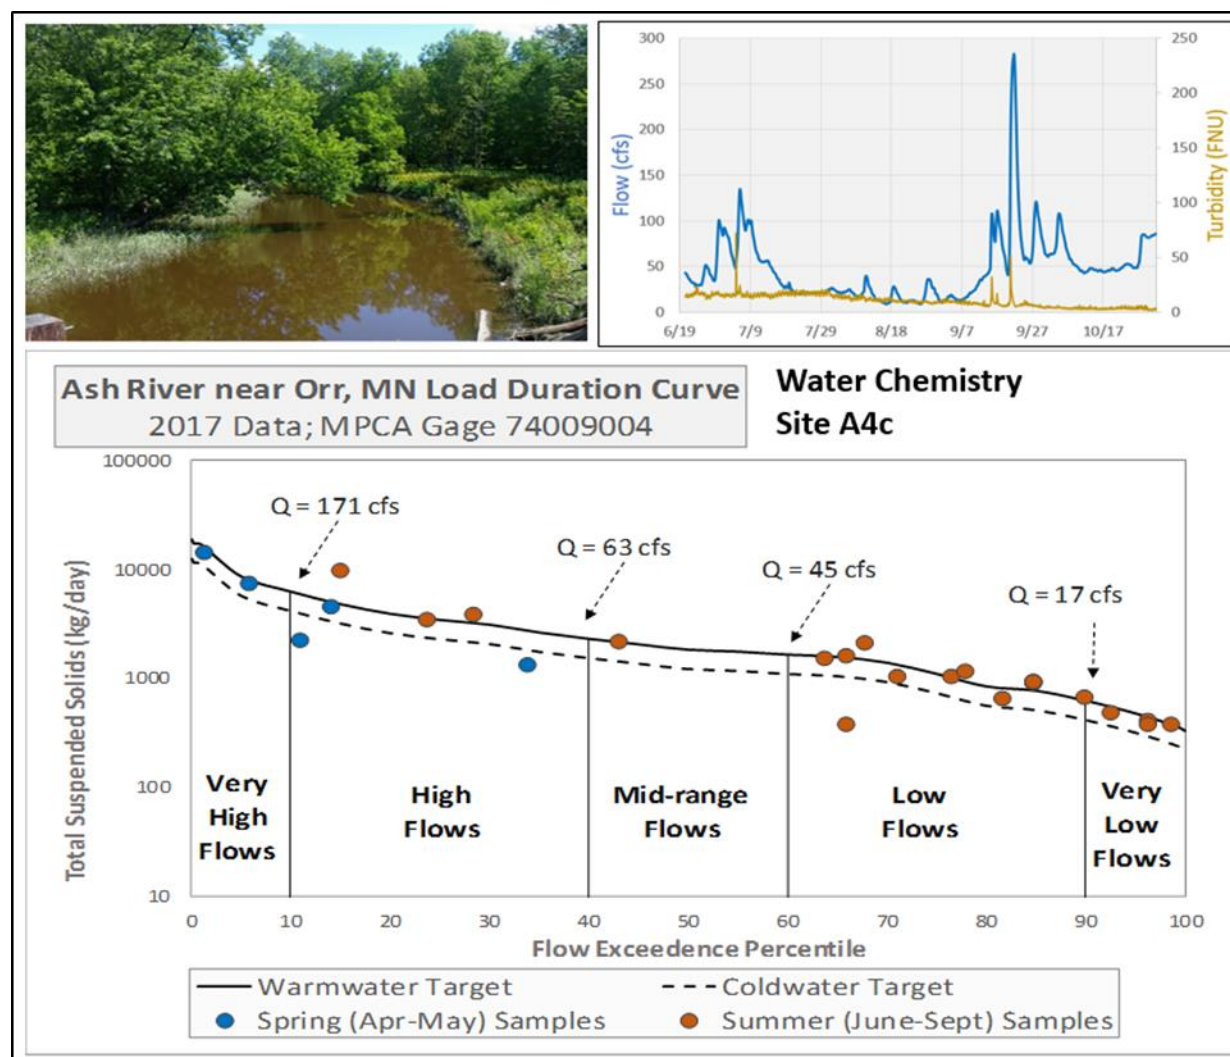
Figure 5. TSS Load Duration Curve at the Ash River Lower-818 flow gage station for flow and TSS samples collected in year 2017. TSS exceeds the Coldwater target for TSS loading at all flow regimes. For high flows, more exceedances occur during summer months compared to spring. The Warmwater target was also plotted. Continuous turbidity and flow are plotted in the upper right.

A basic model using average TSS concentrations and average flows for each of the five flow regimes provided the flow duration curves ([Figures 5 and 6](#)), percent reduction needs ([Tables 4 and 5](#)), and lower annual load estimates reported in this Section 3.6. Load duration curves indicate the probability that a flow is exceeded. For example, a 95% exceedance probability would characterize low-flow conditions in a stream, because 95% of all daily mean flows in the record are greater than that amount. Loads were calculated using the average flow and average TSS concentration for each flow regime. When seasonal variability was further incorporated into load computation, annual load estimates increased to the higher values in our reported range. The two different approaches provided a range of TSS loads for each gage. Analysis of seasonal variability and modeling flows to an extended flow period (beyond two years) could result in more precise load calculations for future work.

The sediment dynamic differences between the two reaches can also be observed by plotting turbidity and flow data together ([Figure 5 and Figure 6](#)) for each site. Turbidity at the Ash River remained at an

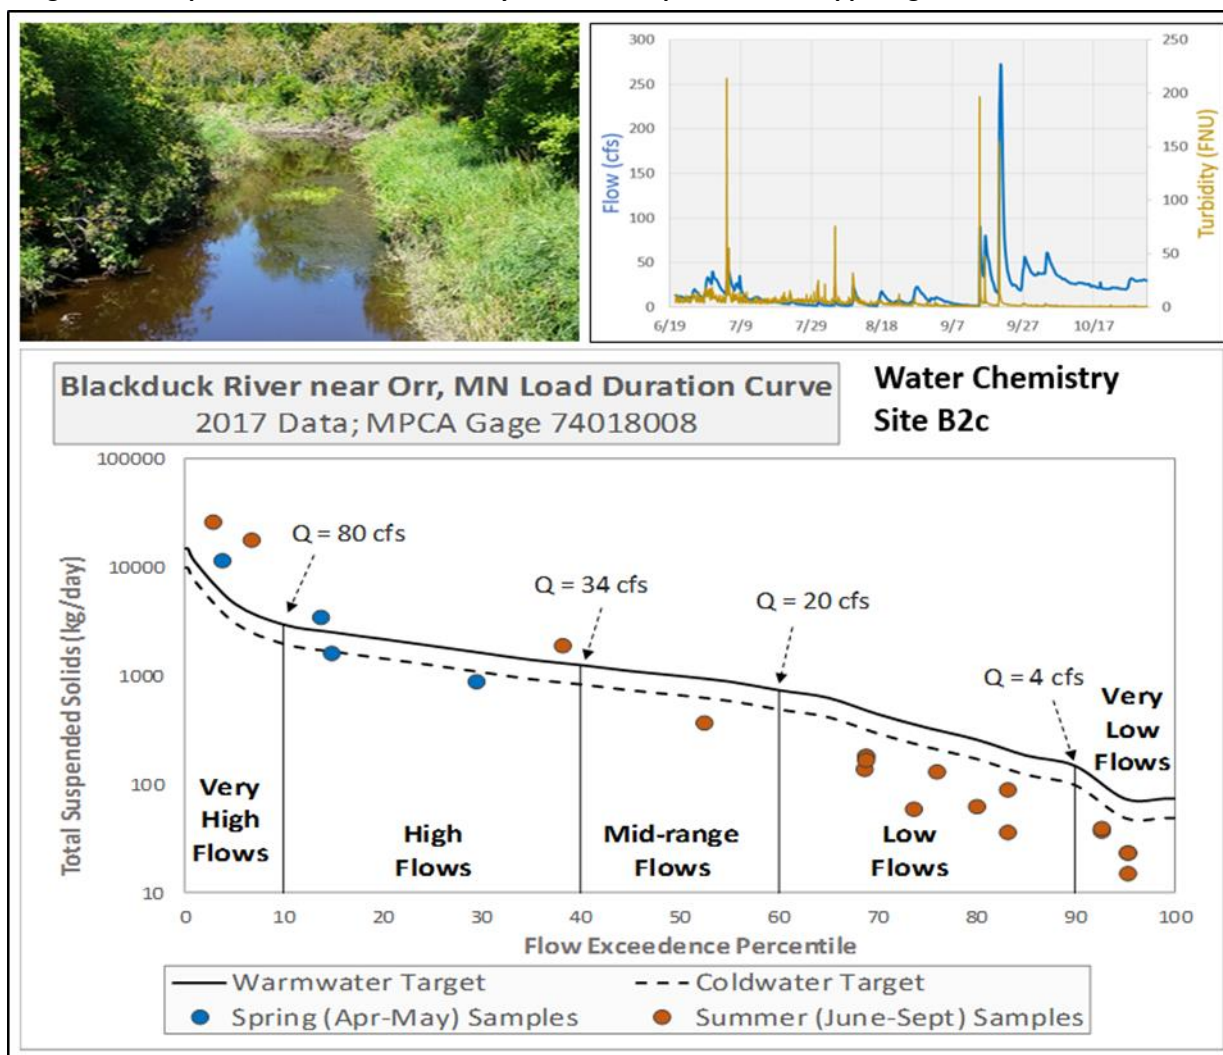
Figure 6. TSS Load Duration Curve at the Blackduck River flow gage station for flow and TSS samples collected in year 2017. TSS exceeds the Coldwater target for TSS loading at high and very high flow regimes. The Warmwater target was also plotted. Continuous turbidity and flow are plotted in the upper right.

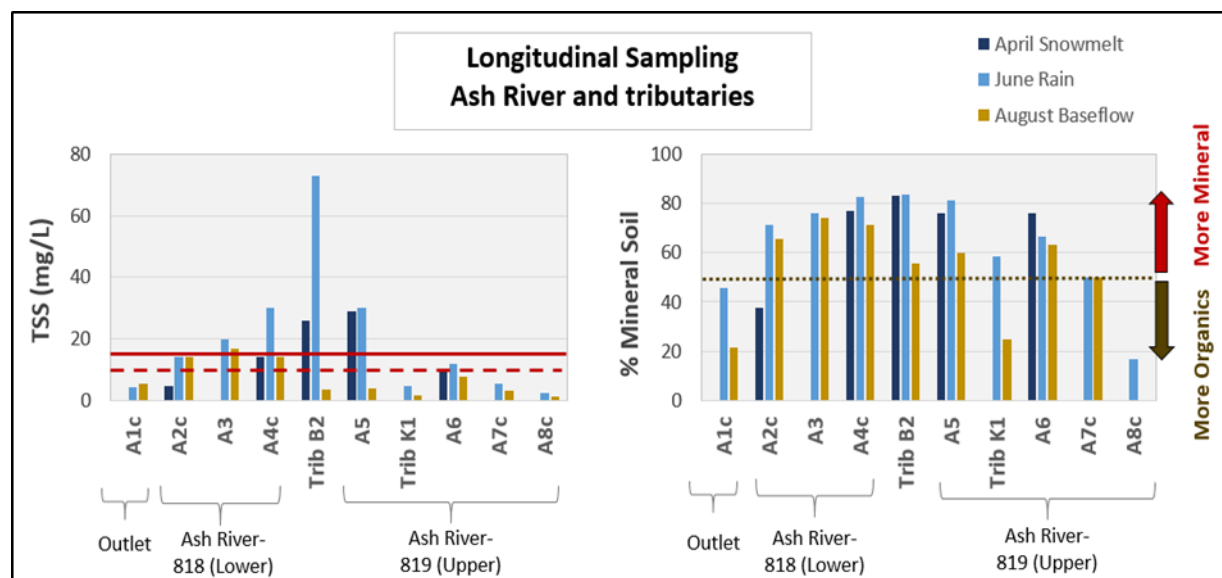
Figure 7. TSS concentrations (left) and percent mineral soil [percentage = (TSS-VSS)/TSS *100] (right) taken longitudinally along the Ash River and on two tributaries during snowmelt, a June rain event, and baseflow of year 2017. The Coldwater (dashed line) and Warmwater (solid line) TSS standards are shown in the left plot. The dashed line in the right plot represents equal proportions (50%) of inorganic/mineral and organic materials.

Changes in TSS concentrations along Ash River were observed through longitudinal sampling of the Ash River and several tributaries. Five to ten water chemistry stations were sampled within a timeframe of a few hours. TSS and Volatile Suspended Solids (VSS) were sampled longitudinally for three flow events (snowmelt, rain, and baseflow). Suspended solid materials were reported as percent mineral soil, calculated as the difference between TSS and VSS divided by TSS. Based on the percent mineral soil, suspended materials were identified as having “more mineral soil” or “more organics.”

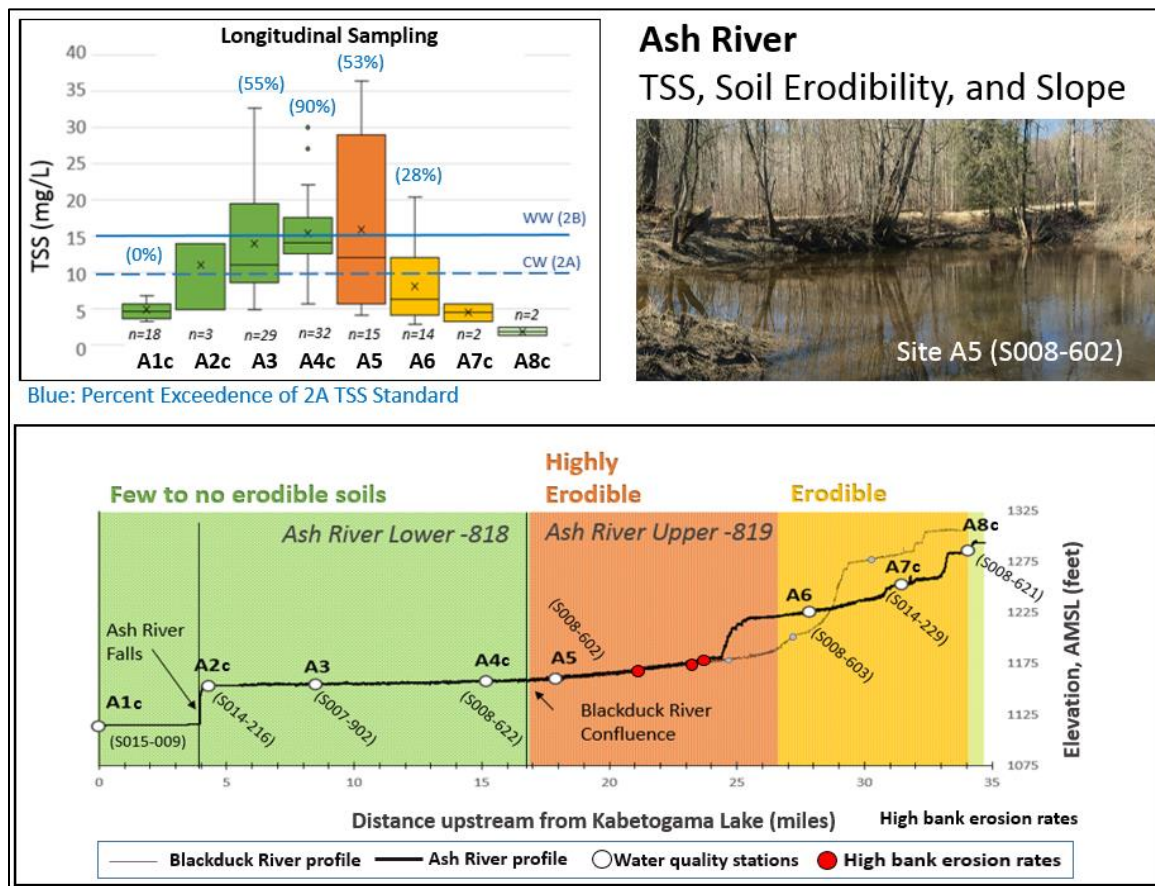
Figure 8. TSS concentrations (2014-2018) at eight stations along the Ash River (upper left), where it represents the number of samples at each station. The stream profile (bottom) was derived from LiDAR data. The EQuis ID for each station (e.g. S015-009 for station A1) is shown in parenthesis. The graph background colors represent soil erodibility obtained from the soil erosion potential map (Error! Reference source not found.).

Stream slope and soil erodibility influences on TSS concentrations along the Ash River are suggested in [Figure 8](#). From the headwaters (site A8c), TSS concentrations increased longitudinally downstream in the Ash River Upper. Soils were most erodible in this AUID and stream slopes were relatively steepened (2% slope). Higher slopes in erodible soils could be a mechanism for increasing erosion or added TSS inputs to the stream. The greatest longitudinal increase in TSS concentrations was observed between sites A6 and A5 where soils were highly erodible and stream slopes were greatest. Several banks with higher erosion rates were located within this reach, which is discussed more in section 3.7.1 of this report. Maximum and average TSS concentrations were greatest among all Ash River sites at station A5.

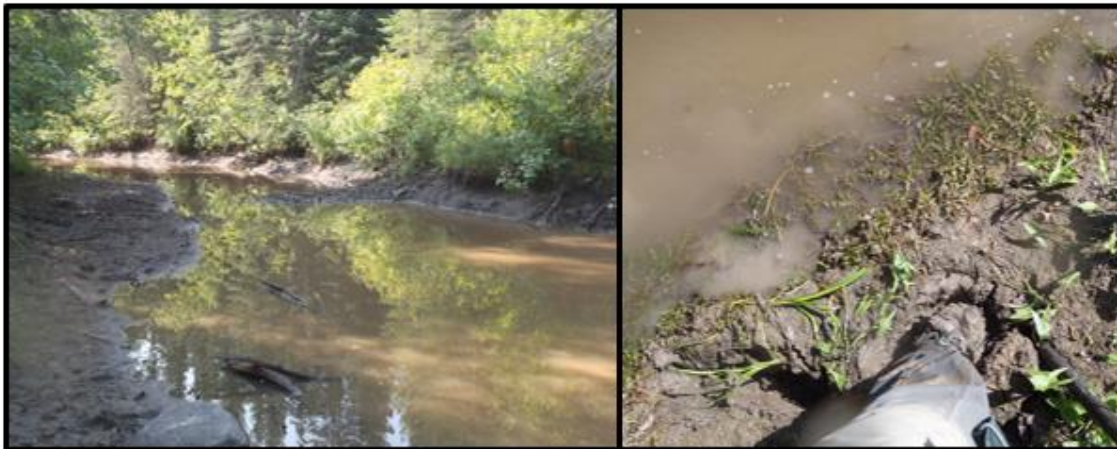
Figure 10. Images of low flow conditions of the Ash River Lower at station A4c show TSS suspended in the stream channel and the exposed silt banks that form the channel.

The longitudinal data indicated that a portion of the suspended sediment generated in the Ash River Upper settled out within the Ash River Lower reach. This infers that particle detachment in the upper river may have contributed to increased siltation and depth of fines in the Ash River Lower, indirectly increasing TSS concentrations under low flow conditions in the Ash River Lower. The banks and bed of the stream at station A4c also had a naturally high silt content ([Figure 10](#)).

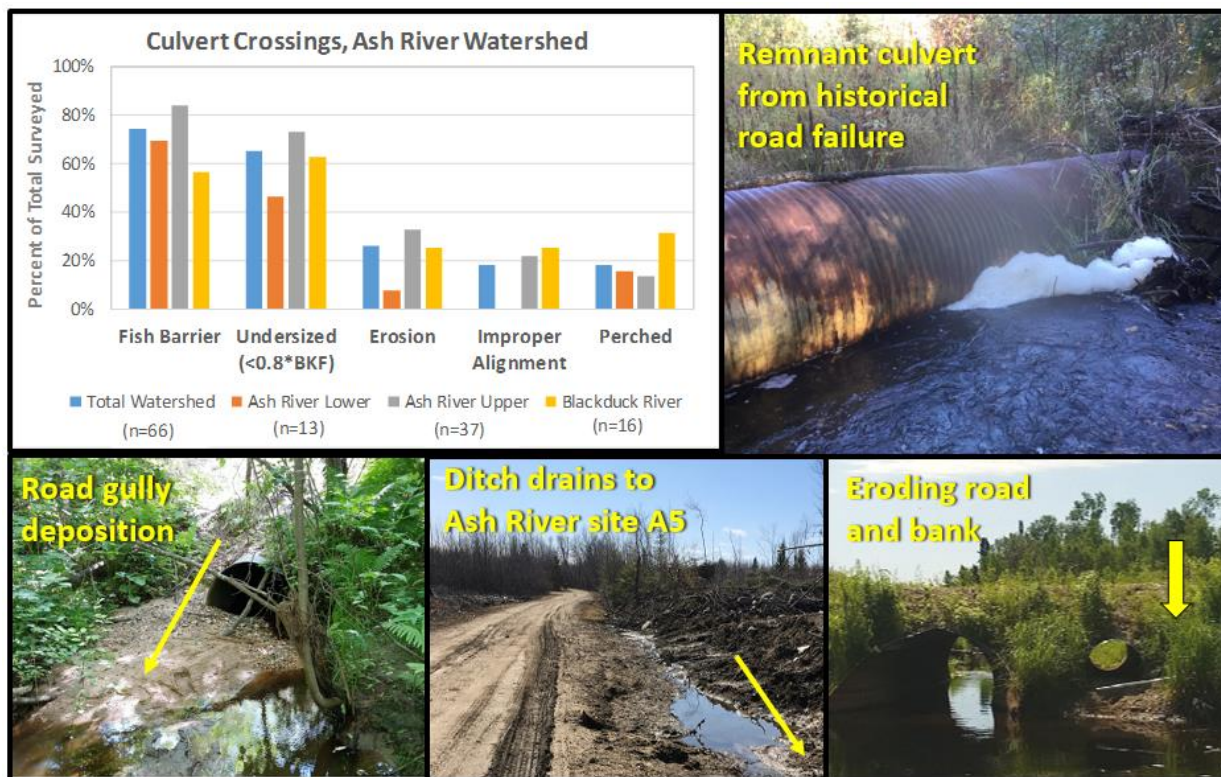
Figure 13. Culvert inventory results (Top Left) in the Ash River Watershed identifying the most commonly found problems at stream-road crossings. Photos: Examples of culverts and roadways that have contributed sediment to stream channels in the Ash River Watershed.

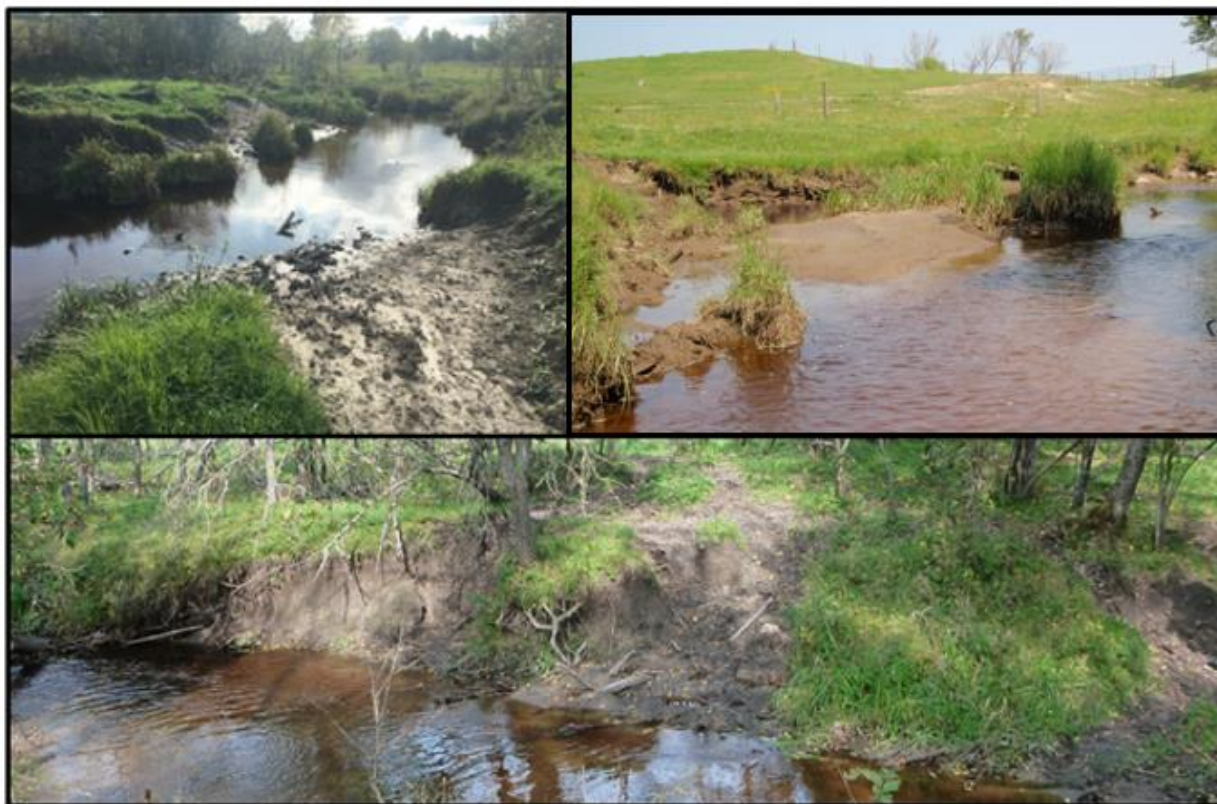
Figure 14. Cattle access areas on the Blackduck River and Ninemile Creek showing trampled banks (top left), sediment deposition (top-right), and steep eroding banks from a combination of streamflow and cattle access (bottom).

Cattle had access to over 3 miles of stream within the ranch including reaches of the Blackduck River, Ninemile Creek, Fawn Creek, and an unnamed tributary. Additionally, smaller ephemeral streams were also being grazed. The total number of cattle varied by season with approximately 500-700 cattle occupying the pasture during summer. While many stream banks remained fully to partially vegetated, cattle access in other areas resulted in trampled banks that were void of vegetation ([Figure 14](#)). While overall, the Blackduck River is incised due to historic channelization, areas over-accessed by cattle were widened in localized areas where banks had been trampled. Fine streambed materials were more dominant in highly accessed areas, burying coarser gravel that is desirable to Coldwater fish and invertebrates.

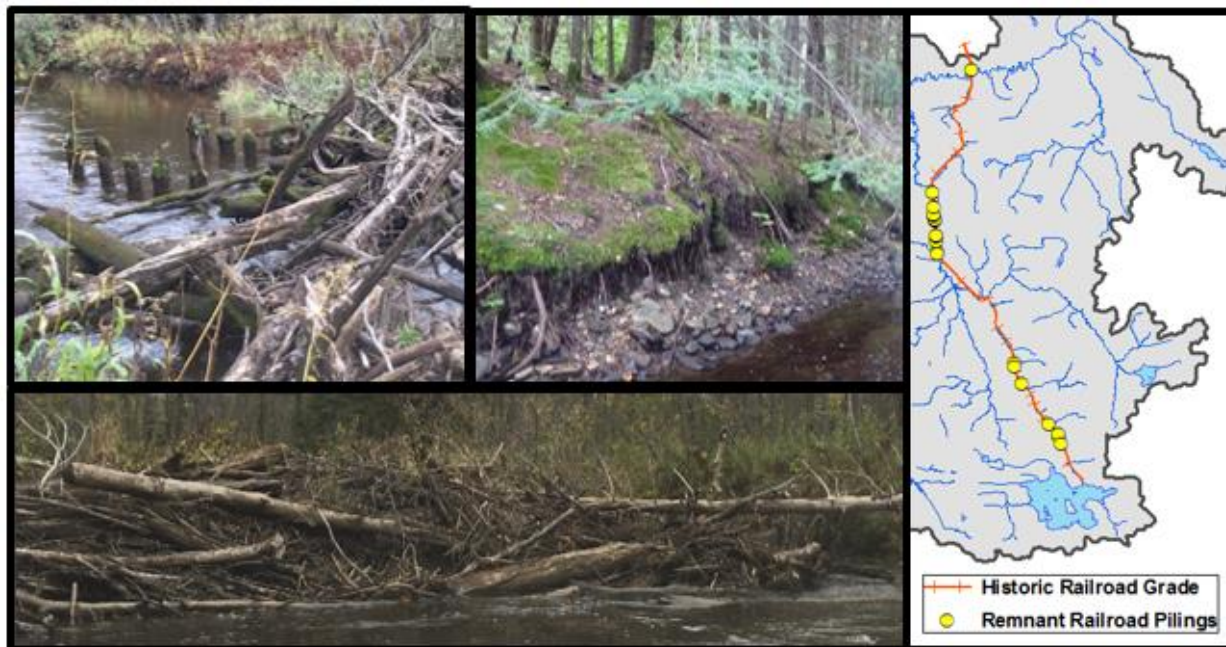
Figure 15. Map (Right) identifying locations where the old railroad historically crossed the Ash and Blackduck Rivers including one location on the Ash River and 18 on the Blackduck River. Pilings remain in the stream at many of these historic crossings causing debris pile-ups (top left and bottom). Bank erosion was identified in the Blackduck River in areas where the old railroad runs parallel with the Blackduck River (Top center).

The BANCS survey identified old railroad grade and in-channel pilings left behind from remnant railway bridges as sources of erosion in the ARW. The old railroad grade transects the ARW from Blackduck Lake to the Ash River Lower. Visual observations of aerial imagery showed eighteen possible railroad crossings on the Black Duck River. Six of those were confirmed to have pilings. The status of pilings are unknown at the remaining nine locations. Pilings were also present at the Ash River water quality station A3, located in Ash River Lower.

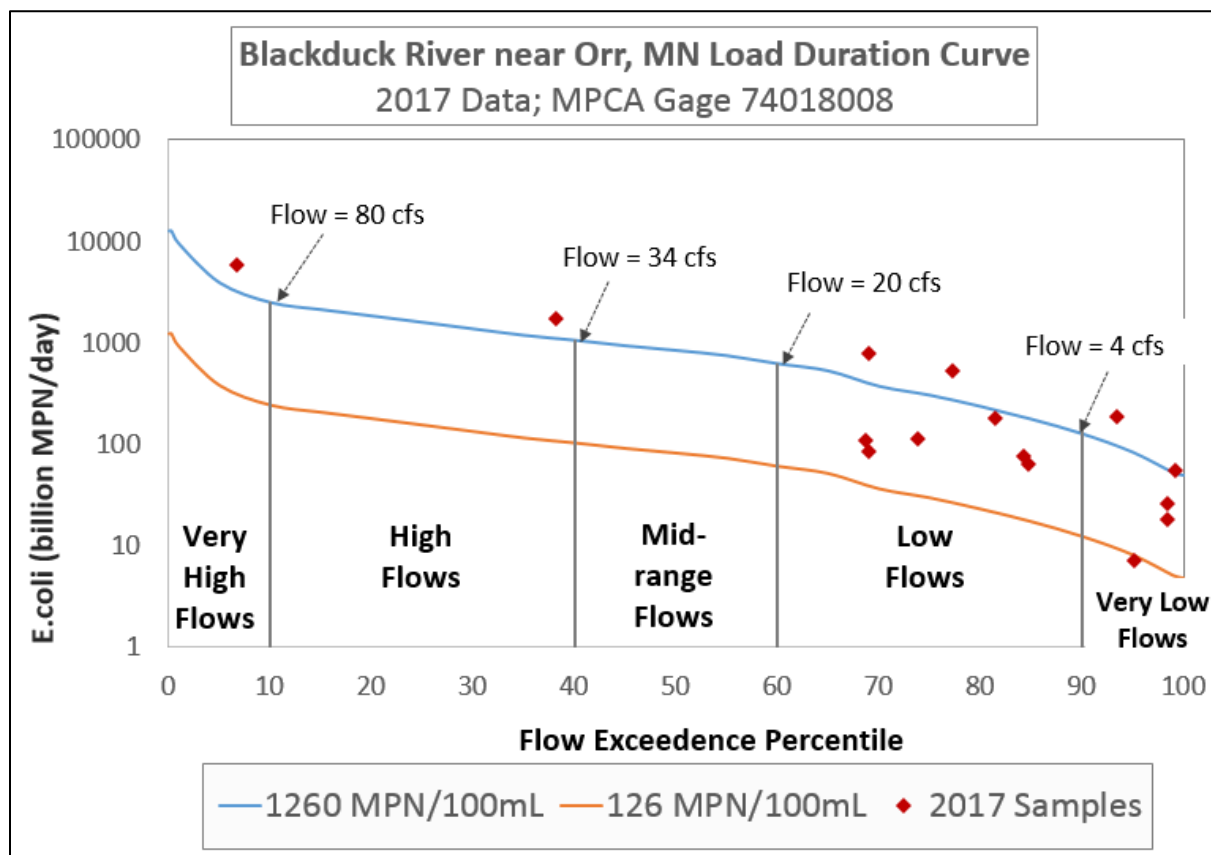
Figure 16. *E.coli* bacteria Load Duration Curve at the Blackduck River station B2c, year 2017. Target loads are shown for the two *E.coli* standards (individual and geometric mean). *E.coli* exceeds the target loads for all sampled flow regimes. No *E.coli* samples were collected for Mid-range flows.

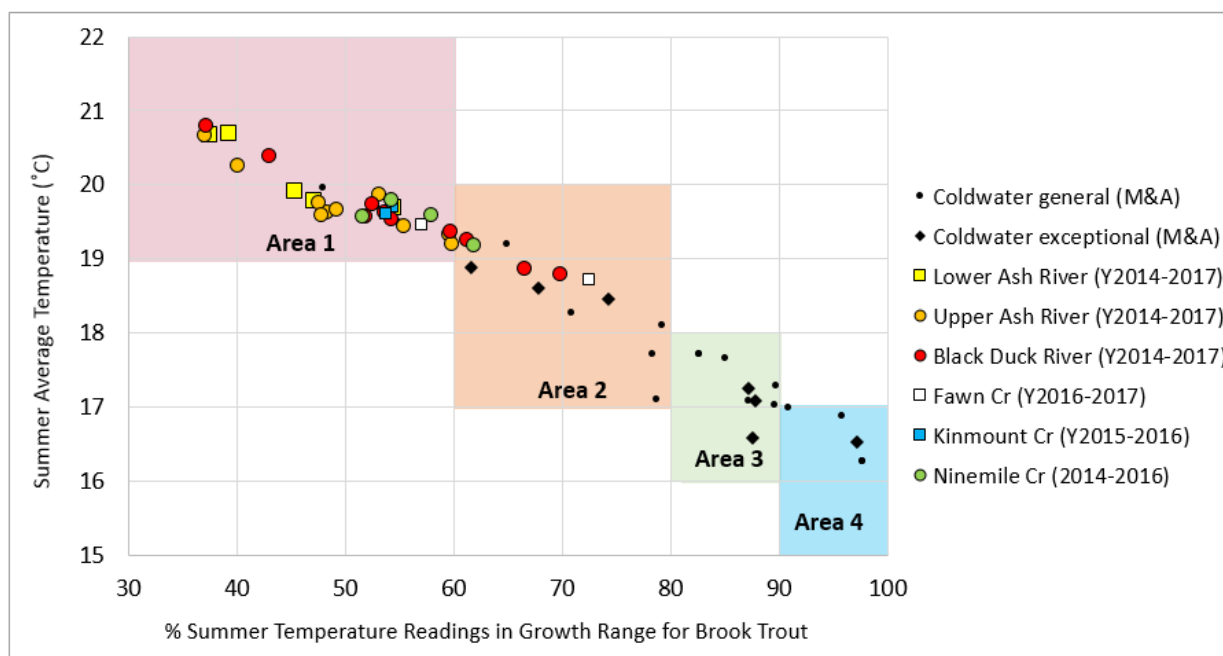
Figure 17. Plot of Summer Average Temperature vs. Percent of Summer Readings within the growth range for Brook Trout, a regionally native Coldwater trout species. Ash River Watershed stations are shown in colored markers, while all other Rainy River Headwater Watershed Coldwater stations collected during the Monitoring and Assessment (M&A) period are shown in black. Diamonds indicating streams with exceptional Coldwater communities.

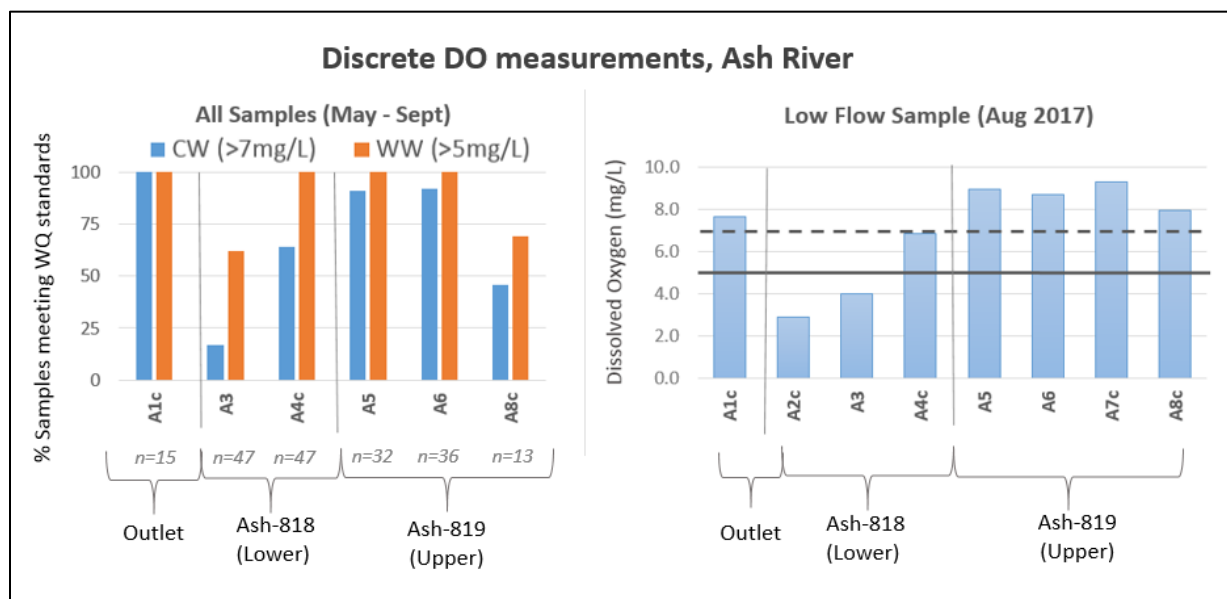
Figure 18. Variations in discrete DO measurements in the Ash River between the headwaters at Ash Lake (S008-621) and the outlet to Kabetogama Lake (S015-009) are shown in two plots. Left: graph of % total measurements taken between May and September in years 2014-2017 that pass the Coldwater and Warmwater DO standards. Right: graph of DO (mg/L) during baseflow of August 14, 2017 show variability of DO within the Ash River. The dash line represents the Coldwater DO standard and the solid line represents the Warmwater DO standard.

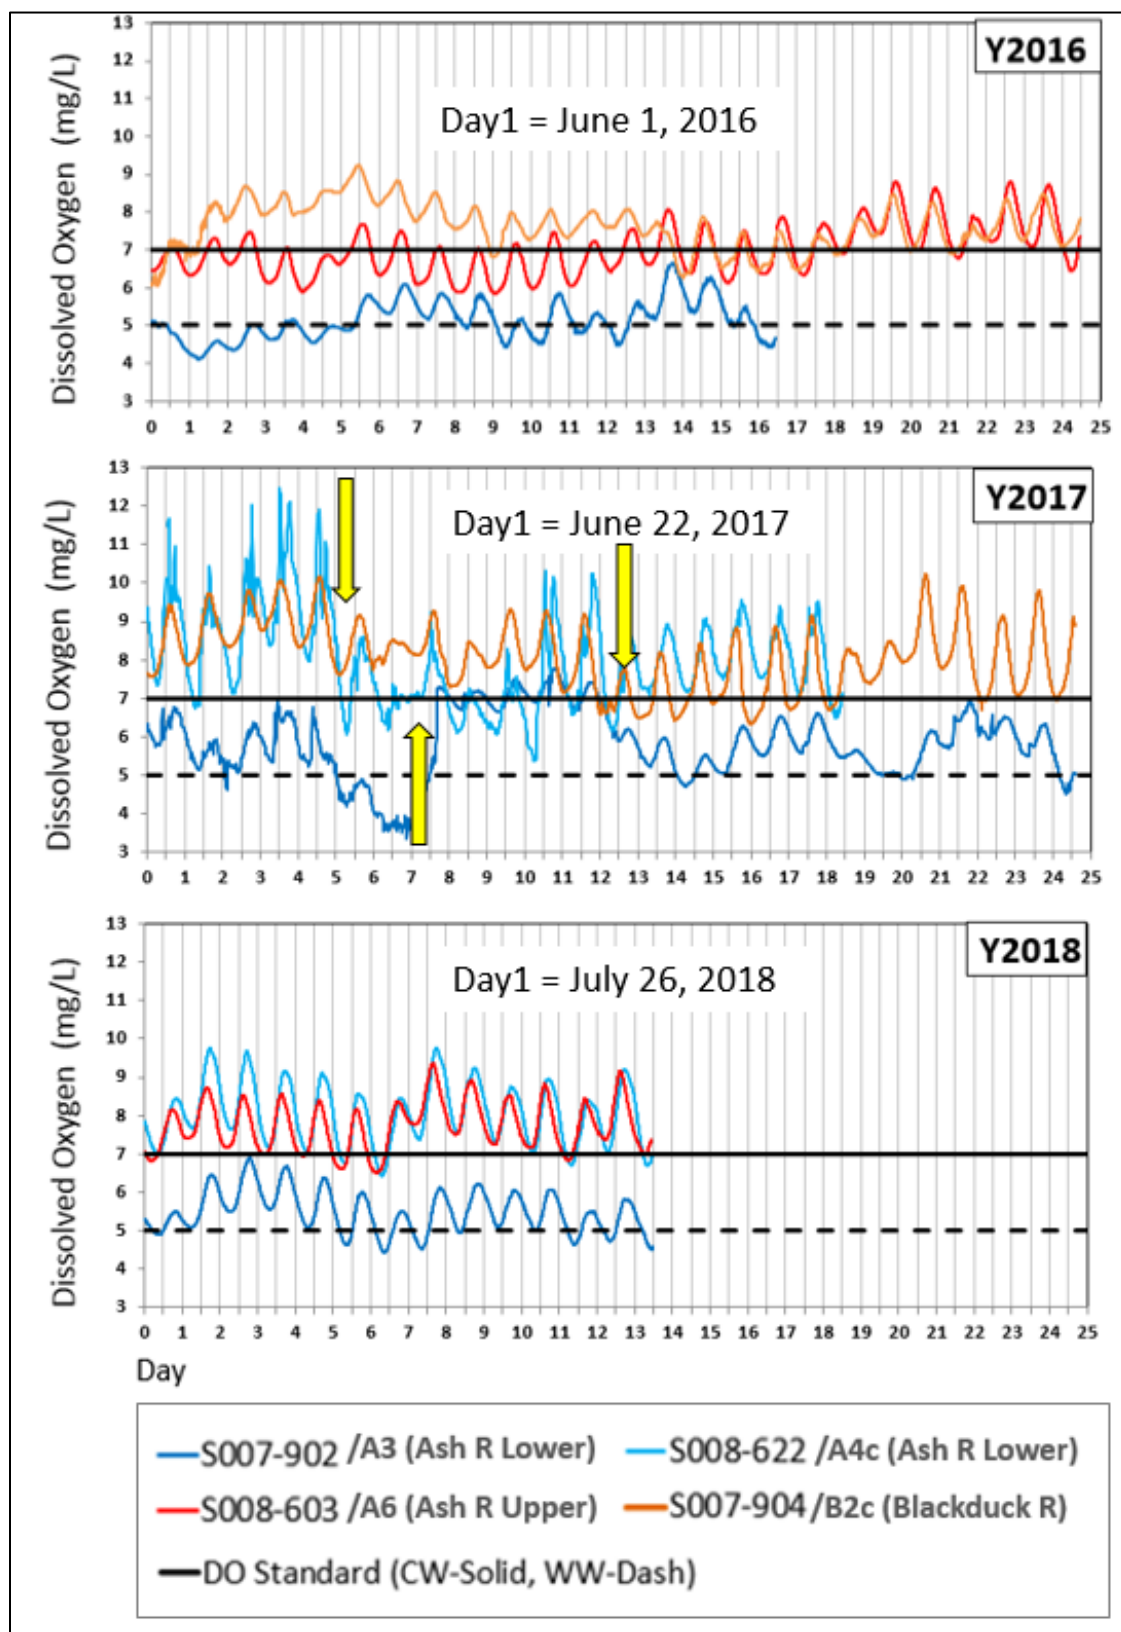
Figure 19. DO levels for reaches of the Ash River and Blackduck River, years 2016-2018.

DO levels in the upstream end of the Ash River Lower (Site A4) noticeably improved from the downstream site. The Warmwater DO standard was always met; however, levels were below the Coldwater standard for 36% of discrete measurements. Continuous data showed that DO was lowest in the late evening to morning hours, but occasionally remained below the standard for consecutive days. DO flux was abnormally high (>3 mg/L) at this station for multiple days in 2017, but decreased following a 0.70-inch rain as did base level DO. Two more 1-inch rain events occurred during the deployment; one raised DO levels in the stream whereas the other decreased DO and DO flux. Yellow arrows mark the timing of these rain events in [Figure 19](#).

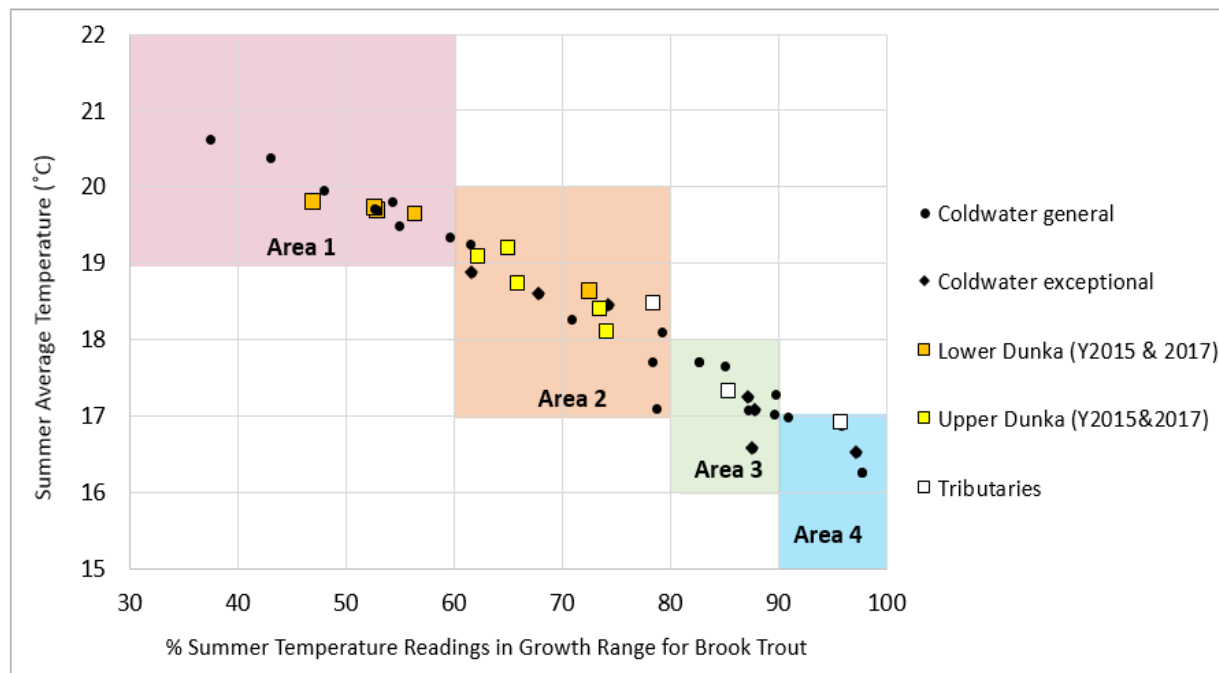
Figure 24. Plot of Summer Average Temperature vs. Percent of Summer Readings within the growth range for Brook Trout. The Dunka River temperature stations are shown in colored markers and tributaries to the Dunka in white. All other RRHW Coldwater station data are shown in black, with diamonds indicating streams with exceptional Coldwater communities.

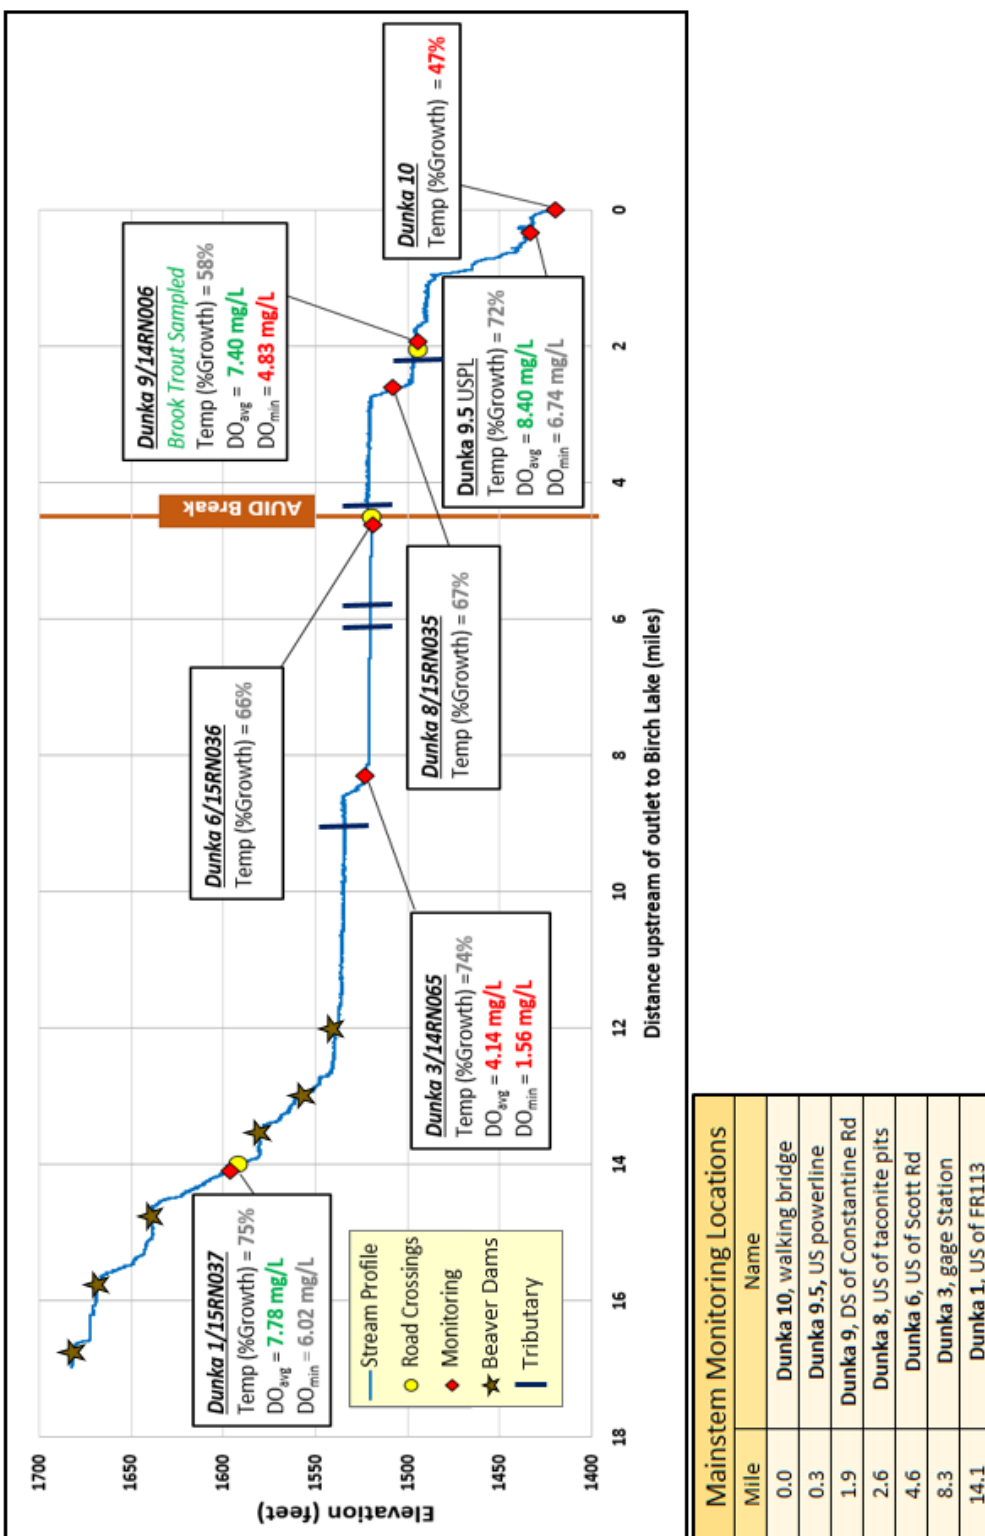
Figure 26. Longitudinal profile of the Dunka River showing monitoring locations and water chemistry results. Water chemistry and stream slope vary from the headwaters of the Dunka River to the outlet at Birch Lake. Green text indicates suitable conditions, red indicates unsuitable conditions, and black indicates marginal to poor conditions for Brook Trout.

Continuous DO was collected in the Dunka River and Unnamed Creek1 June through mid-August. Results were plotted in [Figure 25](#), summarized both below and in the stream profile of [Figure 26](#).

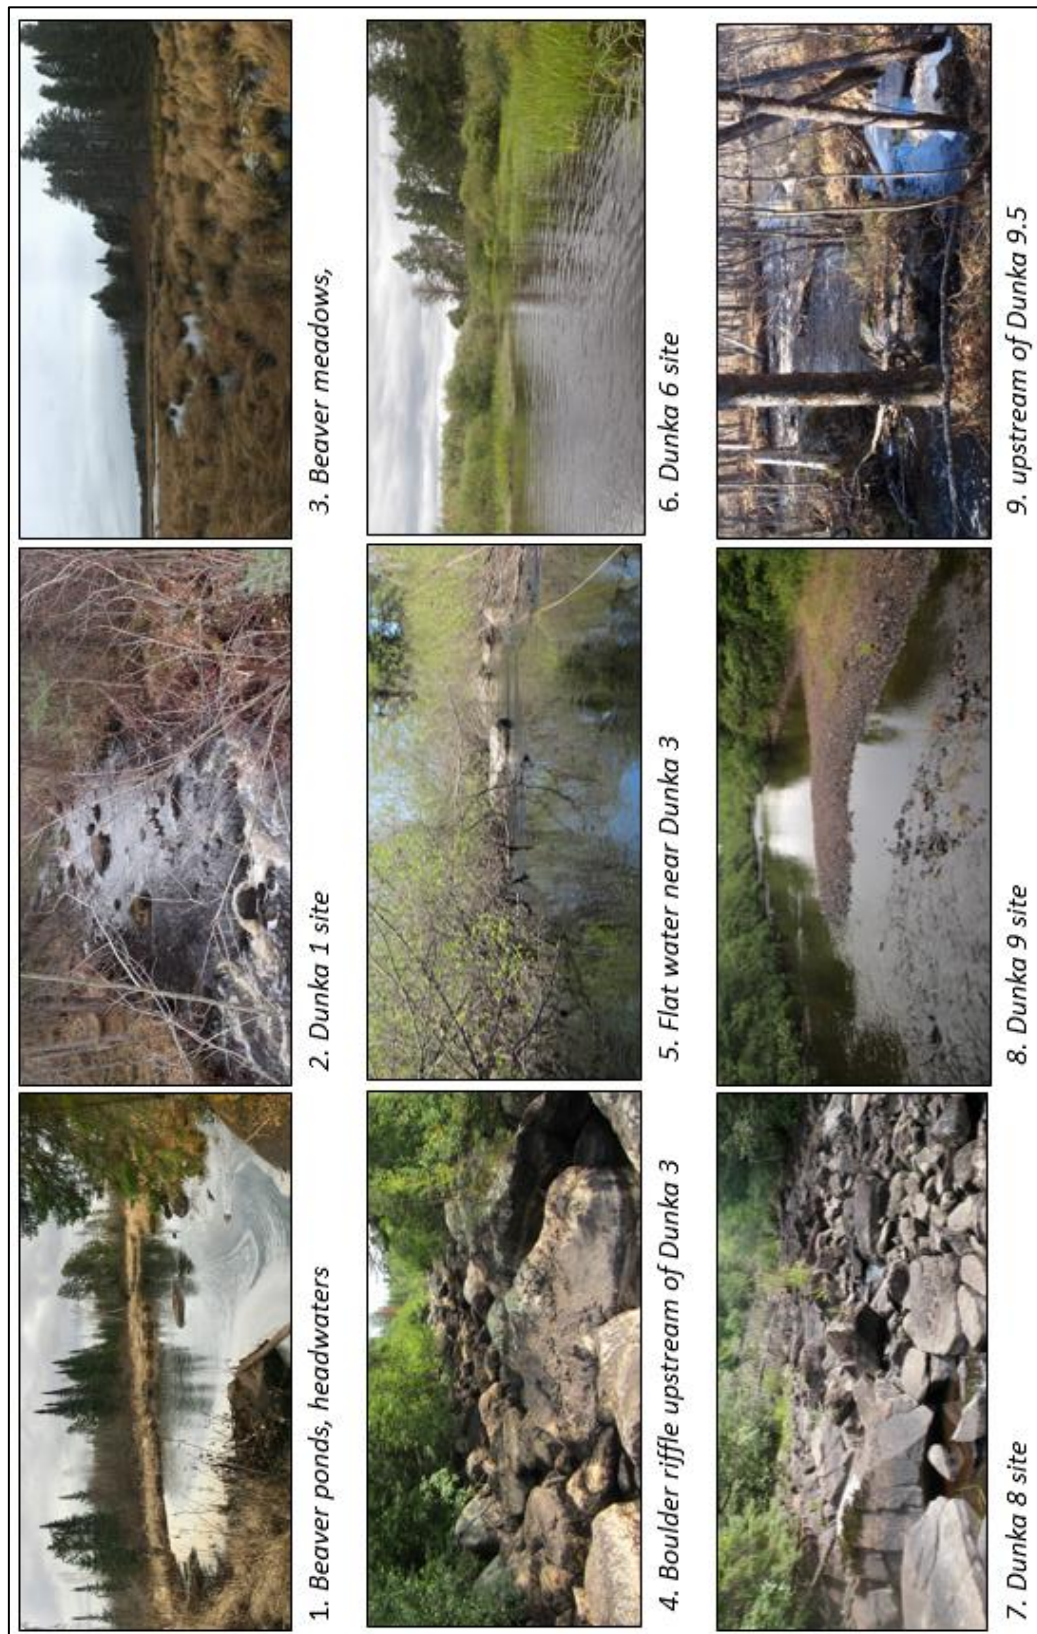
Figure 27. Photos showing physical habitat variations from the headwaters to the mouth on the Dunka River.
