# Missouri River Basin Hydrology, Connectivity, and Geomorphology Assessment Report

MINNESOTA DEPARTMENT OF NATURAL RESOURCES:  
DIVISION OF ECOLOGICAL AND WATER RESOURCES

October 10, 2014

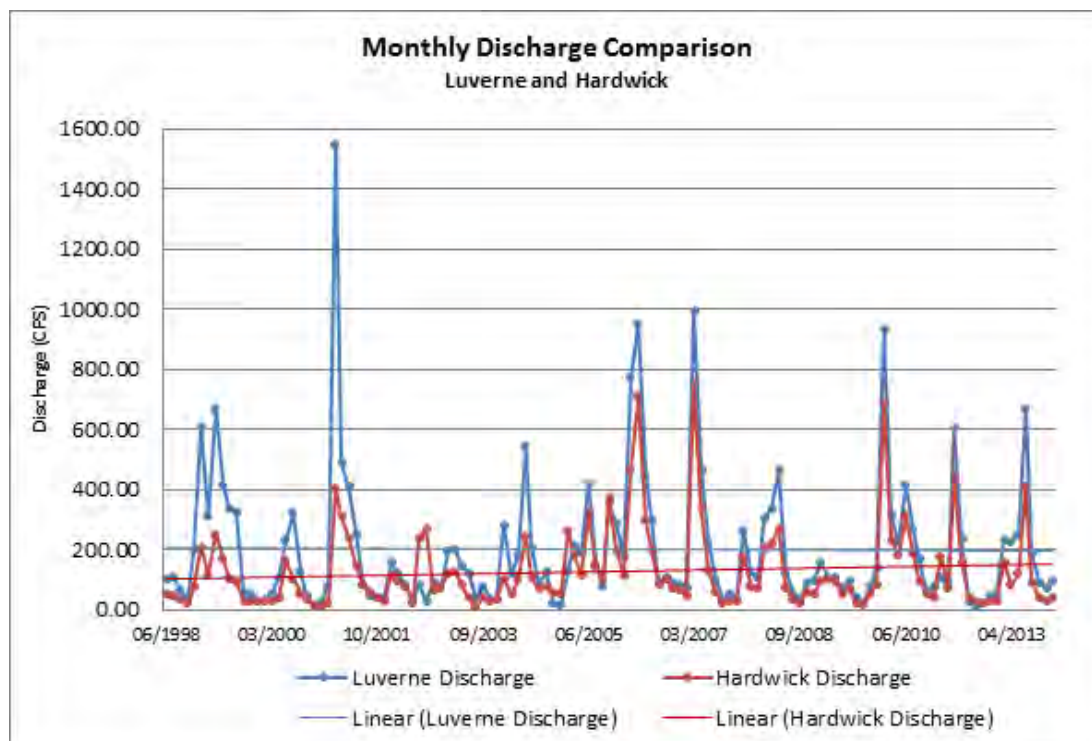
Discharge data for both locations were plotted from 1998 through 2013 (Figure 5). The general response of the watershed to precipitation events is similar. The total discharge volumes were similar from 2001 through 2013, likely due to close proximity of the sample locations and intermittent nature of some of the smaller river and streams in the watershed.

The Luverne site does include an additional watershed area of 105 square miles, which includes discharge from Champepadan and Mound Creeks. Precipitation received in the Champepadan watershed likely accounts for the significantly higher discharge peaks at the Luverne gage in 1998 and 2001. Based on linear trend lines applied to both data sets, the Luverne discharge is staying fairly consistent while the Hardwick discharge is increasing (Figure 5).

**Figure 5. Monthly discharge comparison between the Luverne and Hardwick gages on the Rock River from 1998-2013 with trend lines.**

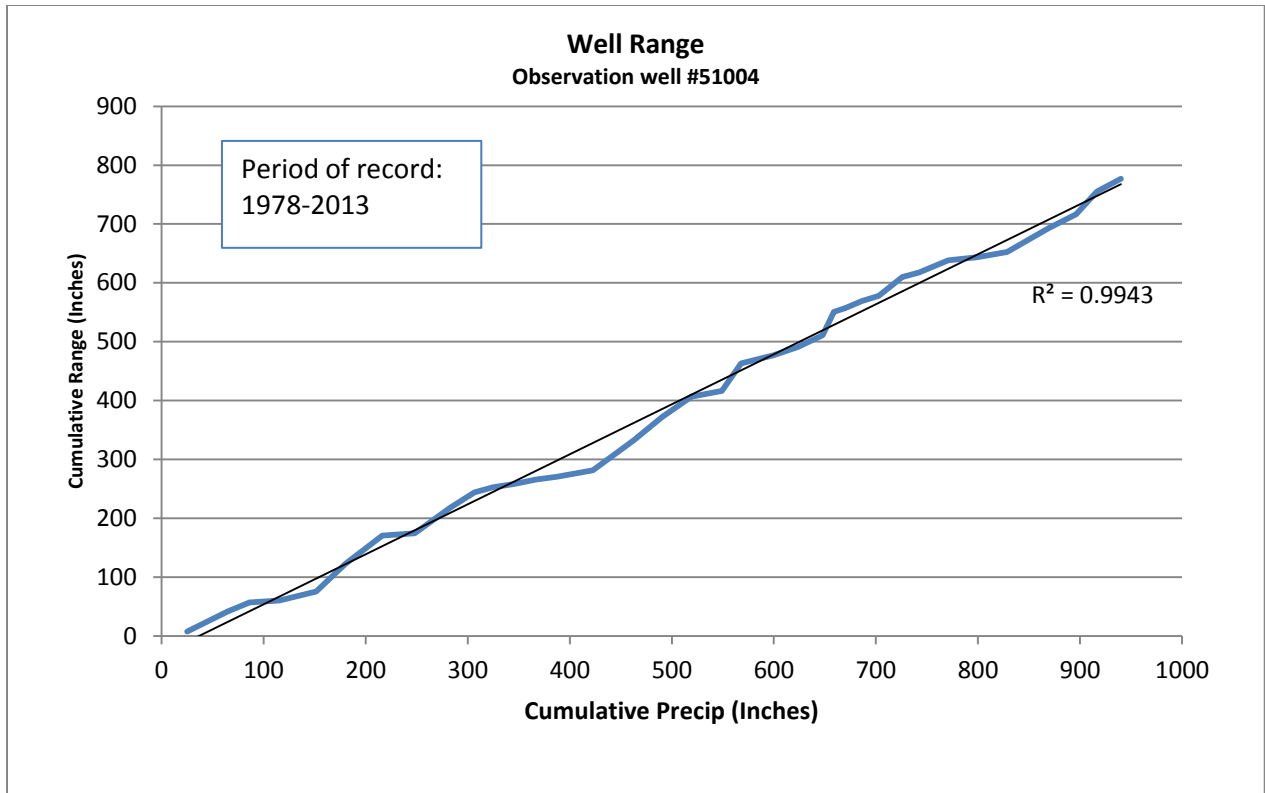
**Figure 14. Groundwater elevation range double mass curve analysis from observation well #51004. The relative proximity to the 1:1 regression line helps show that there has not been a significant change in relationship during the period of record.**

some of the natural variability often recorded in observation wells. While precipitation has been taken into account, it is important to note that climatic impacts have not been eliminated, because antecedent groundwater levels are very important in looking at fluctuations. Over the period of record of the observation well, no significant change in the relationship has been noted. That does not mean that this relationship will not change in the future based on changing land uses or appropriation volumes.

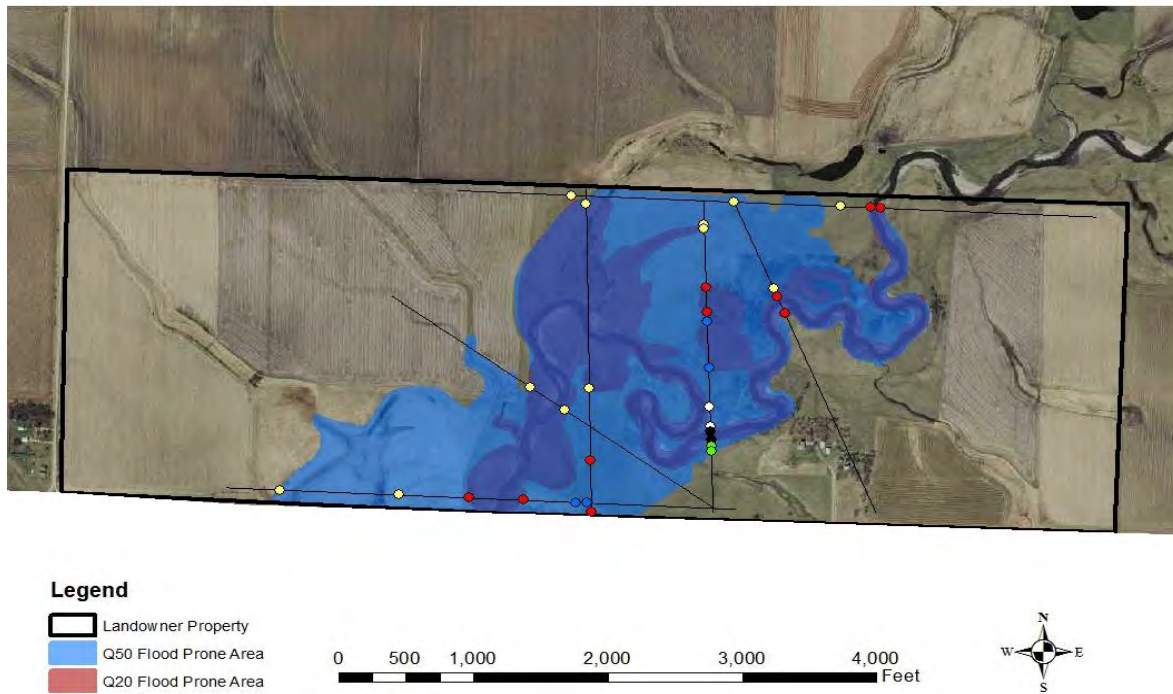
**Figure 19. Polygons depicting the Q50 flood prone area (blue) and the Q20 flood prone area (red) delineated with LiDAR cross sections. Note that most oxbows in the reach appear to be recharged with the Q20 flood flows, but likely not on an annual basis.**

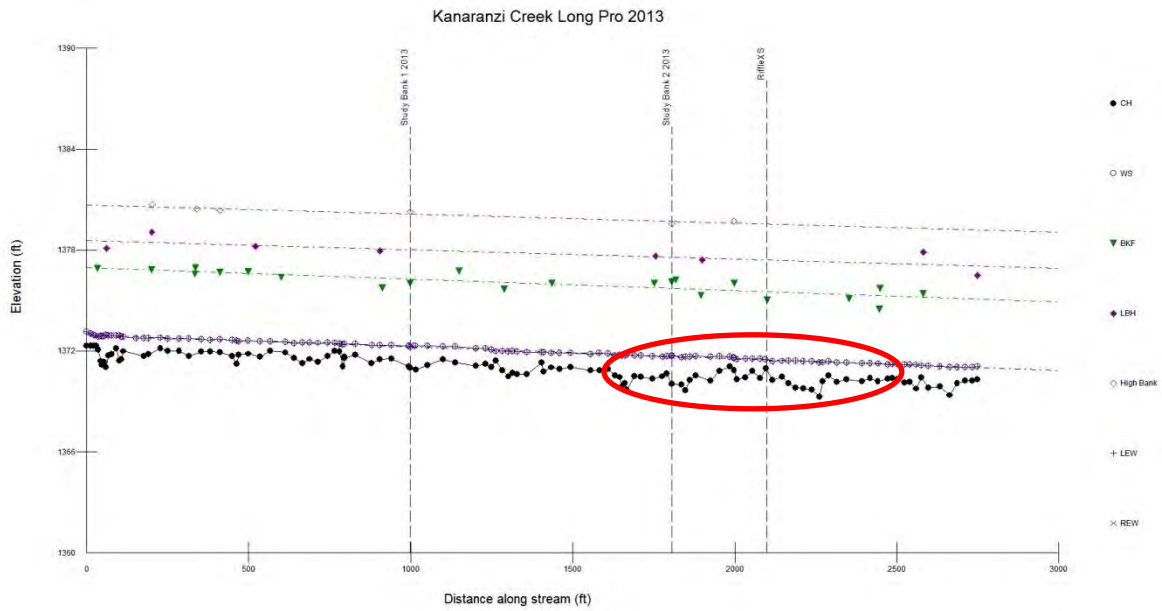
**Figure 26. Longitudinal profile of the survey reach at Kanaranzi Creek. Note the lack of pool quality until the area of study bank 2 and downstream of the riffle cross section.**

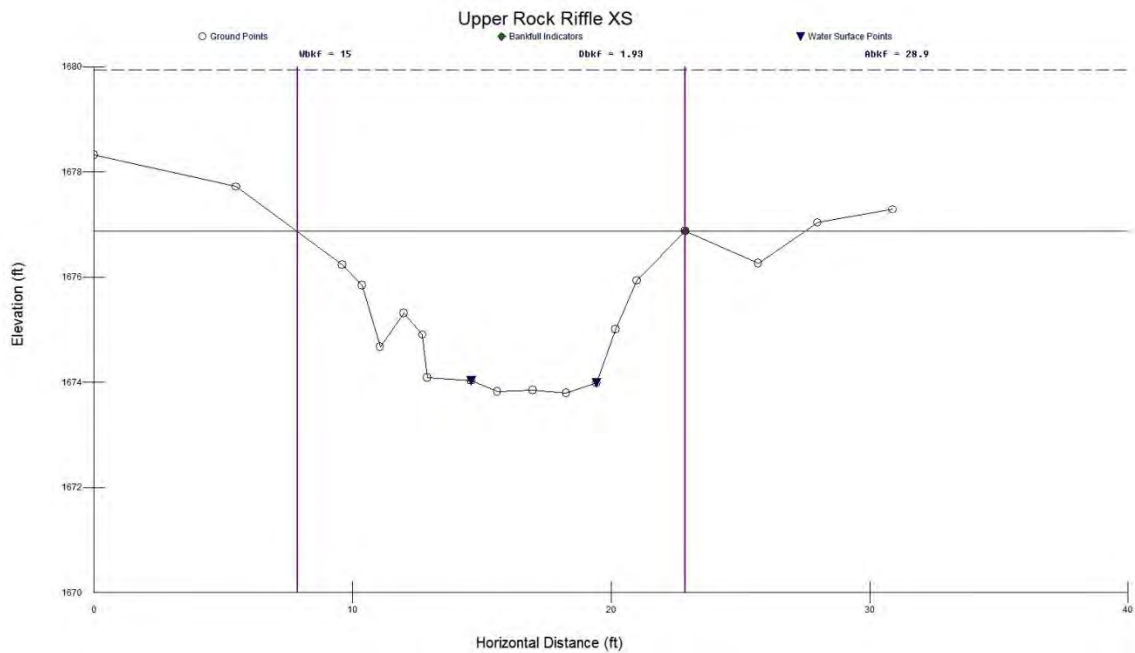
**Figure 30. Graphical view of the representative riffle cross section in the survey reach at the East Branch Rock River site.**

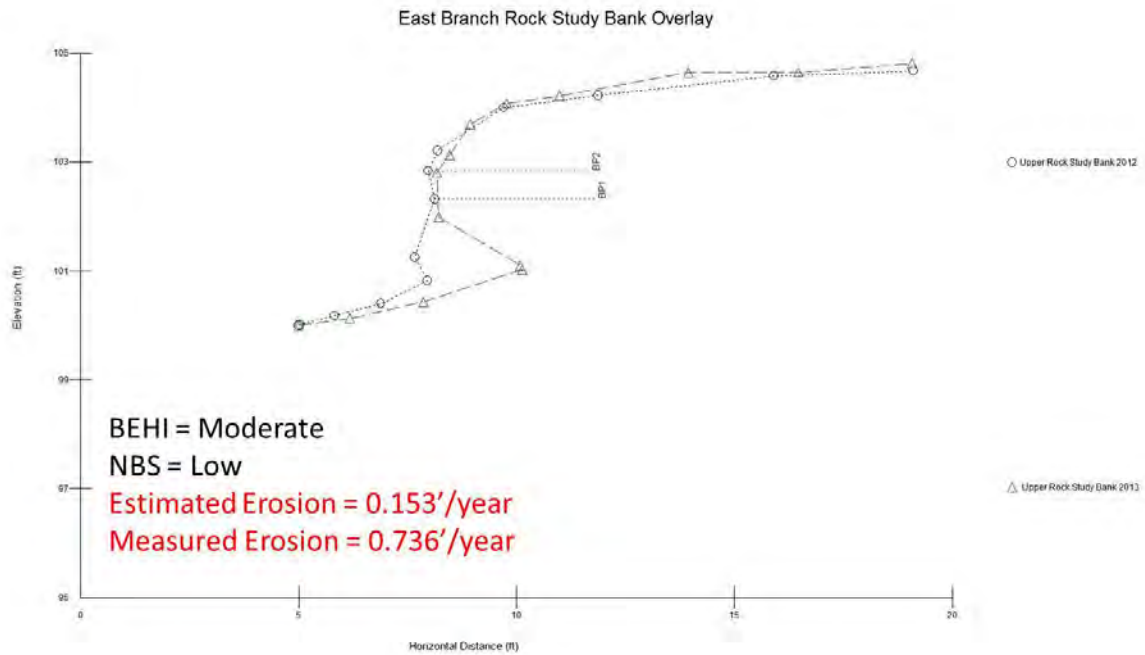
The BEHI matched with NBS model estimated that this reach is contributing 0.007 tons of sediment (14 pounds) per linear foot of stream bank annually using the Colorado erosion rate curve (Rosgen 2001a). These erosion predictions assume that this 308’ reach of stream delivers 2.16 tons of sediment (~0.22 dump truck loads) annually. There was one study bank in this reach that was resurveyed in 2013. The Colorado bank erosion model predicted 0.153’ of erosion and 0.736’ of erosion was measured (Figure 32).

**Figure 32. Study bank overlay for the East Branch Rock River site with estimated and measured erosion rates.**

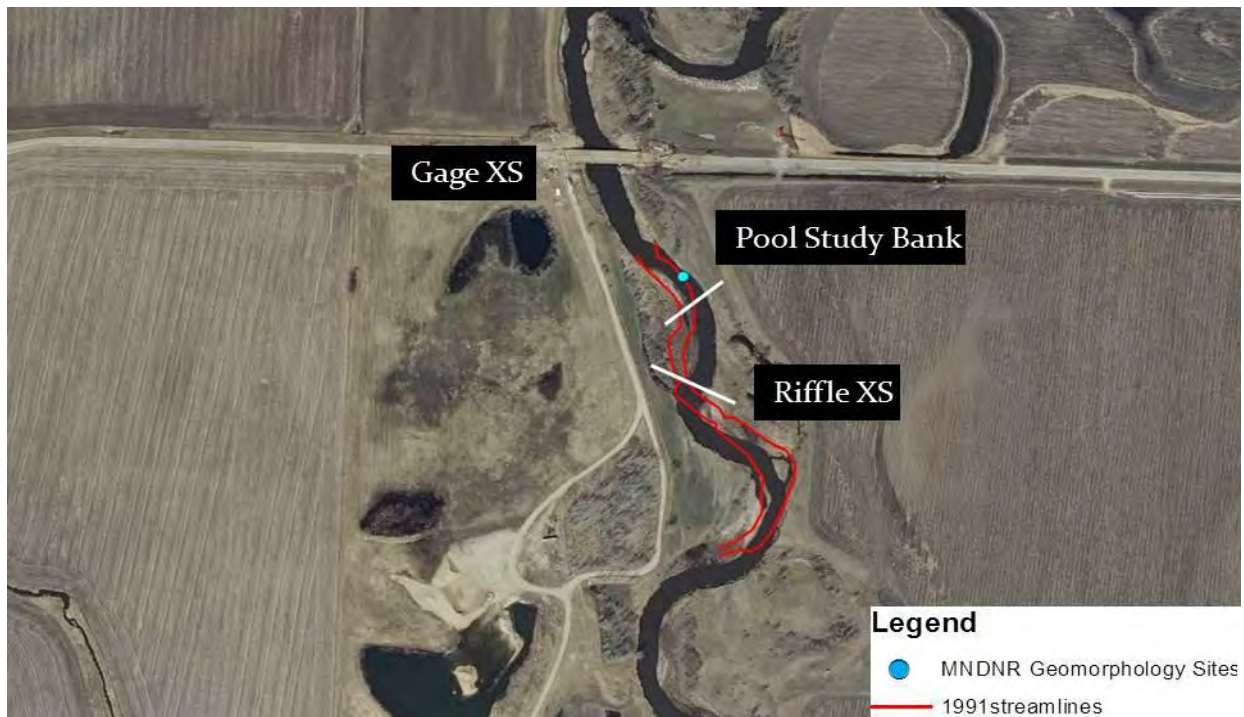
**Figure 36.** Aerial photo of the survey reach with labeled cross section locations and 1991 stream lines.

Since this was a gage site, a cross section was taken at the gage in order to analyze bankfull discharge at the gage location, and also at the riffle location. Discharge analysis at the riffle cross section estimated bankfull discharge to range from 742.5 cfs (U/U\*) to 772.69 cfs (Manning's "n"). At the gage cross section, discharge analysis estimated a range of bankfull flows from 693.28 cfs (U/U\*) to 717.83 cfs (Manning's "n"). Peak flow analysis from the gage data (6/1998-present) estimated the 1.5 year return interval flow to be 680cfs; resulting in the field bankfull estimation to be about a 1.7 year return interval flow.

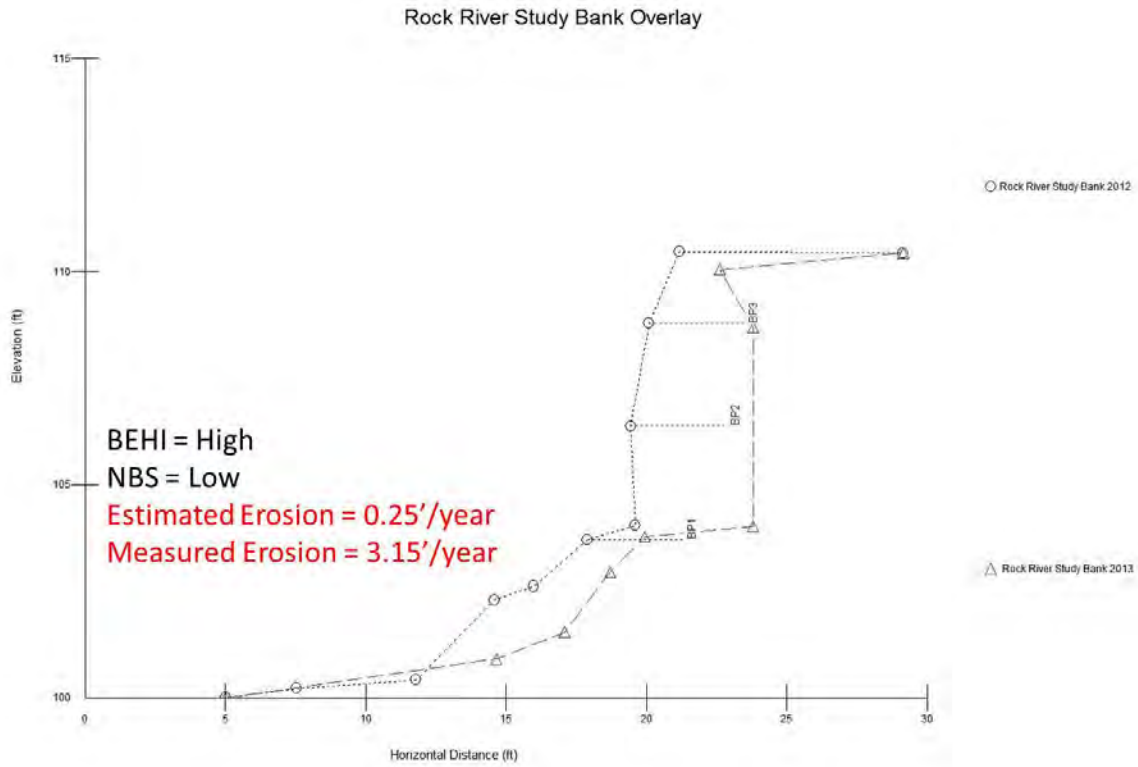
**Figure 37. Study bank overlay for the Rock River site with estimated and measured erosion rates.**

The BEHI matched with NBS model estimated that this reach is contributing 0.038 tons of sediment (76 pounds) per linear foot of stream bank annually using the Colorado erosion rate curve (Rosgen 2001a). These erosion predictions assume that this 1433' reach of stream delivers 54.45 tons of sediment (~5.4 dump truck loads) annually. There was one study bank in this reach that was resurveyed in 2013. The Colorado bank erosion model predicted 0.25-0.38' of erosion and 3.15' of erosion was measured, significantly higher than what was estimated (Figure 37).

Although riparian vegetation quality is better at the Rock River (Hardwick) gage site than at Kanaranzi Creek, high bank erosion and sediment supply was still observed (Figure 37). Much of this was due to the lack of quality vegetation, root depth, and root density; resulting in a poor weighted root density and minimal bank protection (Table 3). Bank angles throughout this reach were also too high to maintain lateral stability. With many outside banks having angles of 90° or higher, the banks already were susceptible to high bank erosion.

At sites like the Rock River gage, it is possible to implement bank protection using natural woody materials to protect the toe of the bank and reduce shear stress up against the bank; a practice known as toe wood protection (Appendix 3). When using toe wood, the purpose is to create bank stability by making a floodplain bench out of trees and woody material on an outside bend. This protects the toe of the bank, and also allows the river to deposit sediment and a seed source to grow natural vegetation on top of the bench. Although this has been shown to work in many cases, a systemic approach that includes better land use practices upstream is a more desirable strategy so it creates watershed stability instead of bank stability. Eroding banks tend to be a symptom of a larger issue in the Missouri River basin, and being able to address the larger issue can implement watershed-wide stream stability.

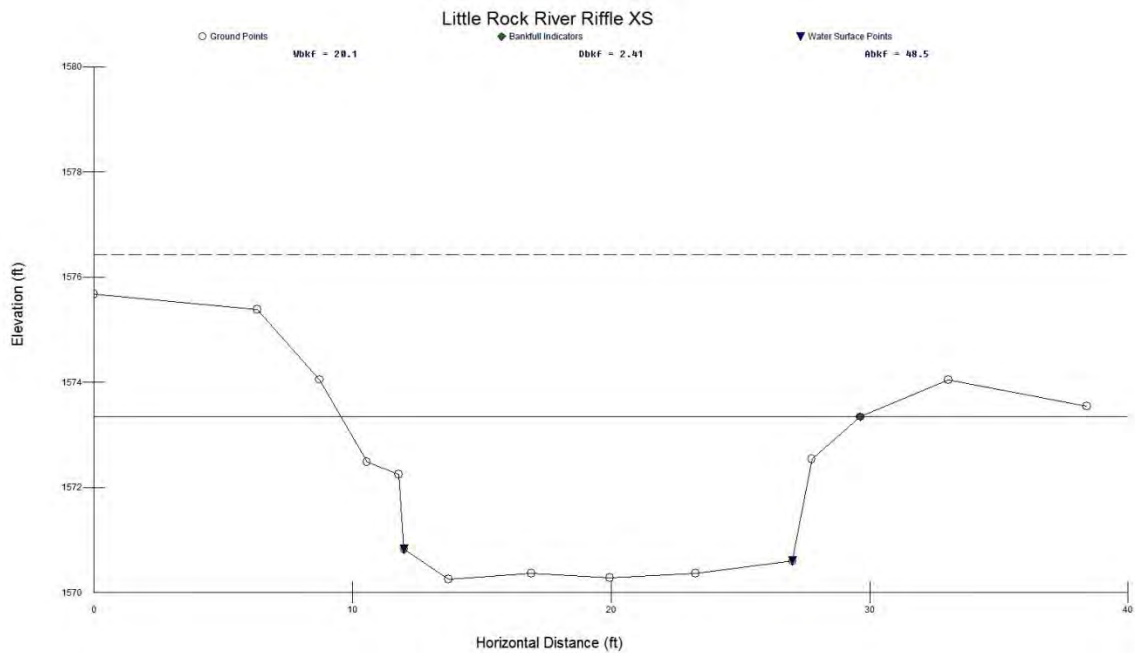
**Figure 39. Graphical view of the representative riffle cross section in the survey reach at the Little Rock River site.**

At this site, the Little Rock River is classified as an E4 indicating that it is a low gradient, gravel bed stream with a low width to depth ratio bankfull channel, typically vegetated banks and good floodplain connectivity (Table 9). E4 stream types have a very high sensitivity to disturbance, good recovery potential, moderate sediment supply, high streambank erosion potential, and riparian vegetation plays a significant role in maintaining stability (Table 5; Rosgen 1994). The width-to-depth ratio at the riffle is 8.96 (Figure 39), a relatively stable W/D ratio for alluvial valley types.

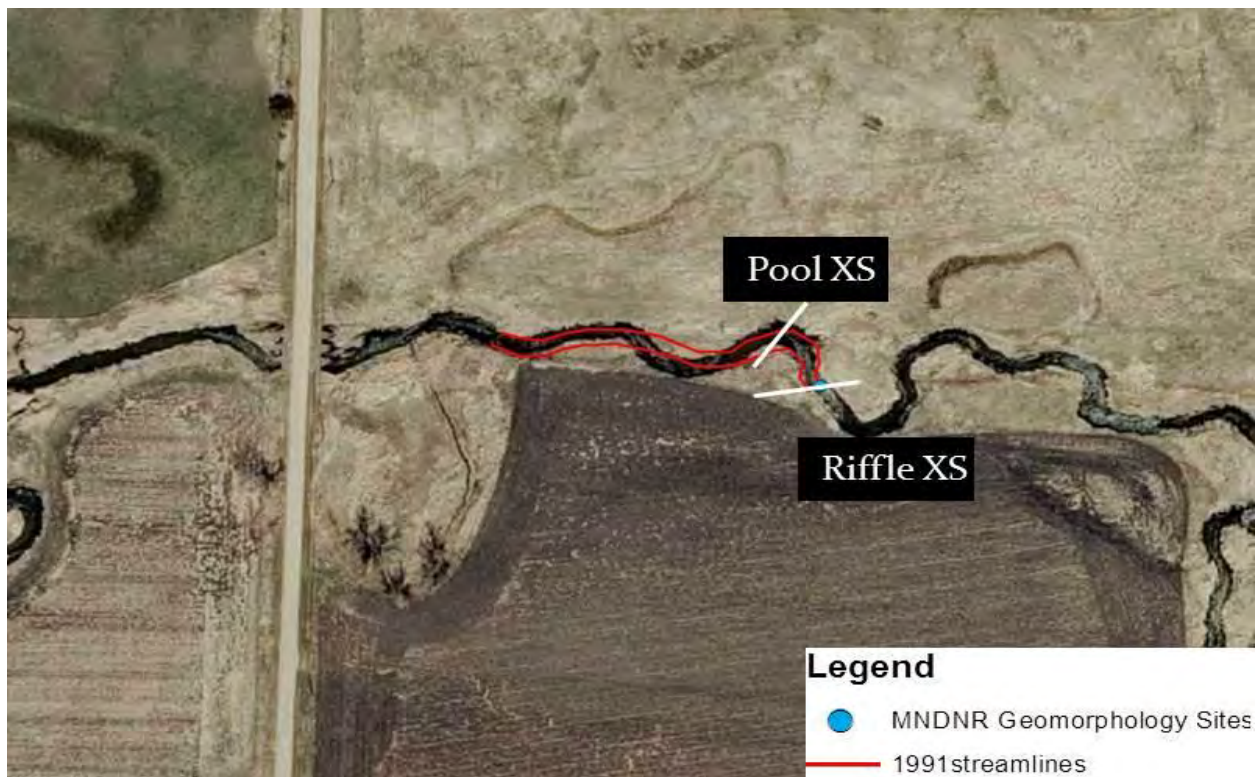
**Figure 40. Aerial photo of the survey reach with labeled cross section locations and 1991 stream lines.**

Bank height ratio at this riffle cross section is 1.22, indicating some incision, but the riffle cross section shows some possible floodplain deposition making that number higher than it really may be. Although the riparian area on the north side of this site is relatively undisturbed, the south side has row-crop agriculture nearly up to the stream banks in spots (Figure 40). The Pfankuch stability rating and aerial photo analysis suggest some instability in this channel, likely due to historical straightening to make the river go through the culverts at the road crossing (Figure 40).

Even though this site appears to be relatively stable compared to other sites, there are still practices worth considering that could potentially stabilize this reach. Two of the major concerns that affect stream stability at this site are culvert sizing and riparian land use on the south side of the stream. The road crossing immediately downstream of the study reach has four culverts; however, it appears that the two southern culverts are the only ones that transport water at normal to low flows (Figure 40). The amount of sediment deposited in the northern two culverts relates to the fact that the road crossing was built too wide for the bankfull channel, and the stream is developing a floodplain in the other two culverts. In order for a stream to maintain stability, it must transport the water and sediment of its watershed, so this site shows what happens when culverts are improperly sized. Ideally, sites like this would have a culvert large enough to handle the bankfull discharge, and then have floodplain relief culverts at the floodplain elevation to allow flood flows to stay on the floodplain and not be bottlenecked (Zytkevich and Murtada 2013). An indirect impact of these culverts stems from the channelization of the stream that directed the flows straight into the culverts. Naturally, the Little Rock River is very sinuous, and in order to maintain stability it is continually working to be sinuous. Much of the lateral bank erosion noted in the study reach stems from this channelization that took place historically.

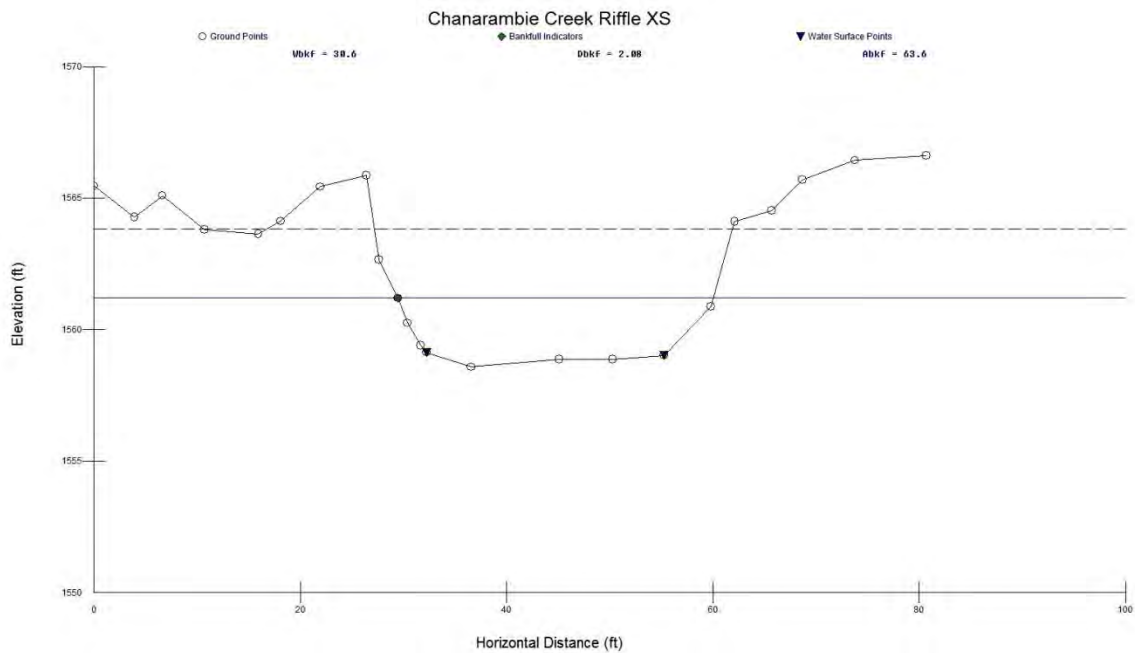
**Figure 44. Graphical view of the representative riffle cross section in the survey reach at the Chanarambie Creek site.**

The width-to-depth ratio at the riffle is 14.64 (Figure 44), relatively low for F channels indicating that this site may have recently transitioned to this unstable stream type. Bank height ratio at this riffle cross section is 2.07, indicating that this channel is fully incised and has no access to its floodplain at 2X bankfull. Lack of riparian vegetation, Pfankuch stability analysis, and aerial photo analysis suggest that this channel is very unstable and will continue to widen out until it can make a new channel and floodplain within the existing channel (Figure 45).

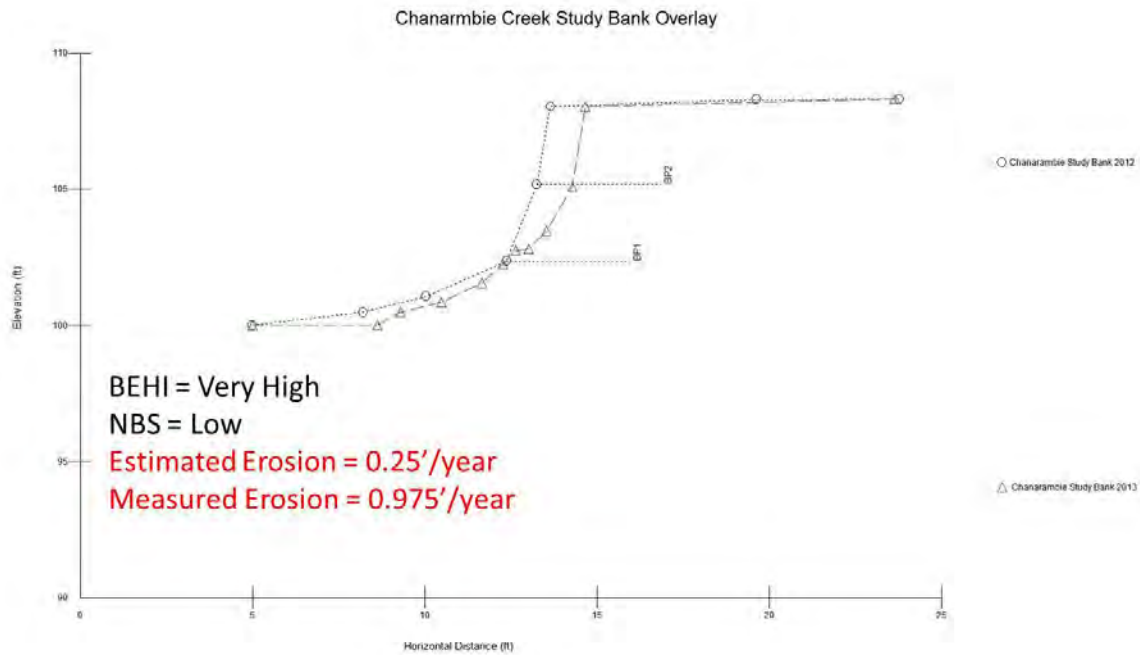
**Figure 46. Study bank overlay for the Chanararnbie Creek site with estimated and measured erosion rates.**

The BEHI matched with NBS model estimated that this reach is contributing 0.0166 tons of sediment (33.2 pounds) per linear foot of stream bank annually using the Colorado erosion rate curve (Rosgen 2001a). These erosion predictions assume that this 650’ reach of stream delivers 10.79 tons of sediment (~1.08 dump truck loads) annually. However, the study bank at this location suggested that the bank erosion model’s estimates were lower than what actual measurements were. The model estimated 0.25’ of bank erosion at the study bank, and 0.975’ of erosion was measured (Figure 46).

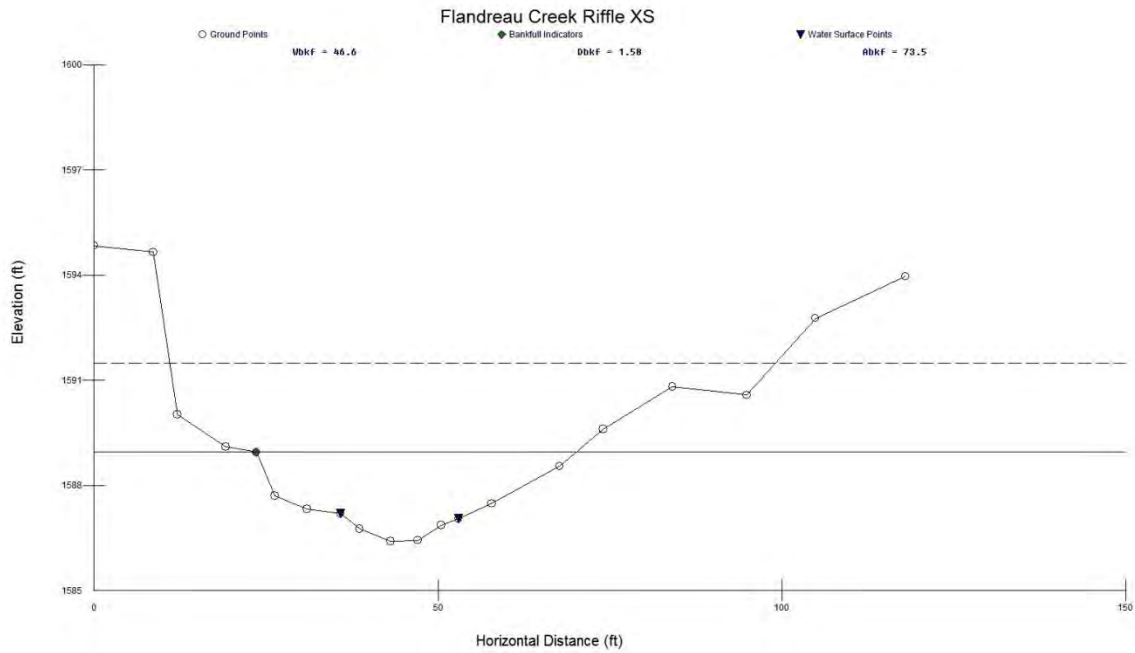
The width-to-depth ratio at the riffle is 29.51 (Figure 48), which is very high for an alluvial valley type, suggesting there may be some disturbance in this stream or bankfull calls are low. Since bankfull has not been validated, bank height ratio of the cross section is likely incorrect at

**Figure 48. Graphical view of the representative riffle cross section in the survey reach at the Flandreau Creek site. Referencing the regional curve (Appendix 2), it appears the bankfull call is low on this cross section and will likely be raised.**

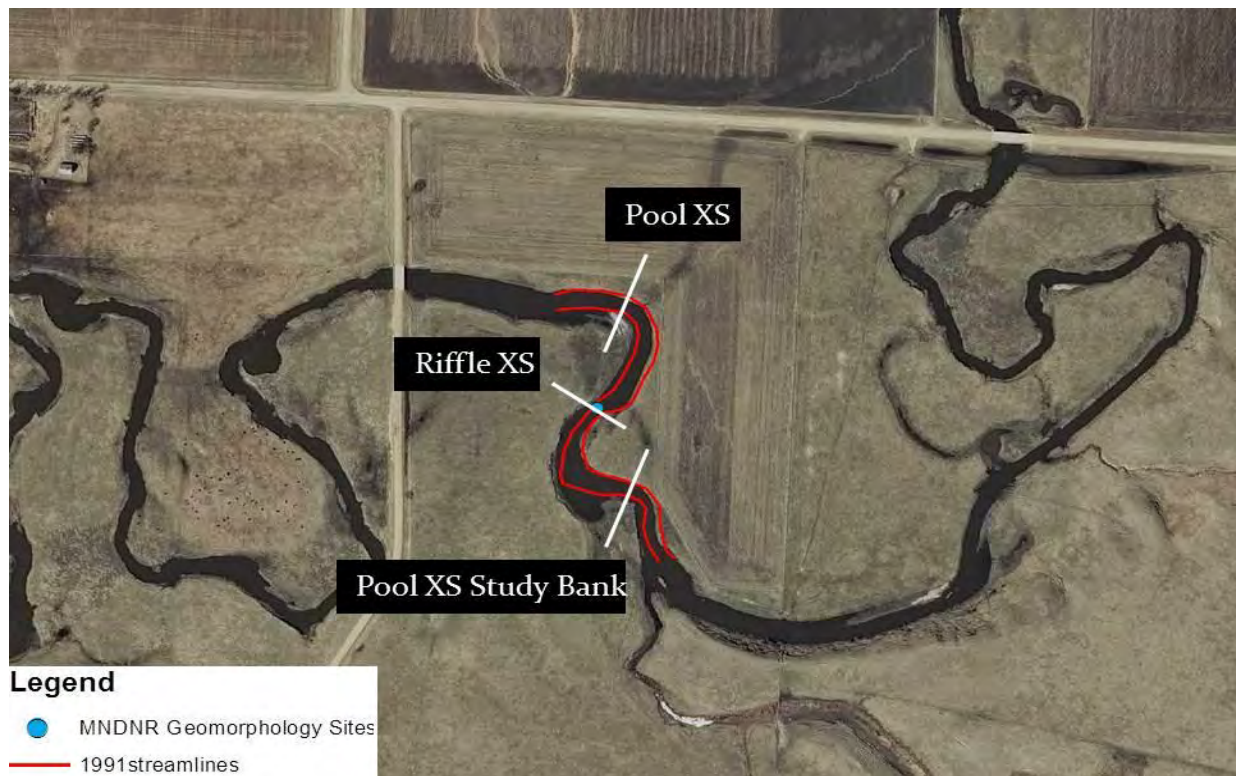
**Figure 49. Aerial photo of the survey reach with labeled cross section locations and 1991 stream lines.**

this point. Lack of riparian vegetation, Pfankuch stability analysis, and aerial photo analysis suggest that this channel is in a successional state and not stable at this time (Figure 49).

Overall, rotational grazing at this location has left the riparian area with relatively good vegetation in comparison to other observed pasture areas. However, there are many bare and over-widened areas within the reach from cattle entering the stream that are large contributors of sediment. While surveying at the site, the landowner discussed how the stream was much narrower and had deep pools (characteristics of an E channel) when he was growing up and fish like northern pike *Esox lucius* were abundant. At some point, the landowner began row-crop farming near the stream and noticed stream succession take place to a wider, shallower channel. Recognizing the effect land use changes had on the stream, the landowner began rotational grazing and establishing a more flourished riparian buffer (Todd Kolander, MNDNR District Manager, personal communication). Although it is difficult to see from aerial photos, Figure 50 shows the study reach in 1938, 1955, and 2011 to document any potential changes that have occurred during the landowner's life span. Figure 50 also shows how wide the channel is upstream of the bridge compared to the rest of the reach; a potential impact on stream stability. Case studies like this show how changes in riparian land use can have a direct impact on stream stability. Undesirable fish communities at this site could be a result of historical channel succession, and the fact that the stream is not in its stable form. It is likely that if the channel were to evolve back to a narrow, deep stream, it could benefit local fish communities.

Given the deep pools, well vegetated riparian area, and gravel substrate, it appears that Flandreau Creek is beginning to restore itself to a stable stream type. Some areas like where the cattle have been accessing the stream could use more vegetation, but most of the stream has vegetated banks that show little cutting and erosion, also verified by aerial photo analysis. Depending on the finalized bankfull call, the rate of incision appears to be higher than what a stable stream would exhibit, so it is possible that grade control structures like cross vanes could improve floodplain connectivity and sediment transport.

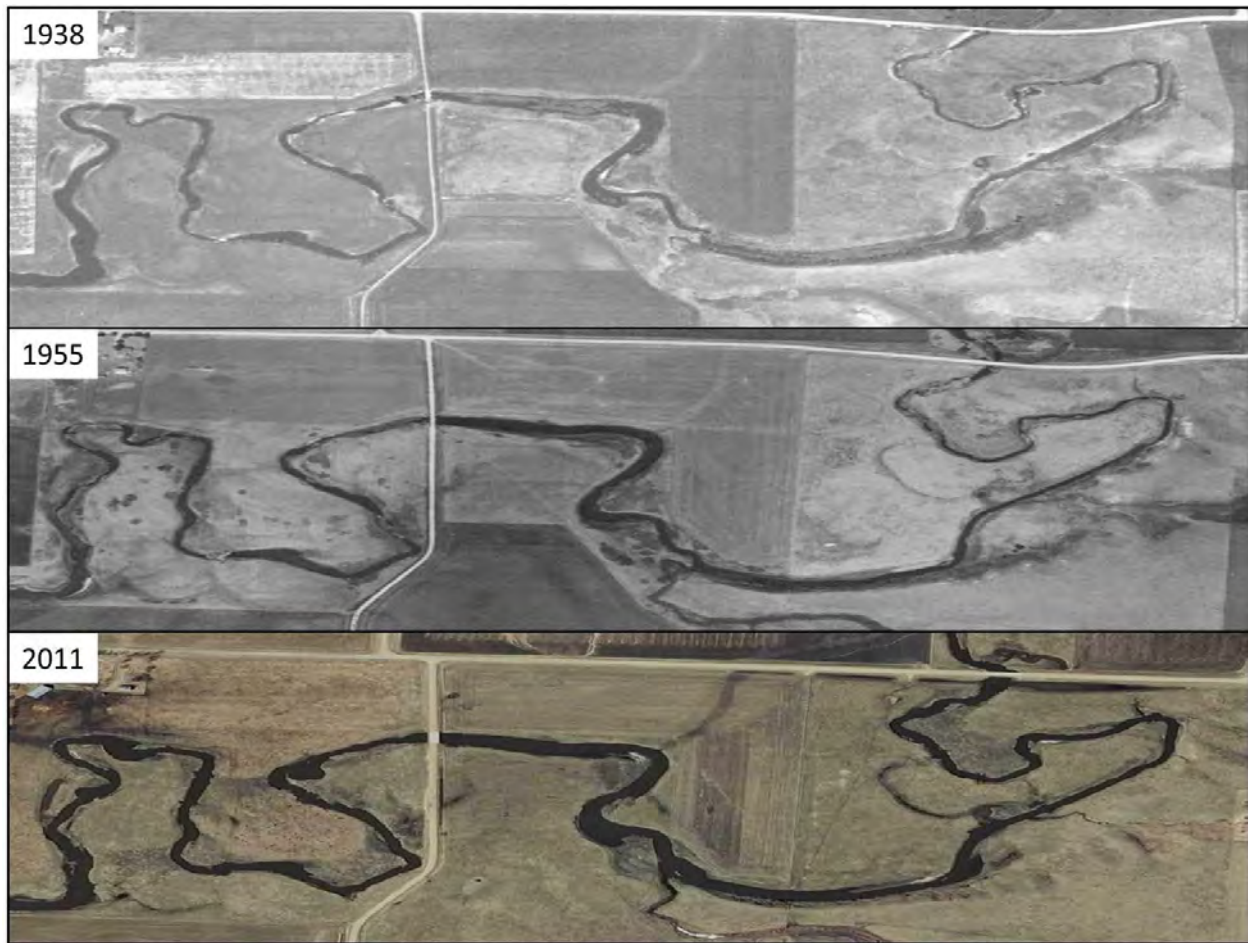
**Figure 50. Aerial photo imagery from 1938-2011 of Flandreau Creek. The pattern of the channel is very similar in 1938 to what it is presently, and some areas appear to be narrower in the past, while others remain similar.**

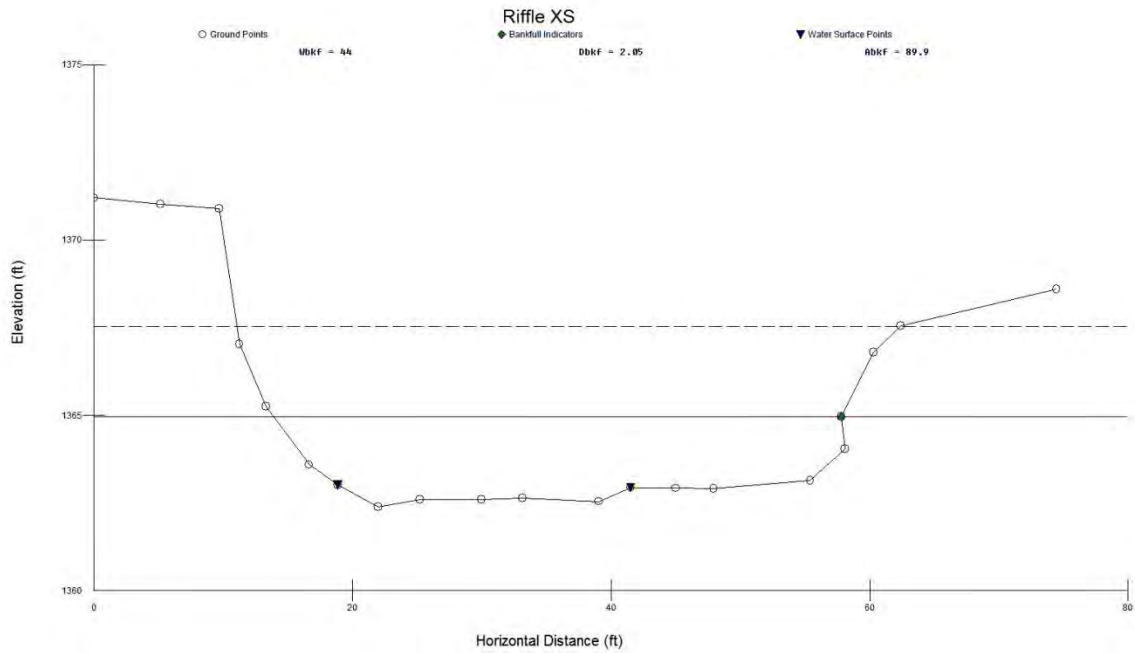
**Figure 52. Graphical view of the representative riffle cross section in the survey reach at the Beaver Creek site.**

The width-to-depth ratio at the riffle is 20.49 (Figure 52), which is high for an alluvial valley type, suggesting there may be some disturbance in this stream or bankfull calls are low. Since bankfull has not been validated, bank height ratio of the cross section is incorrect at this point. Lack of riparian vegetation, Pfankuch stability analysis, and aerial photo analysis suggest that this channel is in a successional state and not stable at this time (Figure 53).

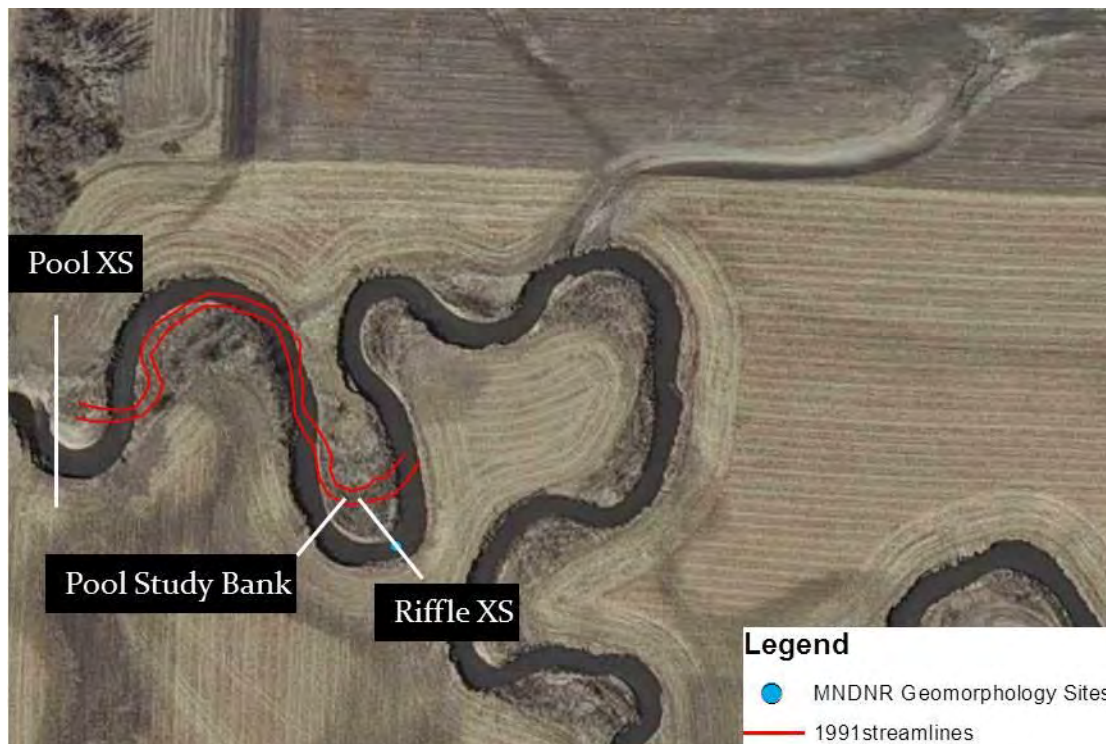
**Figure 53. Aerial photo of the survey reach with labeled cross section locations and 1991 stream lines.**

Overall, the lack of riparian vegetation due to intense row crop agriculture at this site coupled with potentially altered hydrology appears to have set forth channel succession at this site. Much like Chanarambie Creek, Beaver Creek does not exhibit a stable stream type for its alluvial

Given the instability of F channels, there are very few practices that can restore stability. Table 5 states that F5 channels have poor recovery potential, so it is important that a stream like Beaver Creek be restored as a system instead of a site. Like many of the sites in the Missouri River basin, improving the condition of the riparian vegetation would benefit stream health. Row-crop agriculture along the banks of Beaver Creek provides little or no bank protection, resulting in very high bank erosion measurements (2.81'; Figure 54). Now that the stream has reduced floodplain connectivity, it will continue to widen out until a floodplain can be created within the old channel.
