WRAPS report summary Watershed Restoration and Protection Strategy

Cloquet River Watershed

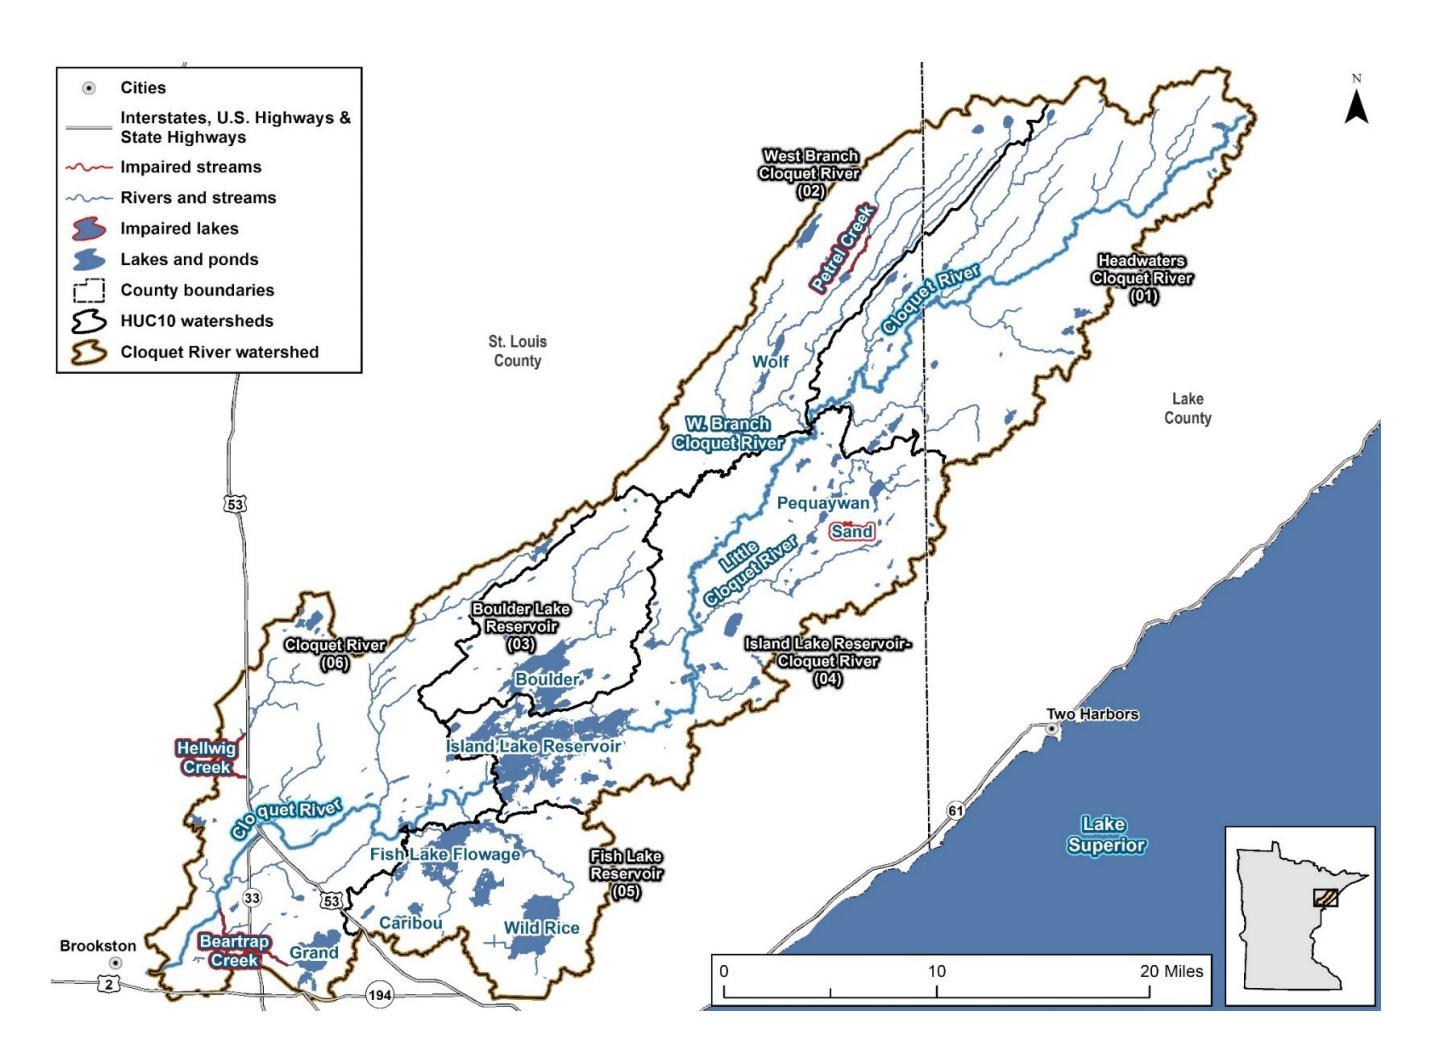
During the first phase of the watershed approach – intensive watershed monitoring – the MPCA collected data about biology such as fish populations, chemistry such as pollutant levels, and flow to determine if streams were meeting water quality standards designed to ensure that waters are fishable and swimmable. Waters are "impaired" if they fail to meet standards. The map at below shows the three impaired streams and one impaired lake in the Cloquet River Watershed.

Twenty-eight uniquely identified stream/river reaches in the watershed were assessed in 2017. Twenty-five stream segments fully support aquatic life. Of the three impaired streams, two of the impairments were attributed to non-pollutant stressors (e.g., lack of quality physical habitat, loss of connectivity), and one stream was impaired due to natural background conditions (wetland dominated watershed with minimal anthropogenic influences).

Twenty-eight lakes fully supported aquatic recreation. One lake did not meet the aquatic recreation standards, however, the impairment was driven by the shallowness of the lake, and by the lake being designated a trout lake and managed by the DNR as a rainbow trout fishery.

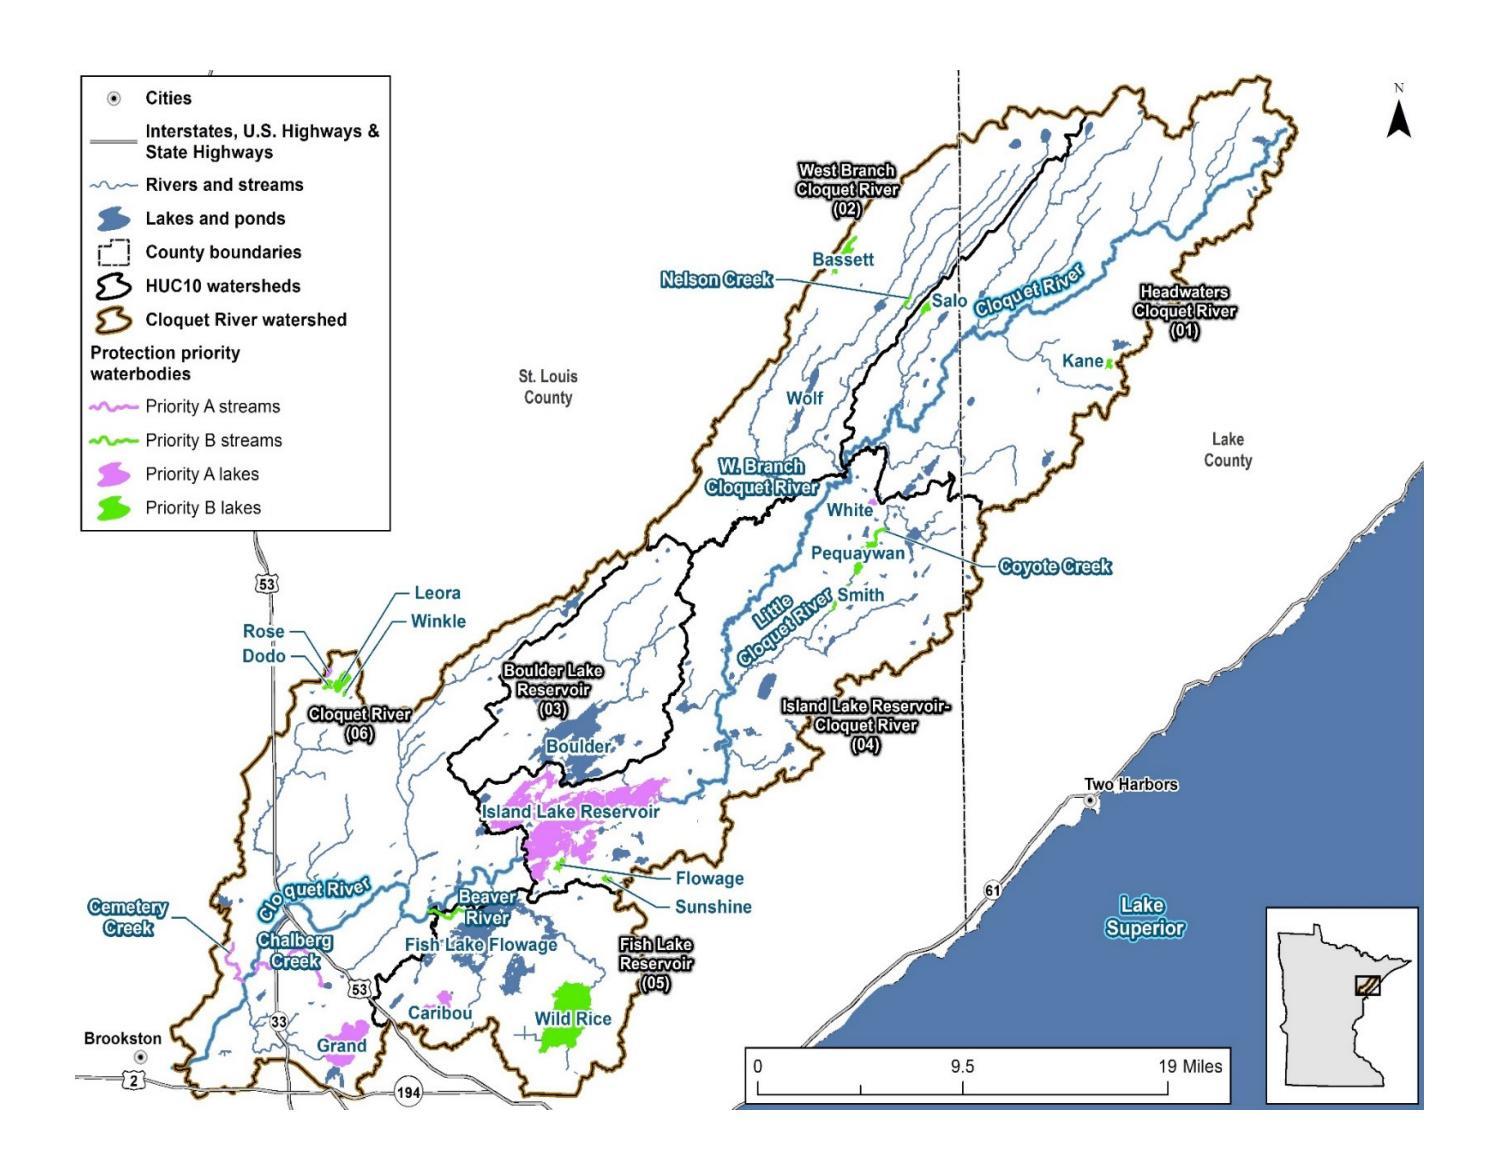
Strategies for addressing the identified issues in the Cloquet River Watershed include promoting shoreland protection, implementing programs for forest protection to maintain healthy working forests on private lands, and restoring altered stream hydrology. The map below displays priority areas for restoration and protection.
