Summary

Chippewa River Watershed

Biological Stressor Identification

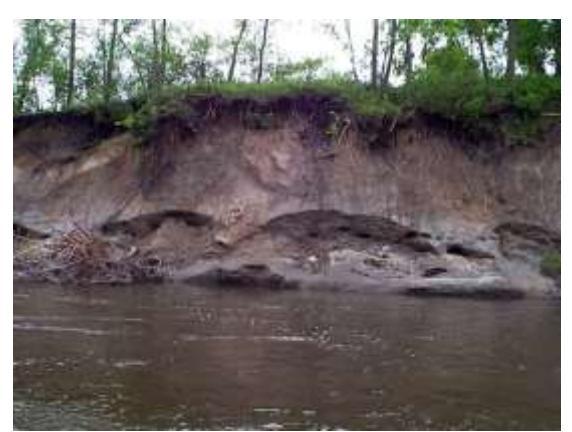
Bank sloughing a source of sediment

Much of the Chippewa River is impaired for turbidity. In 2009 and 2010 most of the Chippewa's load monitoring sites exceeded the standard. In 2009 and 2010 overall, 32% of the samples taken exceeded the standard for turbidity. In the

Chippewa, in areas where row cropping is more prevalent, there is a trend toward higher turbidity during the spring months when there is little canopy cover. The consistently high turbidity levels seen throughout the watershed suggest that aquatic habitat and recreational enjoyment on the Chippewa is seriously degraded.
