April 2020

# Dutch Creek and Fairmont Chain of Lakes Section 319 Small Watershed Focus Program NKE

**Document number:** wq-cwp2-11

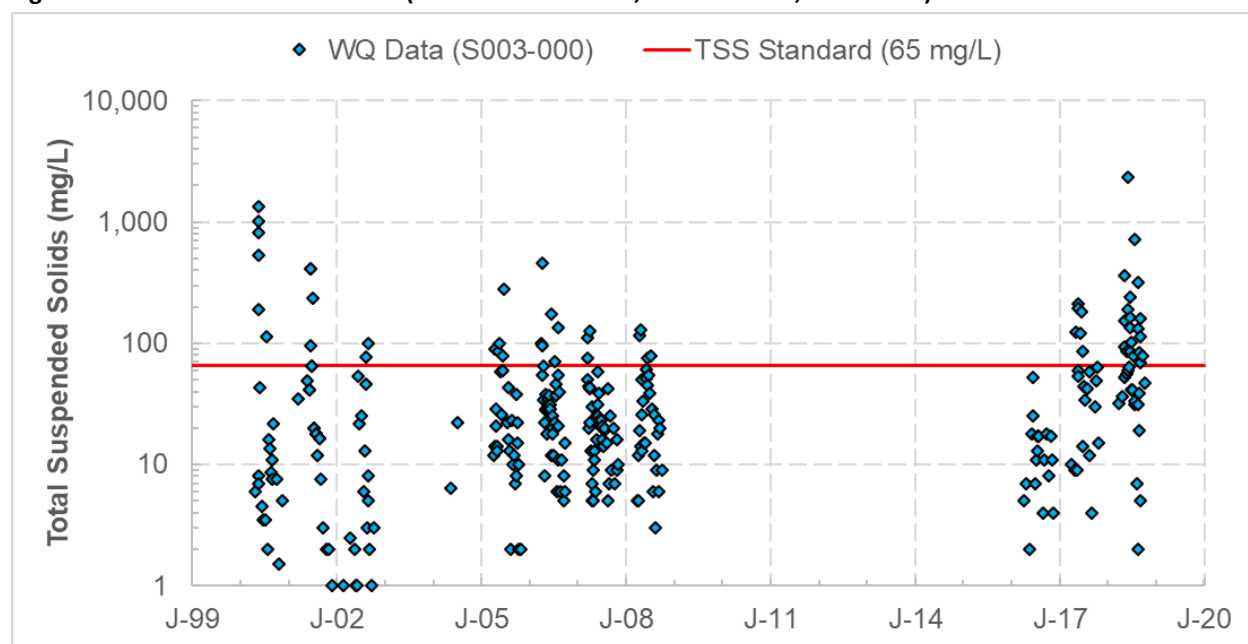
**Figure 12. TSS data for Dutch Creek (AUID 07020009-527, site S003-000, 2005-2018)**

Values in red indicate years in which the numeric criteria (65 mg/L) was exceeded

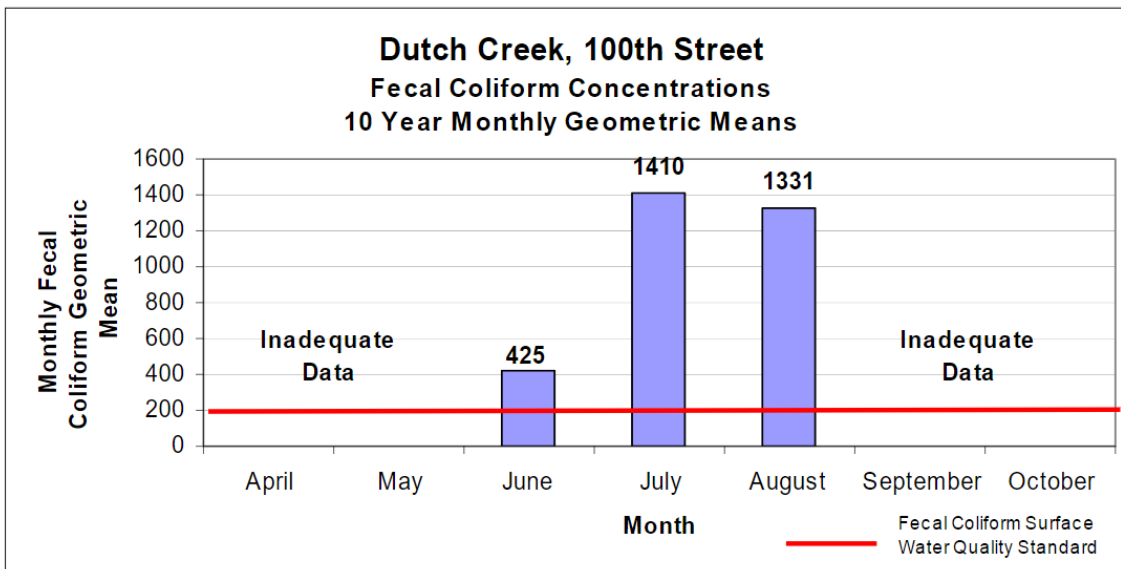
Figure 13. Monthly geometric mean fecal coliform concentrations (1995-2004) (Water Resources Center et al. 2007)

Fecal coliform data are provided in Figure 13, Figure 14, and Table 12 as summarized in the basin-wide fecal coliform TMDL (Water Resources Center et al. 2007). In Dutch Creek, reductions are needed throughout the summer months; in Center Creek, a reduction was only identified for the month of August.

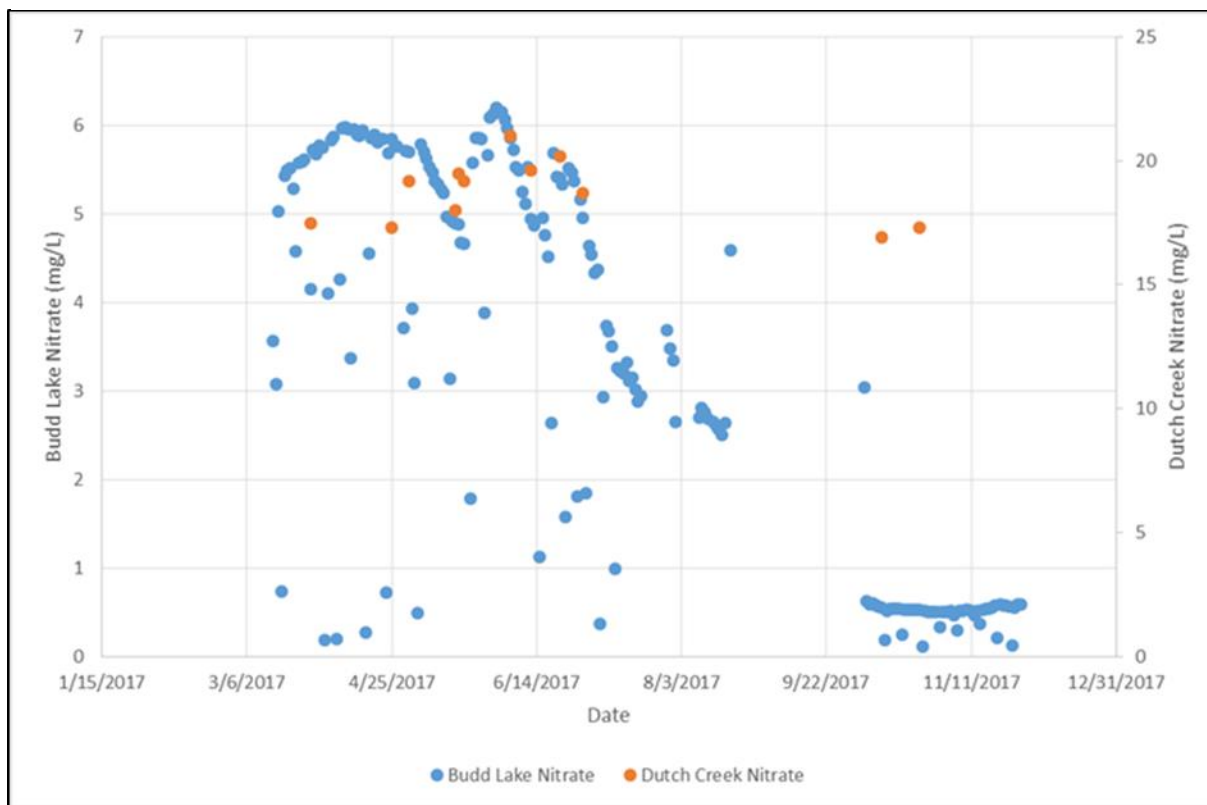
**Figure 20. Dutch Creek and Budd Lake nitrate concentration comparison, 2017 (Tetra Tech 2018) (Note different scales for each waterbody)**

Following the peak in Budd Lake nitrate concentrations in 2016, water quality sampling was completed for Budd Lake and Dutch Creek in 2017. Figure 20 displays the Dutch Creek and Budd Lake nitrate concentrations during 2017. The Dutch Creek nitrate concentrations were consistently above 15 mg nitrate-nitrogen/L. The Budd Lake concentrations were less than 6.5 mg/L nitrate throughout the year with concentrations decreasing to less than 1 mg/L in October and November.

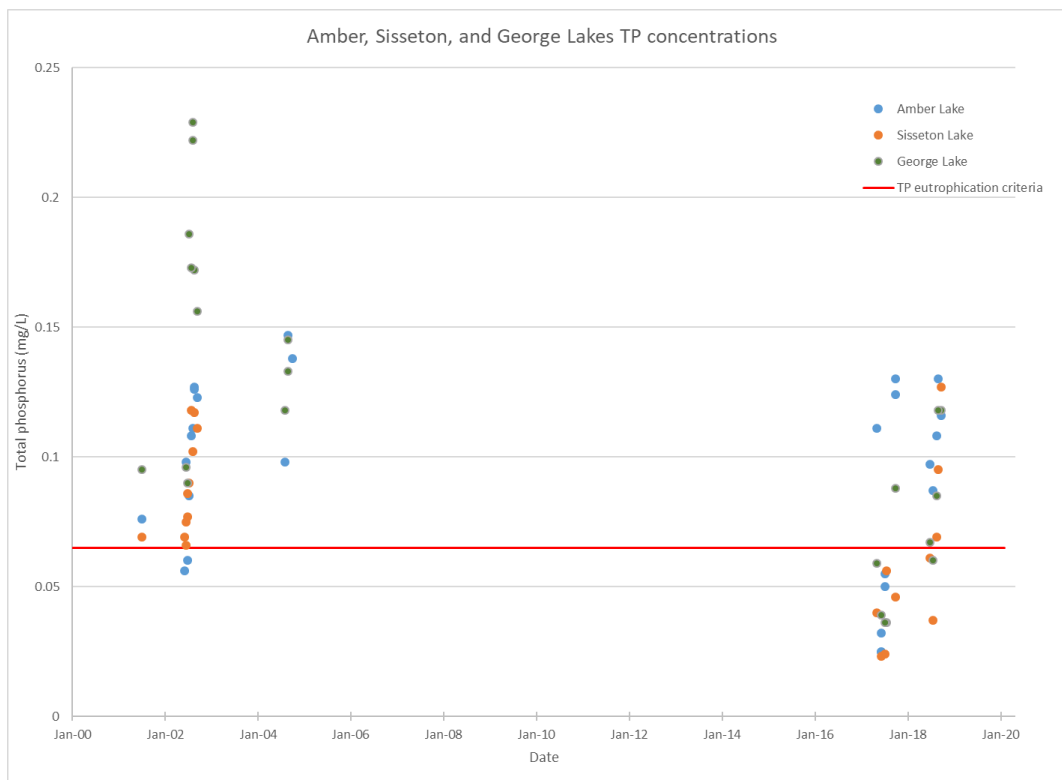
**Figure 21. Total phosphorus 2001-2019 for Amber, Sisseton, and George Lakes**

Water quality data is present for George, Sisseton, and Amber Lakes in 1988, early 2000s, and in recent years. Figure 21 provides a plot of the TP concentrations in the three lakes from 2001 – 2019.

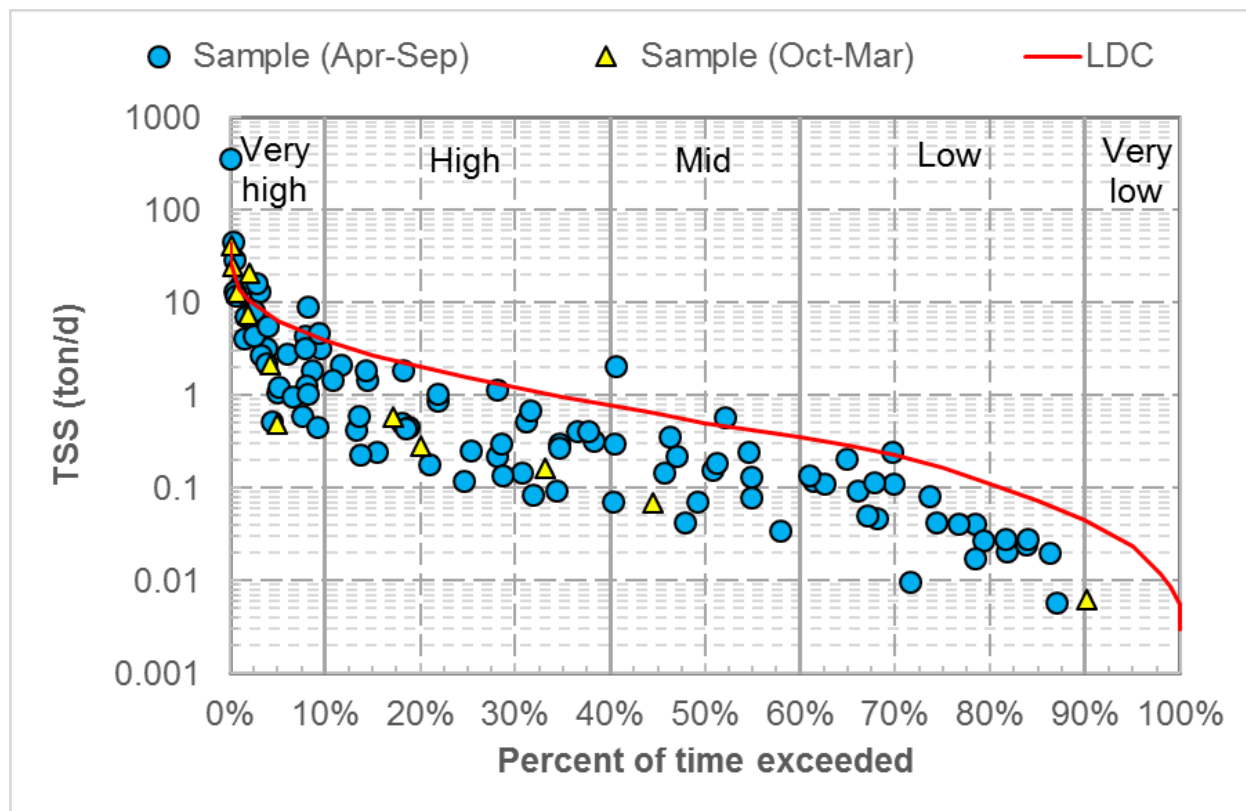
Figure 23. TSS load duration curve, Dutch Creek (527) (MPCA 2019b)

The draft TSS TMDL study determined the load duration curve for Dutch Creek (Figure 23).
