# Thompson Lake

## Results of a Water Quality Study on Thompson Lake in West St. Paul, MN

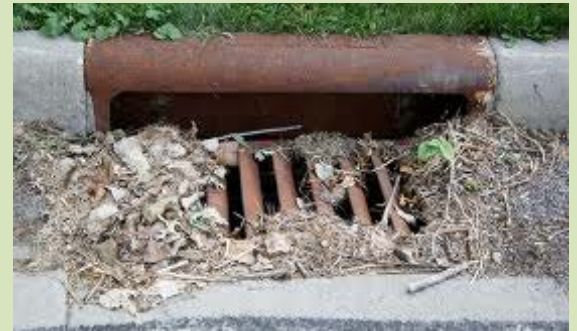
A storm drain funnels rain and snowmelt into stormwater pipes to prevent flooding. But, they also carry pollutants (like oil, deicers, and fertilizers) along with leaves and grass clippings into nearby lakes, streams, or wetlands.
