# Long Prairie River

## Watershed Restoration and Protection Strategies (WRAPS) Report Summary

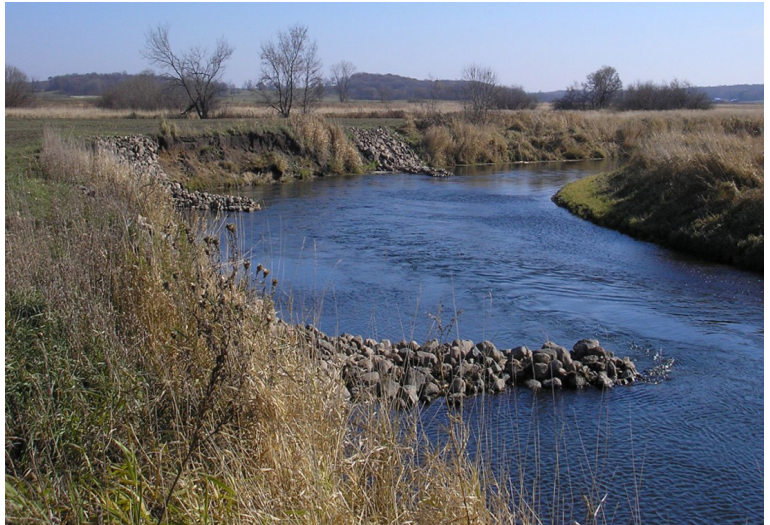
Long Prairie River, showing eroded bank and completed streambarbs. Photo from Shannon Wettstein

Flagship projects in this area included bank stabilizations using engineered streambarbs at locations along the river. Changes to vegetation, hydrology and natural channels have caused many segments of the river cut into banks at the loss of 10-20 feet per year. Streambarbs allow river current energy to be redirected and the barbs enable sediment deposition where banks have eroded.
