# Roseau River Watershed

## Watershed approach

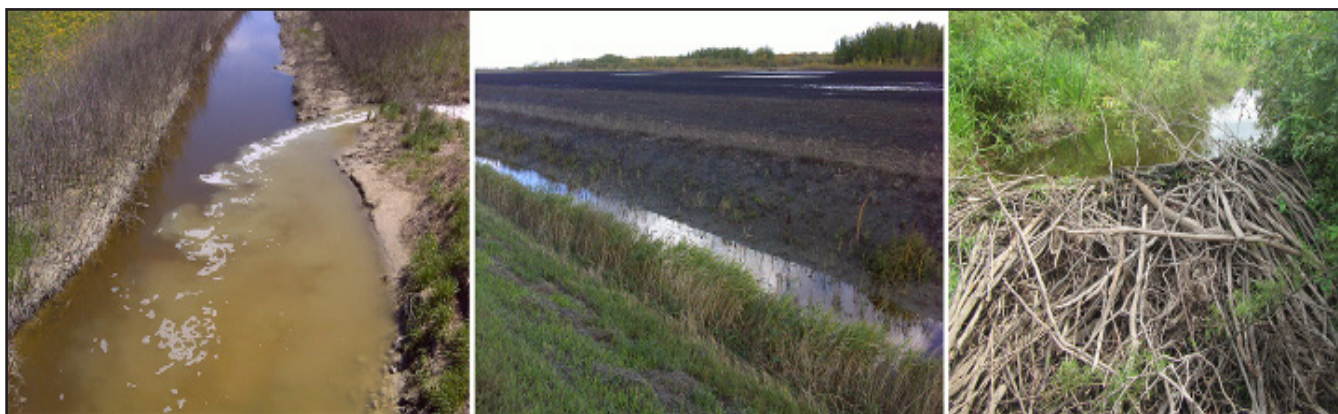
*Images taken during stressor identification field work in the watershed in 2017. Sediment laden water entering Hay Creek from adjacent ditch (left); a partially buffered tributary to Hay Creek (center); and a beaver dam on Severson Creek.*

- Stressors associated with the biologically impaired reaches in the RRW include loss of longitudinal connectivity (barriers to fish passage such as dams, culverts, etc.), flow regime instability (excessively high flows followed by very low-flow conditions), insufficient physical habitat, high suspended sediment, and low dissolved oxygen (DO). Stressors associated with water quality impaired reaches include historical channel modifications that contribute to altered stream hydrology (e.g., extreme peak flows and periods of minimal flow), streambed and bank erosion, upland soil erosion, historical changes in land cover (e.g., native vegetation to cropland), and lack of riparian buffers. Furthermore, livestock populations and unrestricted livestock access to streams contribute toward elevated levels of *E. coli* in the watershed.
